**AQUATIC BASELINE AND IMPACT STUDY AS PART OF
THE ENVIRONMENTAL ASSESSMENT AND
AUTHORISATION PROCESS FOR THE DOORNHOEK
FLUORITE MINE, ZEERUST, NORTH-WEST PROVINCE**

Prepared for

Exigo Pty Ltd

July 2016

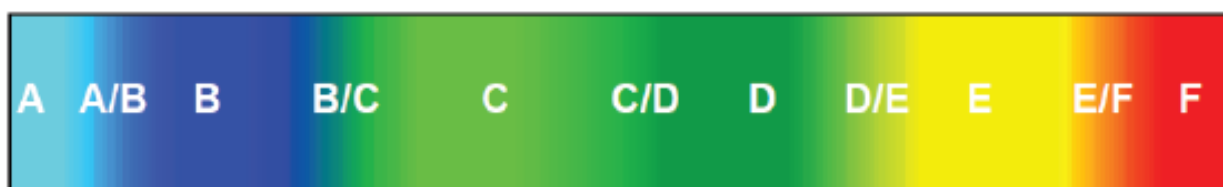
Figure 4: Ecological categories (EC) eco-status A to F continuum approach employed (Kleynhans and Louw 2007)

In addition, the ecological category (EC) classification will be employed using the eco-status A to F continuum approach (Kleynhans and Louw 2007). This approach allows for boundary categories denoted as B/C, C/D etc., as illustrated in Figure 4.

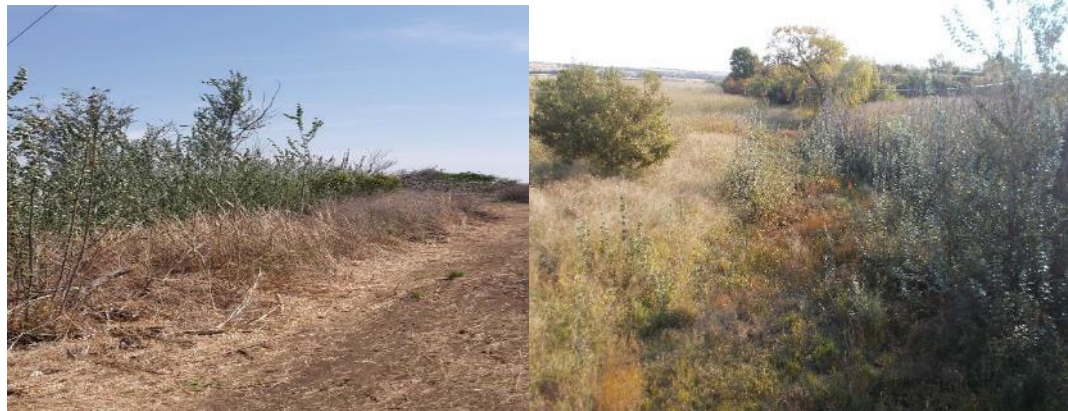
Table 10: Visual description of site DHK IP1 visited during the October 2014 and the May 2016 site assessments.

Figure 7: Interest Point 1 on the upper Klein Marico River at the spring (DHK IP1). Note the severe invasion by *Populus x canescens* during both the October 2014 (left) and the May 2016 (right) assessments.

Significance of the point	Surrounding features	Riparian zone characteristics	Depth and flow characteristics	Water clarity	Impacts and signs of pollution
<p>The site is located on the tarred road bridge. Upstream of this area the system originates in an area dominated by agricultural activities</p>	<p>This site serves to indicate the condition on the upper Klein Marico River system at the spring. The point is upstream of the proposed mining area. The site potentially serves as a reference point for areas further downstream in the system.</p>	<p>The riparian zone along the length of this section of the Klein Marico River is narrow due to the lack of flow in the system. The riparian zone has been severely affected by alien vegetation encroachment</p>	<p>The site was dry at the time of the assessment.</p>	<p>The site was dry at the time of the assessment.</p>	<p>At the time of assessment impacts from upstream agricultural activities is likely. The impact from alien vegetation encroachment is severe.</p>

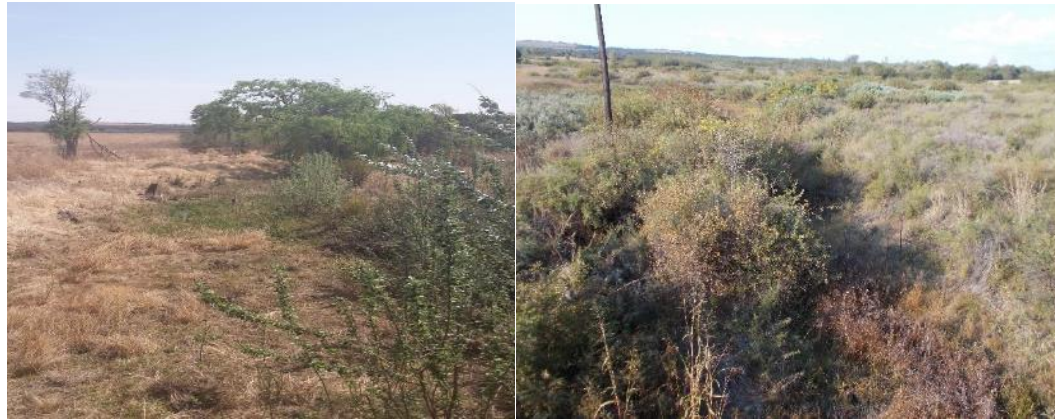
Table 11: Visual description of site DHK IP2 visited during the October 2014 and the May 2016 site assessments.

Figure 8: Downstream view of Interest Point 2 on the upper Klein Marico River (DHK IP2). Note the severe invasion by alien vegetation (left) observed in the October 2014 assessment and the complete lack of flow at this point in the May 2016 assessment (right).

Significance of the point	Surrounding features	Riparian zone characteristics	Depth and flow characteristics	Water clarity	Impacts and signs of pollution
This site serves to indicate the condition on the upper Klein Marico River system downstream of the spring. The point is upstream of the proposed mining area. The site potentially serves as a reference point for areas further downstream in the system	The site is located on the eastern boundary of the study area near to the tarred road	The riparian zone along the length of this section of the Klein Marico River is narrow due to the lack of flow in the system. The riparian zone has been severely affected by alien vegetation encroachment	The site was dry at the time of the assessment.	The site was dry at the time of the assessment.	Impacts from upstream agricultural activities are likely. The impact from alien vegetation encroachment is severe.

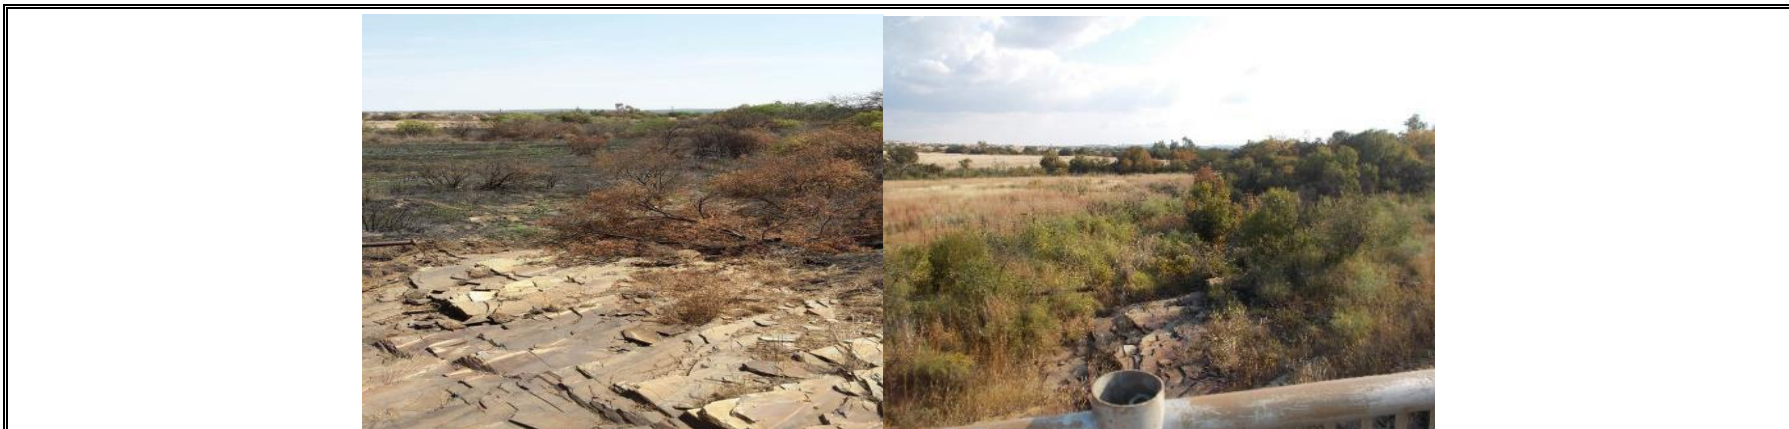
Table 12: Visual description of site DHK IP3 visited during the October 2014 and the May 2016 site assessments.

Figure 9: A general view of a small tributary of the Klein Marico River at Interest point 3 (DHK IP3) during the October 2014 assessment (left). Note the dry bed and the effects from a veld fire. Downstream view of the DHK IP3 site during the May 2016 assessment presented on the right.

Significance of the point	Surrounding features	Riparian zone characteristics	Depth and flow characteristics	Water clarity	Impacts and signs of pollution
<p>Photographs are representative of a small non-perennial tributary of the Klein Marico river near to the DHK B4 point. The point may be of significance during times of flow, potentially affecting water quality in the Klein Marico River system.</p>	<p>The site is located to the north of the Klein Marico River and north of the proposed mining area.</p>	<p>The riparian zone of the system is weakly formed due to a lack of perennial flow in the system.</p>	<p>The site was dry at the time of the assessment.</p>	<p>The site was dry at the time of the assessment.</p>	<p>Impacts from upstream agricultural activities are likely. The impact from fires in the area is considered significant.</p>

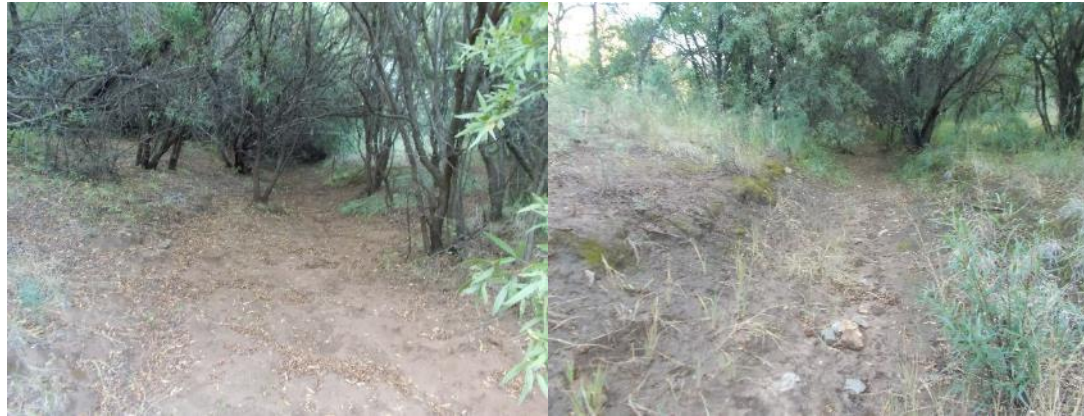
Table 13: Visual description of site DHK IP4 visited during the October 2014 and the May 2016 site assessments.

Figure 10: Upstream view (left) and downstream view (right) of the upper section of a drainage line referred to as the Klein Marico river on some maps (DHK IP4) showing the very dry ephemeral nature of the system during the May 2016 assessment.

Significance of the point	Surrounding features	Riparian zone characteristics	Depth and flow characteristics	Water clarity	Impacts and signs of pollution
Photographs are representative of the upper reaches of a drainage feature referred to as the Klein Marico River on some maps and upstream of the proposed mining area. The site could potentially contribute to some degree to understanding the conditions further downstream.	The site is located in a remote area dominated by grazing activities.	The riparian zone of the system is weakly formed due to a lack of perennial flow in the system. The areas were seen to be significantly affected by livestock grazing	The system was completely dry at the time of assessment.	The site was dry at the time of the assessment.	Impacts from upstream agricultural activities are likely. The impact from livestock grazing is deemed significant.

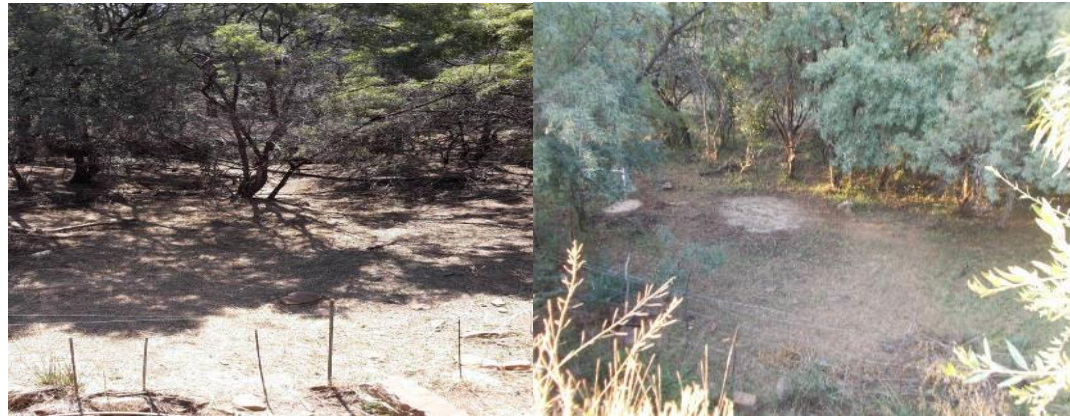
Table 14: Visual description of site DHK IP5 visited during the October 2014 and the May 2016 site assessments.

Figure 11: Upstream view (left) of Interest Point 5 site on an unnamed tributary of the Klein Marico river (DHK IP5) during the October 2014 assessment. Downstream view at this point during the May 2016 assessment provided on the right. Note the dry bed of the system.

Significance of the point	Surrounding features	Riparian zone characteristics	Depth and flow characteristics	Water clarity	Impacts and signs of pollution
<p>The site is situated on a small unnamed tributary of the Klein Marico River to the west of the proposed mining area and downstream of an existing operation. The site is important as a spatial reference and also as a temporal reference prior to the proposed mining of the Doornhoek deposit.</p>	<p>The site is located directly adjacent to the tarred road in the north eastern corner of the study area.</p>	<p>The riparian zone along the length of this well wooded with a fairly limited exotic vegetation component.</p>	<p>The system was completely dry at the time of assessment</p>	<p>The site was dry at the time of the assessment.</p>	<p>Some impact from upstream mining activities may be occurring. Some impacts from livestock grazing may be occurring</p>

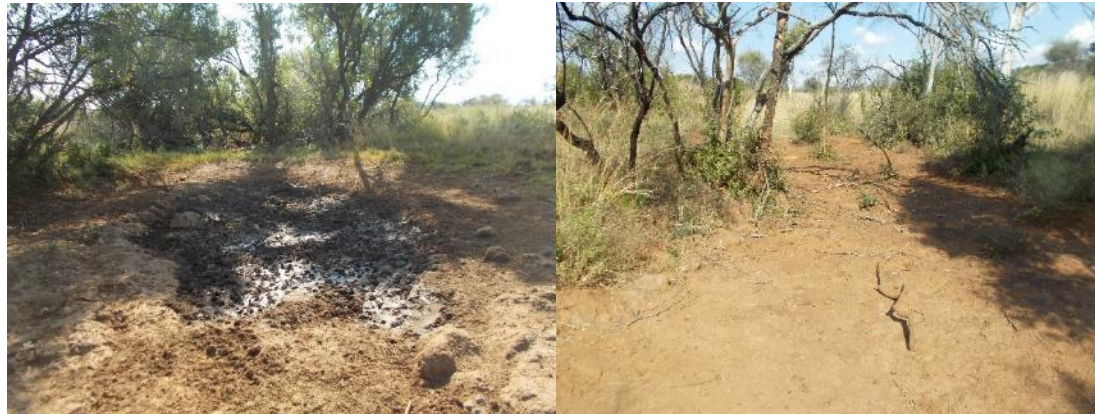
Table 15: Visual description of site DHKK 1 visited during the May 2016 site assessment.

Figure 12: Downstream view (left) of site DHKK 1 visited in the May 2016 assessment on a drainage line in the vicinity of the upper reaches of the Klein Marico river. Upstream view at this point (right) Note the dry bed of the system and the unsuitability of this site for the application of the various biomonitoring indices.

Significance of the point	Surrounding features	Riparian zone characteristics	Depth and flow characteristics	Water clarity	Impacts and signs of pollution
The site is situated on a small drainage line in the vicinity of the upper reaches of the Klein Marico River. The site aids in providing a holistic view of the state of the aquatic resources in the study area and the associated drainage lines.	The site is located within the proposed 20 year mining area and downstream of the proposed 10 – 20 year mining area. It is situated in an open area and can be accessed via a gravel road.	The riparian zone along the length of this drainage line is well wooded with a grassy understory and a fairly limited exotic vegetation component.	The system was completely dry at the time of assessment.	The site was dry at the time of the assessment.	Some impact from upstream mining activities may be occurring. It is evident that when water is present, the site is used as a watering hole for game.

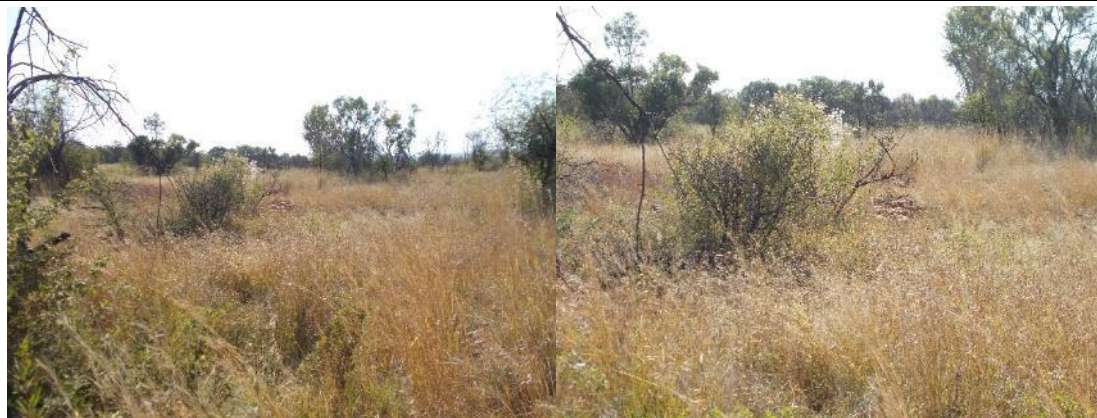
Table 16: Visual description of site DHKK 2 visited during the May 2016 site assessment.

Figure 13: Downstream view of site DHKK 2 visited in the May 2016 assessment on a drainage line in the vicinity of the upper reaches of the Klein Marico river. Note the dry bed of the system and the unsuitability of this site for the application of the various biomonitoring indices.

Significance of the point	Surrounding features	Riparian zone characteristics	Depth and flow characteristics	Water clarity	Impacts and signs of pollution
<p>The site is situated on a small drainage line in the vicinity of the upper reaches of the Klein Marico River. The site is situated upstream of site DHKK 1 and aids in providing a holistic view of the state of the aquatic resources in the study area and the associated drainage lines.</p>	<p>The site is located within the proposed 20 year mining area and downstream of the proposed 10 – 20 year mining area. It is situated in an open area and can be accessed via a gravel road.</p>	<p>The riparian zone along the length of this drainage line is dominated by grasses and a fairly limited exotic vegetation component.</p>	<p>The system was completely dry at the time of assessment.</p>	<p>The site was dry at the time of the assessment.</p>	<p>None evident.</p>

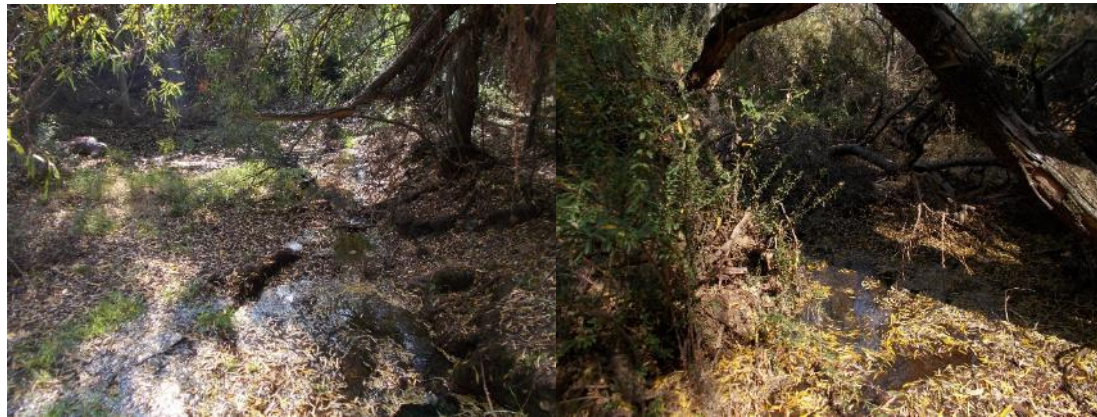
Table 17: Visual description of site DHKK 3 visited during the May 2016 site assessment.

Figure 14: Downstream view (left) of site DHKK 3 visited in the May 2016 assessment on the Klein Marico river. Upstream view at this point (right).

Significance of the point	Surrounding features	Riparian zone characteristics	Depth and flow characteristics	Water clarity	Impacts and signs of pollution
<p>The site is situated on the Klein Marico River itself and while suitable for the application of the various biomonitoring indices was considered near enough to site DHKK 4 for a visual assessment only to be sufficient. The site aids in providing a holistic view of the state of the aquatic resources in the study area.</p>	<p>The site is located downstream of the proposed 20 year mining area and downstream of the proposed 10 – 20 year mining area. It is situated in an open area on a game farm and can be accessed via a gravel road.</p>	<p>The riparian zone along the length of this drainage line is well wooded with a fairly limited understory. There is very little to no impact at this point as a result of exotic vegetation encroachment.</p>	<p>The system was relatively shallow and comprised of pools and runs <math>< \frac{1}{2}</math> m deep.</p>	<p>Water was clear.</p>	<p>None evident.</p>

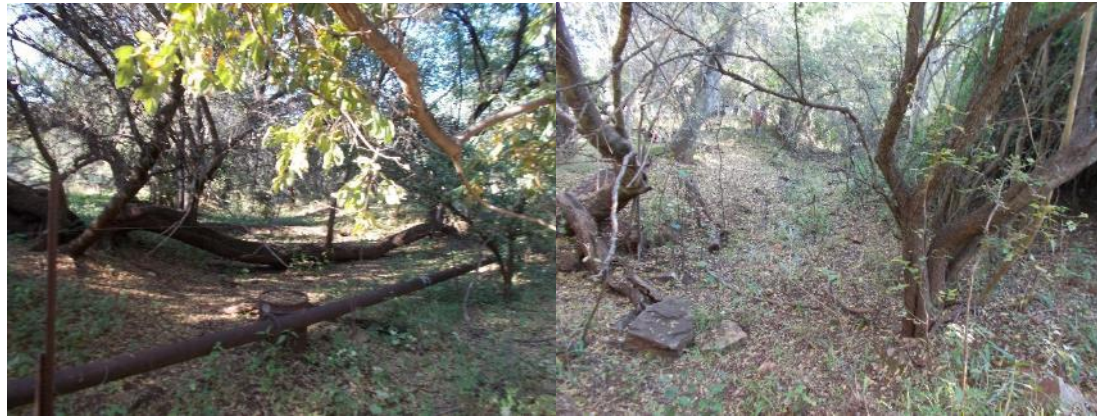
Table 18: Visual description of site DHKK 5 visited during the May 2016 site assessment.

Figure 15: Upstream view (left) of site DHKK 5 visited in the May 2016 assessment on a drainage line in the vicinity of site DHK B1. Downstream view at this point (right).

Significance of the point	Surrounding features	Riparian zone characteristics	Depth and flow characteristics	Water clarity	Impacts and signs of pollution
<p>The site is situated on a drainage line in the vicinity of the unnamed tributary of the Klein Marico River. The site aids in providing a holistic view of the state of the aquatic resources in the study area and the associated drainage lines.</p>	<p>The site is located downstream of the proposed 20 year mining area and downstream of the proposed 10 – 20 year mining area. It is situated in an open area on a game farm and can be accessed via a gravel road.</p>	<p>The riparian zone along the length of this drainage line is well wooded with a fairly limited understory. There is very little to no impact at this point as a result of exotic vegetation encroachment.</p>	<p>This point was dry at the time of the assessment.</p>	<p>Site was dry at the time of the assessment.</p>	<p>None evident.</p>

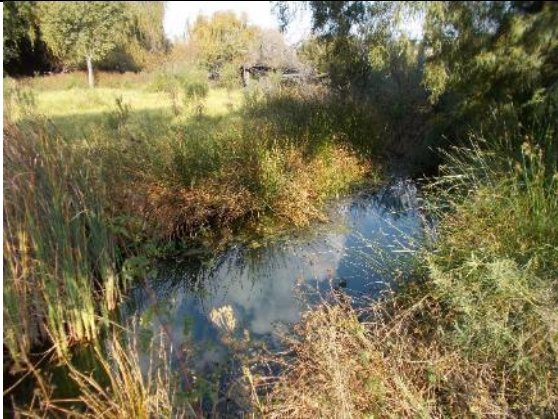
Site DHK B3		In situ physico-chemical water quality			Aquatic macro-invertebrate community integrity

Parameter	October 2014	May 2016	Invertebrate community assessment (SASS5 and IHAS)				
		pH	6.96	7.73	Parameter	October 2014	May 2016		
		EC (mS/m)	45.3	52.0	SASS5 score	70	64		
		DO (mg/L)	6.23	6.12	Number of taxa	14	12		
				ASPT score	5.0	5.3			
				IHAS score	65 (Adequate)	55 (Inadequate)			
				MIRAI score	62.1	54.4			
		Site specific temporal water quality variations (% var)			Site specific aquatic invertebrate community variations				
		Parameter	% Var compared to feasibility assessment (October 2014)		Parameter	% of ref ecoregion data October 2014	% of ref ecoregion data May 2016	% Var May 2016 compared to October 2014	
		pH	+11.1		SASS5	46.7	42.7	-8.6	
		EC (mS/m)	+14.8		ASPT	84.7	89.8	+6.0	
		DO (% sat)	-0.9		IHAS	NA	NA	-15.4	
Algal proliferation	Significant algal proliferation was noted on the rocks at this point. Both marginal and aquatic vegetation were also significantly affected as a result of algal proliferation.	Sensitive macro-invertebrate species observed at this point: <i>Atyidae, Hydracarina, Lestidae</i>			Key Drivers of System Change

Depth profiles	The river consisted mostly of shallow riffles and deep sections in the larger pools.	Fish species observed: None			<ul style="list-style-type: none"> ➤ Flow is severely affected at this point as a result of the road crossing; ➤ Lack of significant flow variation and diversity will largely shape the structure of the aquatic macro-invertebrate community at this point and taxa dependent on faster flow conditions are likely to be largely absent; ➤ The presence of relatively sensitive species, which are adapted to slow flowing pool like habitat, serve as an indication that the water quality at this point is currently unlikely to limit the aquatic community present. 				
Flow condition	The Klein Marico River was flowing very slowly at this point. No fast flowing water was present.	Additional species observed: <i>Daphnia</i> sp.			<ul style="list-style-type: none"> ➤ The low flows and water abstraction from the system of the Klein Marico River in the vicinity of the proposed project reduces the Ecological Importance and Sensitivity of the system in this area significantly; ➤ The Klein Marico River system is expected to exhibit broad variability in aquatic community integrity on a temporal scale due to variations in flow and habitat availability in the system. As more data on the system is collected, better inferences on the ecological condition of the community will be possible; ➤ Due to the degree of sensitivity of the system to habitat changes and loss of instream flow, careful design and operational procedures will be required to limit the impact on the Klein Marico River.

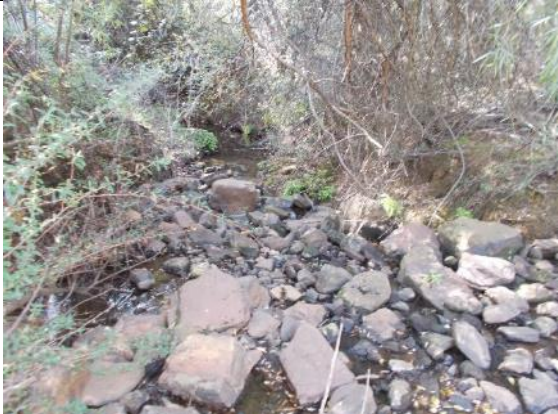
Site DHKK 4		In situ physico-chemical water quality		Aquatic macro-invertebrate community integrity

Parameter	May 2016	Invertebrate community assessment (SASS5 and IHAS)	
		pH	8.04	Parameter	May 2016
		EC (mS/m)	48.0	SASS5 score	114
		DO (mg/L)	6.45	Number of taxa	21
DO (% sat)	75.58	ASPT score	5.4	IHAS score	60 (Inadequate)
Temp (°C)	15.7	MIRAI score	79.6	Site specific aquatic invertebrate community variations from reference data	
		Parameter	% of ref ecoregion data May 2016		
		SASS5	76.0		
		ASPT	91.5		
		IHAS	NA		
Algal proliferation	None noted.	Sensitive macro-invertebrate species observed at this point: <i>Atyidae, Hydracarina, Caenidae, Gomphidae Pyralidae, Philopotamidae</i>		Key Drivers of System Change <ul style="list-style-type: none"> ➤ Lack of significant flow variation and diversity will largely shape the structure of the aquatic macro-invertebrate community at this point and taxa dependent on faster flow conditions are likely to be largely absent; ➤ The presence of very sensitive species, with special mention of the <i>Pyralidae</i>, which are adapted to slow flowing pool habitat, serve as an indication that the water quality at this point is currently unlikely to limit the aquatic community present. ➤ The Klein Marico River system is expected to exhibit broad variability in aquatic community integrity on a temporal scale due to variations in flow and habitat availability in the system. As more data on the system is collected, better inferences on the ecological condition of the community will be possible; ➤ Due to the degree of sensitivity of the system to habitat changes and loss of instream flow, careful design and operational procedures will be required to limit the impact on the Klein Marico River.

Depth profiles	The river was generally $\lt; \frac{1}{2}$ m at this point at the time of the assessment.	Fish species observed: None			
Flow condition	The Klein Marico River was flowing slowly at this point. No fast flowing water was present.	Additional species observed: <i>Daphnia</i> sp. Tadpoles			
Riparian zone characteristics	The riparian vegetation is relatively sparse and consists of a mix of sedges, grasses, shrubs and riparian trees.	Impacts and Essential Mitigation No impacts were observed.			
Water clarity and odour	Water was clear at the time of the assessment. No odours were evident.				
Significance	The point also serves to indicate the condition of the Klein Marico River prior to any effects as a result of the activities of the proposed Doornhoek mining project.				
SITE ECOSTATUS CATEGORY	May 2016				
Dickens & Graham (2001)	Category B				
Dallas (2007)	Category C/D				
MIRAI	Category B

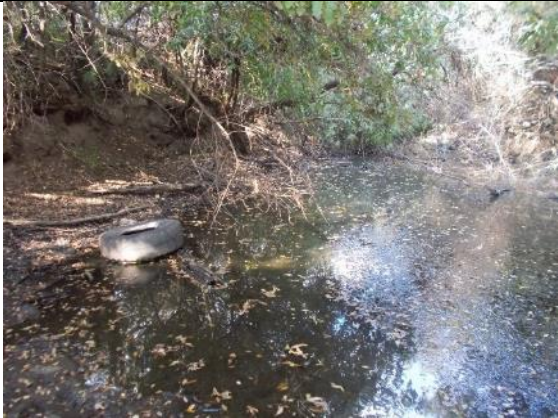
Site DHK B4		In situ physico-chemical water quality			Aquatic macro-invertebrate community integrity

Parameter	October 2014	May 2016	Invertebrate community assessment (SASS5 and IHAS)				
		pH	7.82	7.91	Parameter	October 2014	May 2016		
		EC (mS/m)	37.9	48.0	SASS5 score	67	70		
		DO (mg/L)	6.86	6.36	Number of taxa	12	15		
		DO (% sat)	85.2	71.4	ASPT score	5.6	4.7		
Temp (°C)	18.5	13.7	IHAS score	57 (Inadequate)	44 (Inadequate)				
		Site specific temporal water quality variations (% var)			Site specific aquatic invertebrate community variations				
		Parameter	% Var compared to feasibility assessment (October 2014)		Parameter	% of ref ecoregion data October 2014	% of ref ecoregion data May 2016	% Var May 2016 compared to October 2014	
		pH	+1.2		SASS5	44.7	46.7	+4.5	
		EC (mS/m)	+26.6		ASPT	94.9	79.7	-16.1	
		DO (% sat)	-16.2		IHAS	NA	NA	-22.8	
Algal proliferation	None observed.		Sensitive macro-invertebrate species observed at this point: <i>Hydracarina, Caenidae, Lestidae</i>			Key Drivers of System Change

Depth profiles	The river consisted mostly of shallow glides and deep sections in the larger pools.		Fish species observed: <i>Tilapia sparrmani</i> x 5			➤ Flow is severely affected at this point as a result of the road crossing;			
Flow condition	The Klein Marico River was flowing very slowly at this point. No fast flowing water was present.		Additional species observed: Frogs and tadpoles.			➤ Lack of significant flow variation and diversity will largely shape the structure of the aquatic macro-invertebrate community at this point and taxa dependent on faster flow conditions are likely to be largely absent;			
Riparian zone characteristics	The riparian zone along the length of this section of the Klein Marico River is narrow and incised with a weakly developed riparian zone. Trees dominate the area and the banks are categorised with a sparse understory.		Impacts and Essential Mitigation			➤ The Klein Marico River system is expected to exhibit broad variability in aquatic community integrity on a temporal scale due to variations in flow and habitat availability in the system;

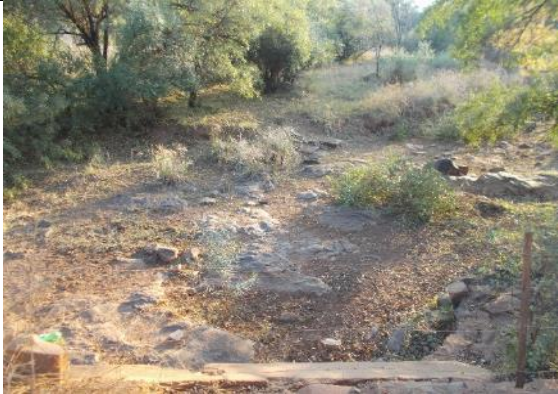
Site DHK B5		In situ physico-chemical water quality		Aquatic macro-invertebrate community integrity

<p>Figure 19: Downstream view of the DHK B5 site during the May 2016 assessment.</p>		Parameter	October 2014	Invertebrate community assessment (SASS5 and IHAS)	
				Parameter	October 2014
		pH	7.59	SASS5 score	70
		EC (mS/m)	52.6	Number of taxa	14
DO (mg/L)	7.39	ASPT score	5.0		
DO (% sat)	89.75	IHAS score	54 (Inadequate)		
Temp (°C)	17.4	MIRAI score	62.1		
		Site specific aquatic invertebrate community variations from reference data			
		Parameter	% of ref ecoregion data October 2014		
		SASS5	46.7		
		ASPT	84.7		
		IHAS	NA		
Algal proliferation	Some algal proliferation was observed in the October 2014 assessment.	Sensitive macro-invertebrate species observed at this point: <i>Caenidae</i>		Key Drivers of System Change <ul style="list-style-type: none"> ➤ The Klein Marico River system is expected to exhibit broad variability in aquatic community integrity on a temporal scale due to variations in flow and habitat availability in the system. The lack of flow at this point is likely seasonal and possibly related to drought conditions experienced at the time of the May 2016 assessment. However, this is likely to severely limit the diversity and sensitivity of the aquatic macro-invertebrate community expected to occur at this point; ➤ In addition, the results of the water quality analysis during the October 2014 assessment suggests that some impact to water quality at this point may limit the sensitivity of the aquatic community present; ➤ When water is present, the aquatic community likely to occur at this point will be limited to those species adapted specifically to slow flows and still water environments; ➤ Due to the degree of sensitivity of the system to habitat changes and loss of instream flow, careful design and operational procedures will be required to limit the impact on the Klein Marico River.

Depth profiles	Water was absent at this point during the May 2016 assessment.	Fish species observed: None			
Flow condition	According to the assessment in October 2014, when water is present, the Klein Marico River is characterised by slow flows at this point. However, water was absent in the current May 2016 assessment.	Additional species observed: None			
Riparian zone characteristics	The riparian vegetation is relatively sparse and consists of a mix of sedges, grasses, shrubs and riparian trees.	Impacts and Essential Mitigation			
Water clarity and odour	Water was clear during the October 2014 assessment, while water was absent in the May 2016 assessment. No odours were evident.	During the October 2014 assessment, limited impacts on the instream ecology were visually evident, although some impact due to water abstraction from the system leading to reduced instream flow and loss of refuge pools was considered likely to be occurring. Some impact on water quality was also deemed possible due to the algal growth observed in the system and some impact from livestock watering was observed. The lack of water at this point during the May 2016 assessment may be related to water abstraction activities taking place upstream of this point, however, nation-wide drought conditions in the months preceding the May 2016 assessment are likely to have exacerbated this impact.

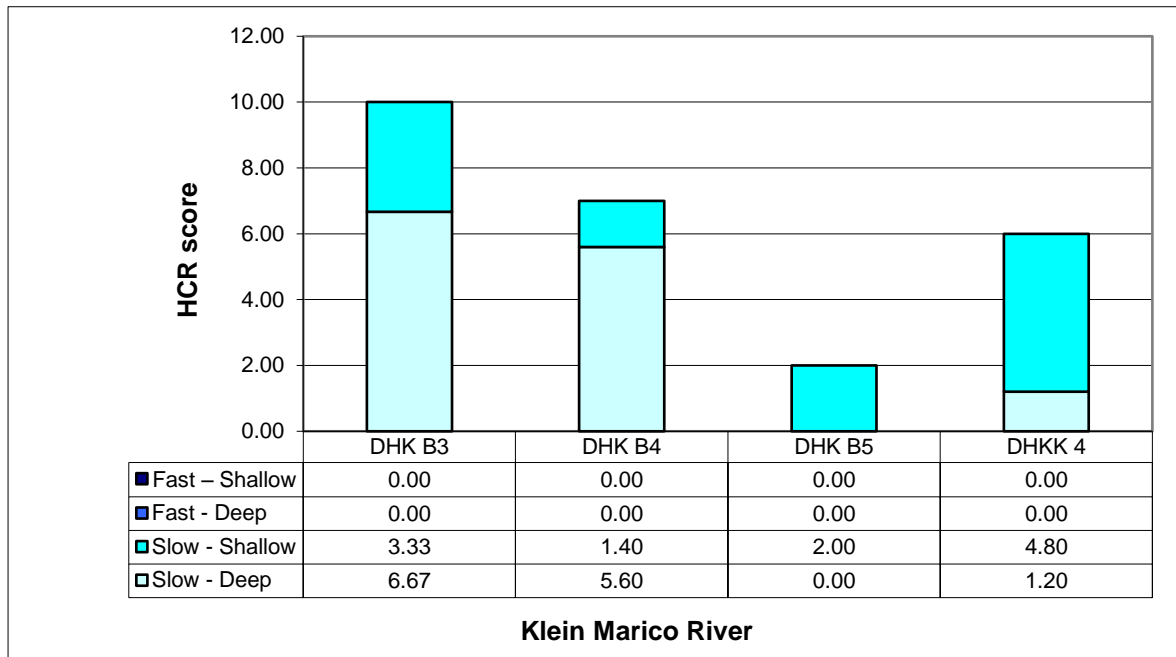
The HCR (Habitat Cover Rating) results for the Klein Marico River sites assessed in October 2014 and the May 2016 (DHK B3, DHK B4, DHK B5 and DHKK 4) are provided below.

Figure 20: HCR scores for the sites assessed on the Klein Marico River considered to be representative of conditions during both the October 2014 and May 2016 site visits.

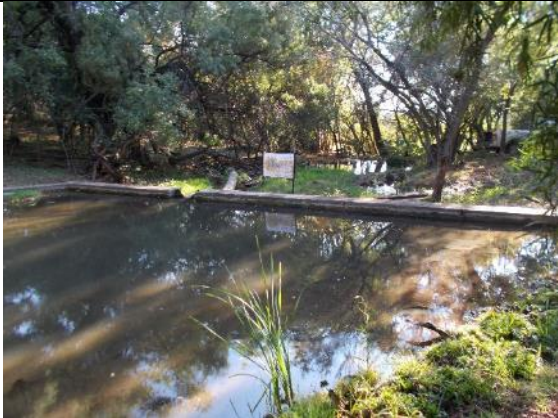
Site DHK B1		In situ physico-chemical water quality			Aquatic macro-invertebrate community integrity

Parameter	October 2014	May 2016	Invertebrate community assessment (SASS5 and IHAS)			
		pH	7.53	7.98	Parameter	October 2014	May 2016	
		EC (mS/m)	45.3	53.0	SASS5 score	32	91	
		DO (mg/L)	7.45	7.26	Number of taxa	7	18	
		DO (% sat)	85.44	91.99	ASPT score	4.6	5.1	
Temp (°C)	21.7	19.5	IHAS score	52 (Inadequate)	72 (Adequate)			
		Site specific temporal water quality variations (% var)			Site specific aquatic invertebrate community variations			
		Parameter	% Var compared to feasibility assessment (October 2014)		Parameter	% of ref ecoregion data October 2014	% of ref ecoregion data May 2016	% Var May 2016 compared to October 2014
		pH	+5.98		SASS5	21.3	60.7	+184.4
		EC (mS/m)	+17.0		ASPT	78.0	86.4	+10.9
		DO (% sat)	+7.7		IHAS	NA	NA	+38.5
Algal proliferation	None.	Sensitive macro-invertebrate species observed at this point: <i>Atyidae, Hydracarina, Caenidae, Gomphidae</i>			Key Drivers of System Change

Depth profiles	The river consisted mostly of a shallow pool and isolated shallow runs in some areas.	Fish species observed: None			➤ Lack of significant flow variation and diversity will largely shape the structure of the aquatic macro-invertebrate community at this point and taxa dependent on faster flow conditions are likely to be largely absent;			
Flow condition	The unnamed tributary of the Klein Marico River was flowing very slowly at this point. No fast flowing water was present.	Additional species observed: None.			➤ The presence of relatively sensitive species, which are adapted to slow flowing pool like habitats, serve as an indication that the water quality at this point is currently unlikely to limit the aquatic community present.			
Riparian zone characteristics	The riparian zone at the spring is intact but a short distance downstream grazing and other disturbances along with water abstraction have severely affected the site. The riparian zone at this point is affected by alien vegetation encroachment to a small degree and some impacts as a result of erosion at this point are evident.	Impacts and Essential Mitigation At the time of assessment no significant impacts on the instream ecology were visually evident. Small impacts related to erosion in some areas as a result of poor vegetation cover, limited impacts associated with alien vegetation encroachment and the build-up of detritus in the system were observed.			➤ The low flows and water abstraction from this system reduces the Ecological Importance and Sensitivity significantly;

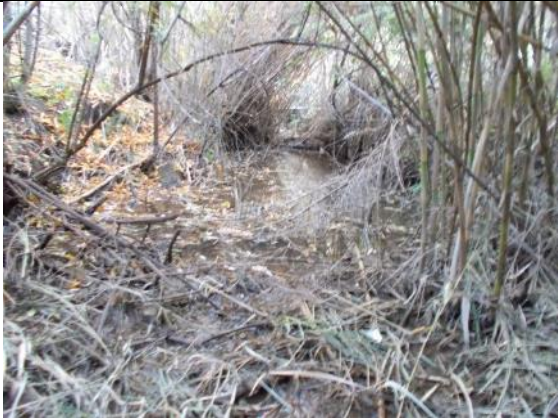
Site DHK B2		In situ physico-chemical water quality			Aquatic macro-invertebrate community integrity

Parameter	October 2014	May 2016	Invertebrate community assessment (SASS5 and IHAS)			
		pH	7.92	7.80	Parameter	October 2014	May 2016	
		EC (mS/m)	51.5	64.0	SASS5 score	61	47	
		DO (mg/L)	8.29	6.43	Number of taxa	9	12	
DO (% sat)	87.72	71.65	ASPT score	6.8	3.9			
Temp (°C)	17.5	13.4	IHAS score	59 (Inadequate)	46 (Inadequate)			
		Site specific temporal water quality variations (% var)			Site specific aquatic invertebrate community variations			
		Parameter	% Var compared to feasibility assessment (October 2014)		Parameter	% of ref ecoregion data October 2014	% of ref ecoregion data May 2016	% Var May 2016 compared to October 2014
		pH	-1.5		SASS5	40.7	31.3	-23.0
		EC (mS/m)	+24.3		ASPT	115.3	66.1	-42.6
		DO (% sat)	-18.3		IHAS	NA	NA	-22.0
Algal proliferation	Algal proliferation was observed in isolated areas at this point.		Sensitive macro-invertebrate species observed at this point: <i>Atyidae, Hydracarina</i>			Key Drivers of System Change <ul style="list-style-type: none"> Lack of significant flow variation and diversity at this point largely shapes the structure of the aquatic macro-invertebrate community present with taxa dependent on faster flow conditions absent; The severely reduced flow at this site in relation to the upstream DHK B1 site (resulting from the weir constructed at the latter site further reducing flow) plays a significant role in the spatial variation of the SASS5 and ASPT scores obtained in the current assessment, with the SASS5 score decreasing by 48.4% and the ASPT score decreasing by 23.5% in a downstream direction; The river systems in the vicinity of the proposed mining project are expected to exhibit broad variability in aquatic community integrity on a temporal scale due to variations in flow and habitat availability. As more data is collected, better inferences on the ecological condition of the community will be possible; Due to the degree of sensitivity of the systems to habitat changes and loss of instream flow, careful design and operational procedures will be required to limit the impact on this tributary of the Klein Marico River, with special mention of the need to mitigate any losses to catchment yield as a result of the activities of the proposed Doornhoek mining project.

Depth profiles	The river consisted mostly of a shallow pool and very shallow runs in some areas.		Fish species observed: None					
Flow condition	The unnamed tributary of the Klein Marico River was flowing very slowly at this point. No fast flowing water was present.		Additional species observed: Tadpoles					
Riparian zone characteristics	The riparian zone along the length of this section of the unnamed tributary of the Klein Marico River is relatively narrow due to the limited development of the system. The riparian vegetation is relatively dense and is dominated by woody species.		Impacts and Essential Mitigation At the time of assessment limited impacts on the instream ecology were visually evident. Some impact due to water abstraction from the system, leading to reduced instream flow and loss of refuge pools, is considered likely to be occurring. Some impact on water quality was also deemed possible due to the algal growth observed in the system and some impact from livestock watering was observed.

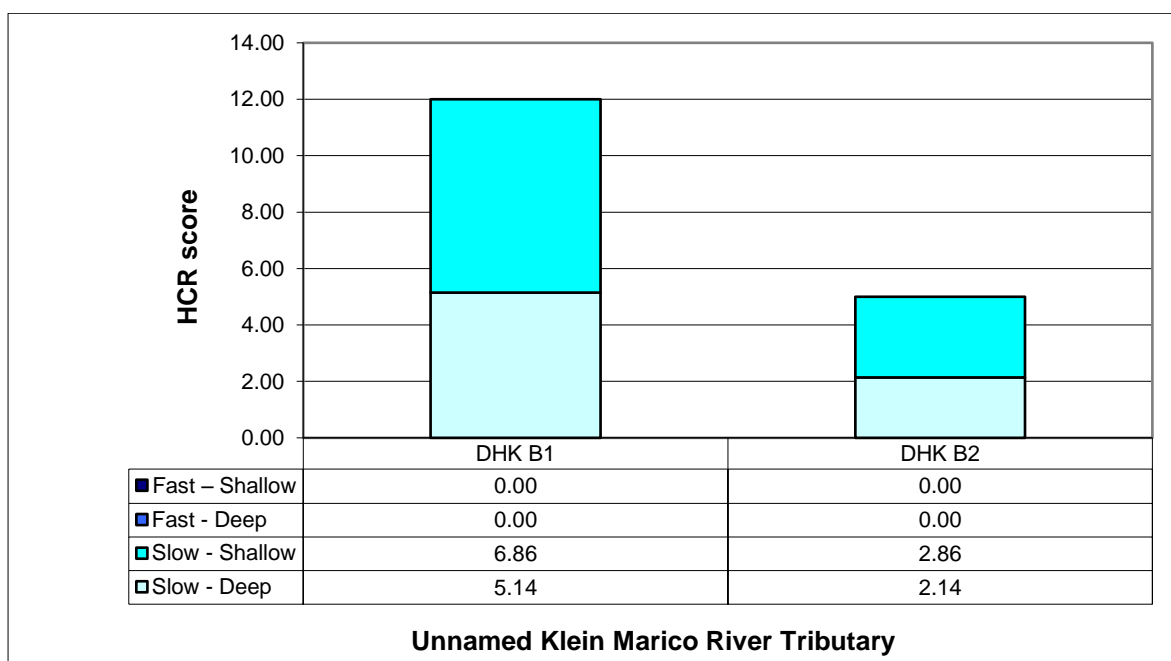
The HCR (Habitat Cover Rating) results for the sites on the unnamed tributary of the Klein Marico River assessed in October 2014 and the May 2016 (DHK B1 and DHK B2) are provided below

Figure 23: HCR scores for the two sites assessed on the unnamed tributary of the Klein Marico River in October 2014 and May 2016.
