ASSESSMENT OF THE GROOT RIVER, MEIRINGSPOORT FOLLOWING DIESEL CONTAMINATION

1ST MONITORING REPORT

Prepared by
Justine Ewart-Smith and Riaan van der Walt
February 2018

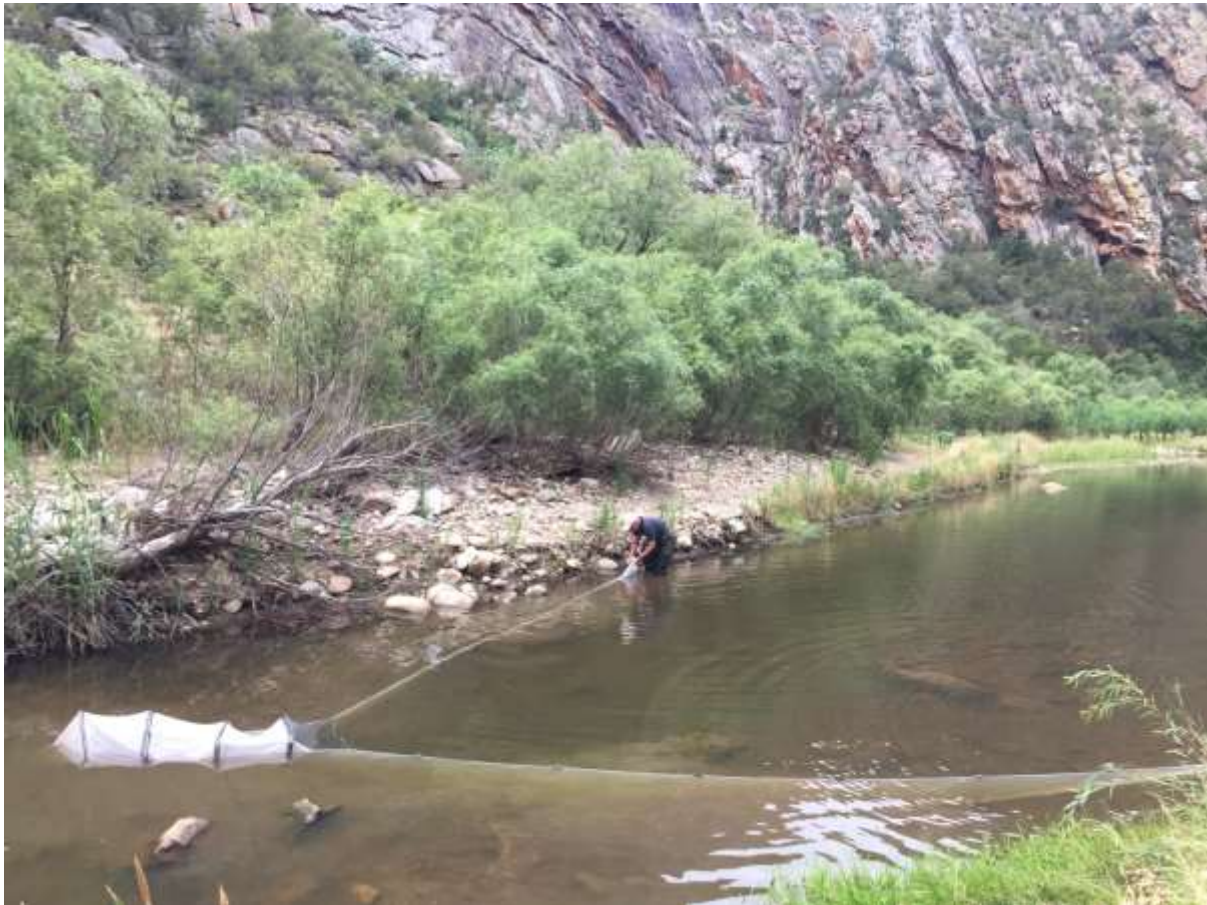
Samples were collected using Fyke nets situated in suitable pool habitat located within the vicinity of each of the 5 biomonitoring sites thus representative of communities 1) above spill, 2) within the spill zone and 3) below spill zone. The fyke nets (60 cm x 60 cm bottom entrance) were set at the top of each pool with the open end of the net downstream and the wings attached to the banks. Fyke nets were left overnight and retrieved the following morning and all fish caught were identified to species level, measured and total length (TL) recorded.

Figure 3.2 Fyke nets were set at the upstream end of the selected pool habitats and left overnight.

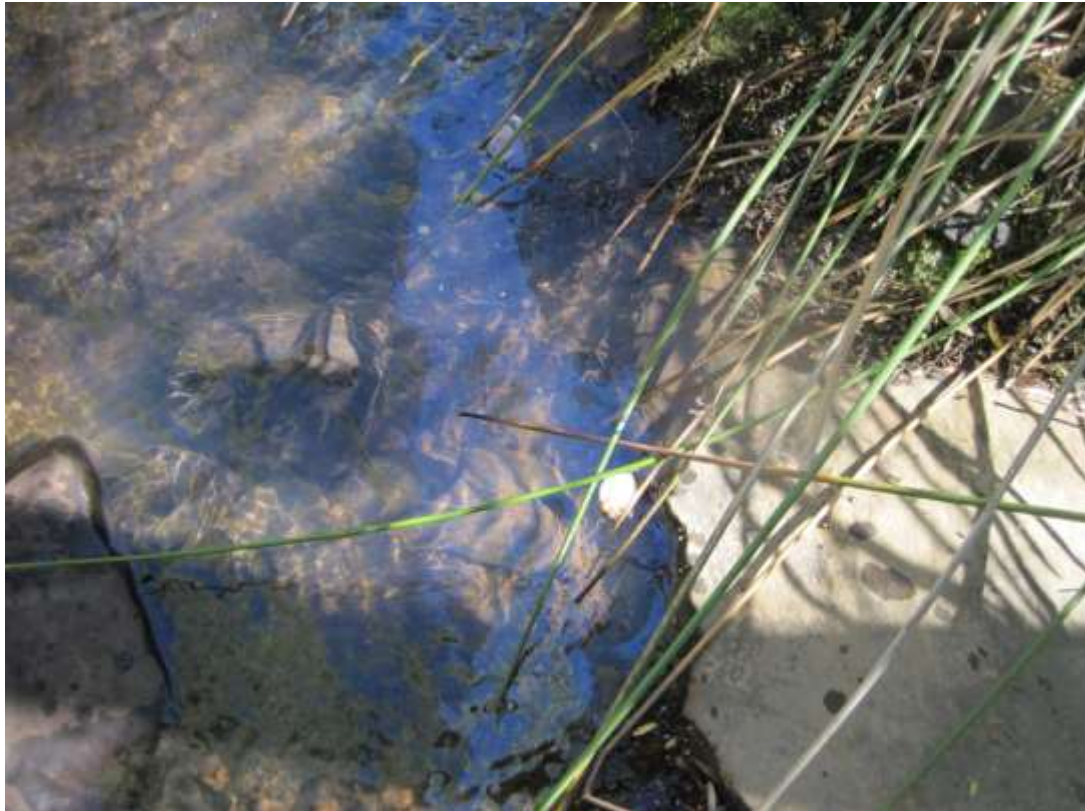
Diesel Range Organic (DRO) concentrations in the range C₁₀-C₁₉ were recorded in the sediments within the Impact Zone during December 2017 with the highest concentrations at site 2 (Spiltech) decreasing with distance downstream (site 3: Derde Tol Drif) (Table 4.1). Surprising, low concentrations C₁₅ and C₁₇ were recorded at site 1: Middelwater, which is the upstream control site where it was expected that hydrocarbon contamination would be zero. This suggests that, besides contamination from the diesel spill event, the Meirings River may be contaminated with hydrocarbons from other sources, possibly vehicular activity within the river channel upstream or runoff from the road.

Despite the presence of hydrocarbons within the Impact Zone during December 2017, the concentrations were significantly lower than those measured by Geomeasure (Geomeasure 2017) immediately following the diesel spill (Table 4.1). While no slicks or sheens typical of refined fuels such as diesel were evident initially, following disturbance of the substratum and marginal vegetation for sampling purposes, clear diesel slicks were evident, particularly at the Spiltech site during December 2017 (Figure 4.2). This suggests that while surface water clean-up operations have been effective, the sediments along the river are still contaminated with hydrocarbons.

Figure 4.1 Surface water slicks present at site 2 (Spiltech) following disturbance of the marginal vegetation and substrate during December 2017

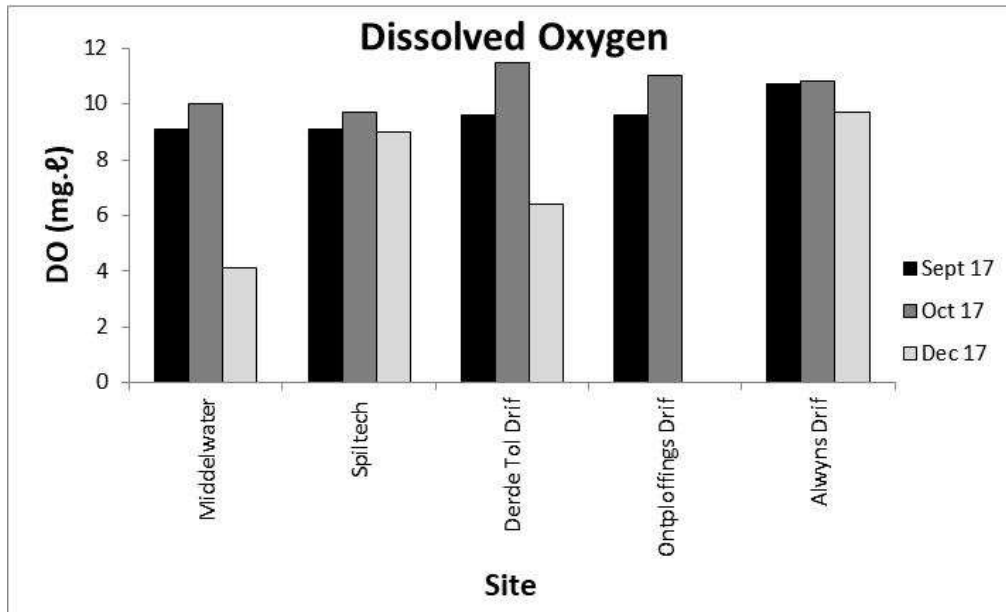
Dissolved Oxygen (DO) concentrations were significantly lower in December 2017, particularly at sites 1 and 3 compared with concentrations recorded in September and October 2017 (Figure 4.2). These concentrations are comparable with those measured within the impact zone immediately following the diesel spill in August 2017. Interestingly, the Spilltech site had a relatively high DO concentration (9 mg/l) during December 2017 (Table 4.2). DO concentrations < 8 mg/l are generally considered impacted (DWAf 2008). These low DO concentrations in the Meirings River may, in part, reflect natural seasonal conditions with barely perceptible flow and high water temperatures evident at the time of sampling in December 2017

Figure 4.2 Dissolved Oxygen Concentrations (DO) measured in September, October and December 2017.

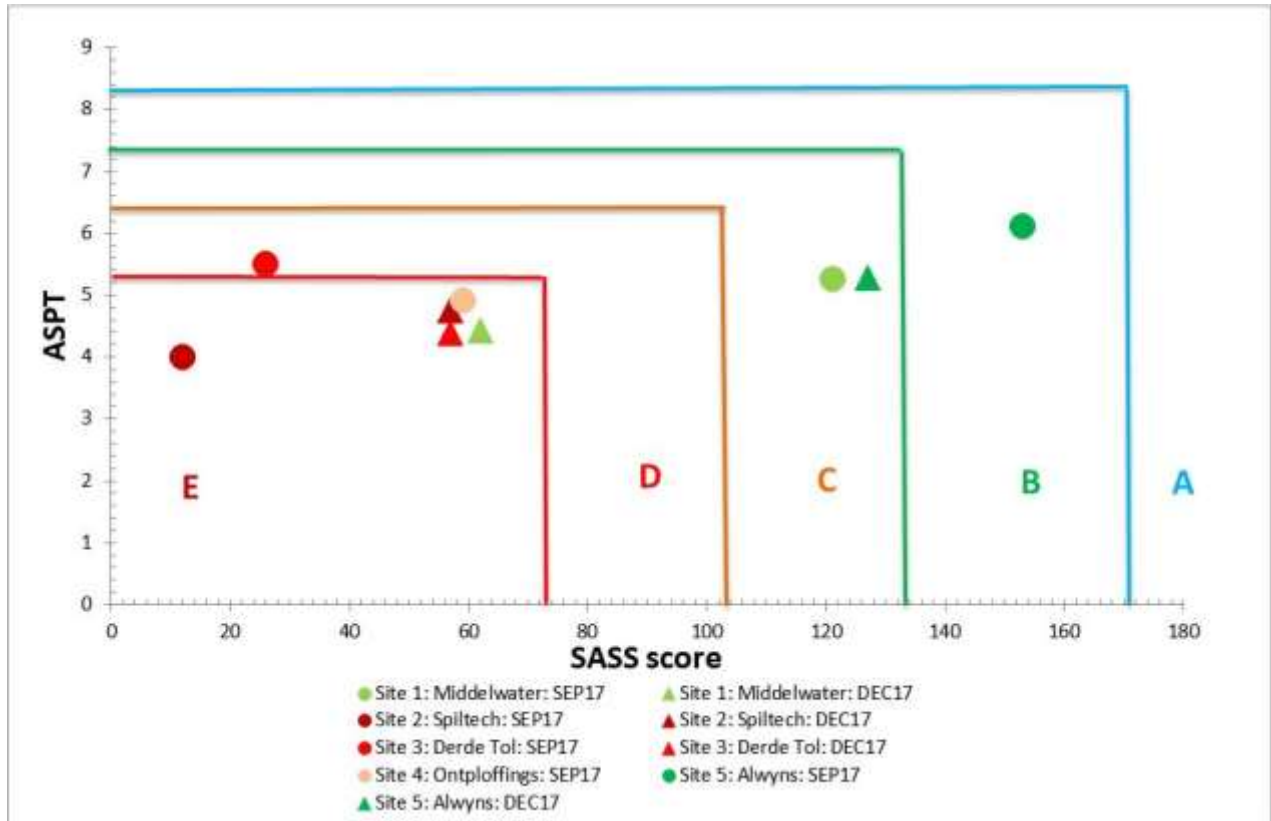
At Middelwater (site 1), upstream of the impact zone, both the SASS and ASPT scores were lower than that recorded in September 2017 (Figure 4.5). Similarly, a reduction in both SASS and ASPT scores was recorded at Alwyns Drif (site 5) in December 2017 far downstream of the impact zone. However, the ecological condition of the Middelwater site dropped from a category D to a category E (Figure 4.5) in December 2017, with less change in condition evident at Alwyns Drift.

Relative to the September 2017 invertebrate communities within the impact zone (Sites 2 and 3), a considerable recovery was evident at both impacted sites, but particularly at the Spiltech site (site 2) immediately downstream of the spill entry point (Figure 4.5). Very few invertebrates were present during the September 2017, with those surviving taxa known to be hardy and pollution tolerant. By December 2017, a total of 57 individuals representing 12 families were recorded at this site (Appendix A2). Although most taxa within the impact zone are considered relatively hardy and pollution tolerant, indicative of a severely altered condition (ecological condition is a category E), the community in December 2017 is comparable with the upstream control site (Middelwater) (Appendix A1 and A2).

While site 3 at the lower extend of the impact zone (i.e. Derde Tol Drif) shows a drop in Ecological Condition from a Category D to a Category E (Figure 4.5), this is also likely linked to poor habitat available associated with low water levels in December 2017. Indeed, the SASS and ASPT scores for individual biotopes (Figure 4.6) show higher SASS and ASPT scores for both stones and gravel-sand-mud (GSM) in December 2017, compared with September 2017 but lower values for vegetation. While the higher scores for stones and GSM indicate recovery of the system since September 2017, the lower scores for vegetation are indicative of poor habitat quality in December relative to September 2017 because most of the marginal vegetation was above the water level at this time.

Figure 4.5 SASS scores and ASPT values at biomonitoring sites on the Meirings River for both September and December 2017. The biological bands depicting change in condition are taken from Dallas (2007).

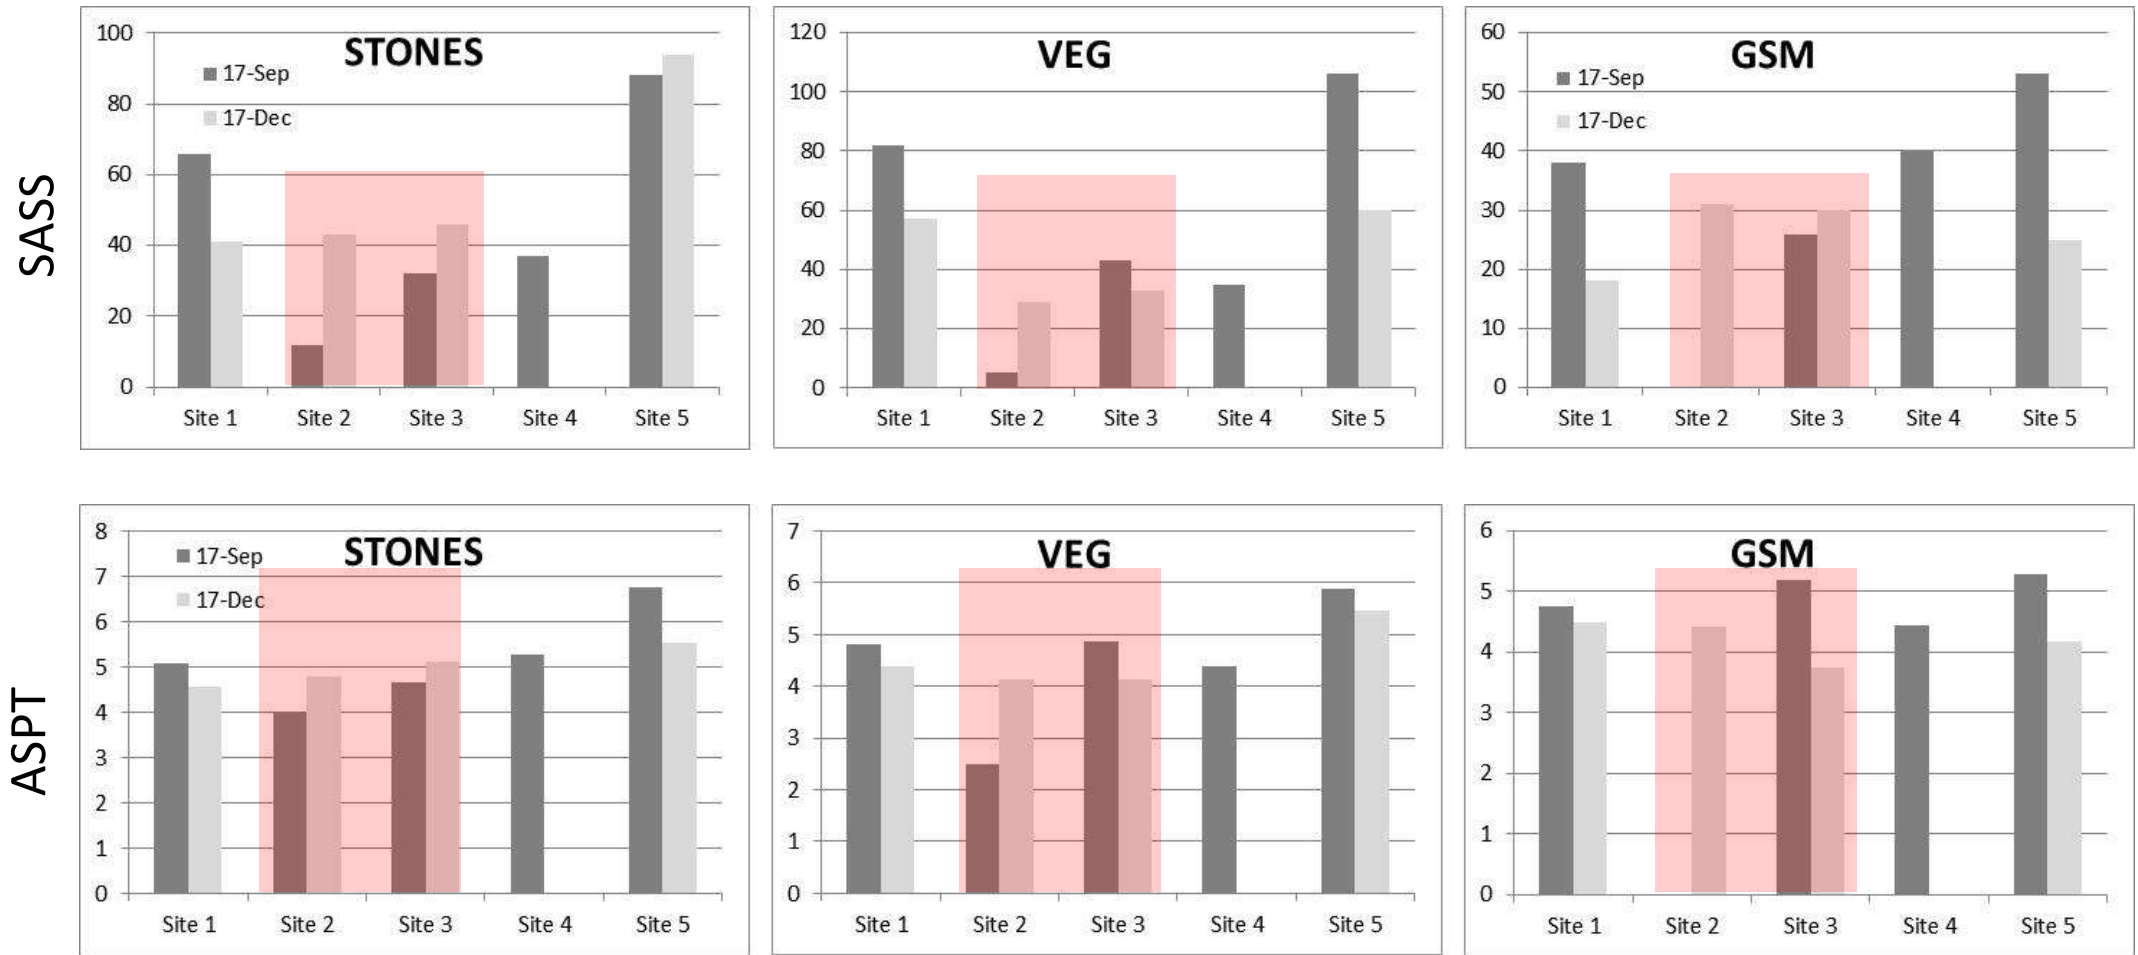
The macroinvertebrate community data are summarised as SASS and ASPT scores for each site (Figure 4.5) and for each biotope sampled in December 2017 (Figure 4.6). The relative abundance of each taxon reported is given in Appendix A.

Figure 4.6 SASS scores and ASPT values at biomonitoring sites for each of the three biotopes sampled (i.e. Stones, Vegetation and Gravel-Sand-Mud (GSM)) on the Meirings River. The red area represents sites within the impact zone and shows the difference in recovery between biotopes dependant on the availability of aquatic habitats.

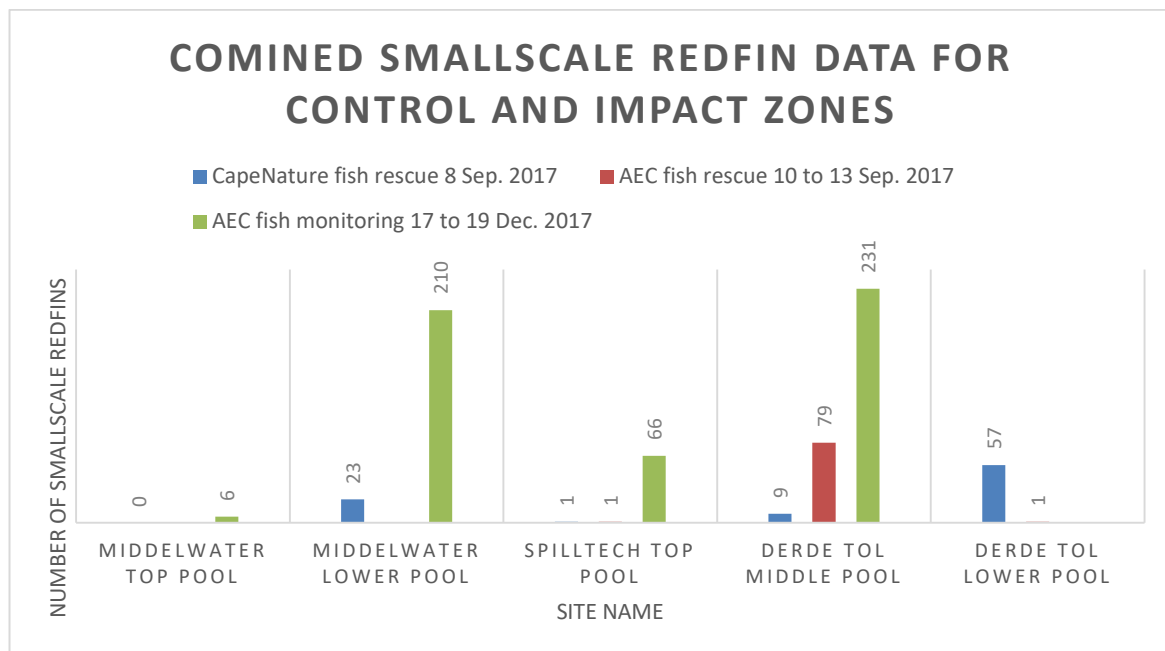
effort by CapeNature (Jordaan 2017) between 6 and 8 September 2017, most of the smallscale redfins were caught in the lower pool at Derde Tol. This is most likely due to the fact that the redfins moved downstream in order to avoid hydrocarbon contamination and a sudden drop in oxygen associated with the spill event. This pool was not suitable for fyke netting during this monitoring due to a lack of water, most likely caused by the mechanical clearing of sand from the Derde Tol road crossing by the Provincial Roads Department. CapeNature also reported that the redfins caught during the first rescue effort were lethargic and this can also have prevented them from being trapped in the fyke nets during the two rescue efforts. The juvenile smallscale redfins caught during this monitoring were estimated to be between 10 and 5 weeks old. Some of the female redfins caught were gravid (Figure 4.7), indicating further spawning events in the upcoming weeks.

Figure 4.7 Combined data of smallscale redfins from the three rescue/monitoring efforts in 2017. Only the data for the control and spill zone sites are included.

The pool below Ontploffings Drif were also sampled In December 2017 (Figure 4.7) and yielded adult and juvenile smallscale redfins. This pool is about 500 meters below the spill zone and will be a good indicator of whether or not the impacts of the spill event have extended downstream of the spill zone that extends as far as Derde Tol Drif. All fish sampled were in a healthy state with gravid females present.

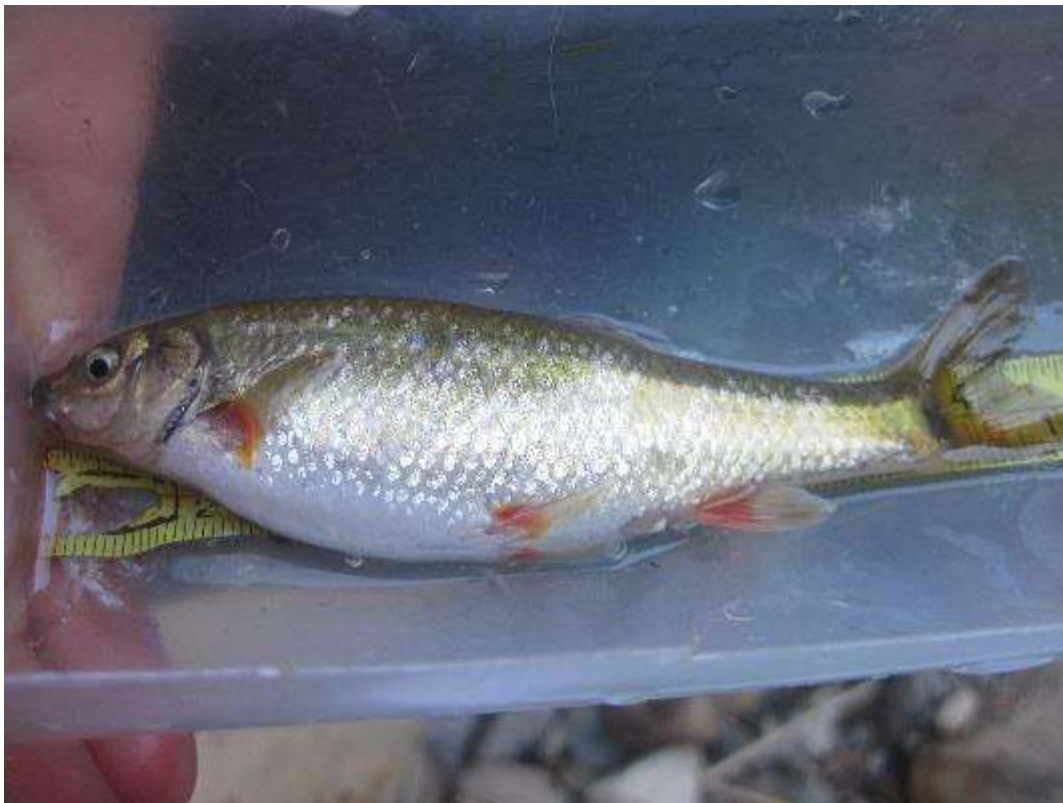
These results confirm the importance of the two large pools (Spilltech top pool and Derde Tol middle pool) in spill zone for the future survival of the smallscale redfin in the Gouritz catchment (Table 4.3). The combined data of the two rescue efforts and monitoring events (Figure 4.7) indicate that healthy numbers of smallscale redfins are still present in the spill zone and that recruitment has taken place this summer (Figure 4.8). During the first rescue

Figure 4.8 A gravid female smallscale redfin from the spill zone.
