BI-ANNUAL AQUATIC BIOMONITORING FOR VLAKVARKFONTEIN

June 2016

Report name	Bi-annual aquatic biomonitoring of the aquatic resources (rivers & streams) associated with the Vlakvarkfontein Colliery, Mpumalanga.	
Reference code	GSW-0174EX	
Submitted to	Geo Soil & Water CC	
Report writer	Dale Kindler

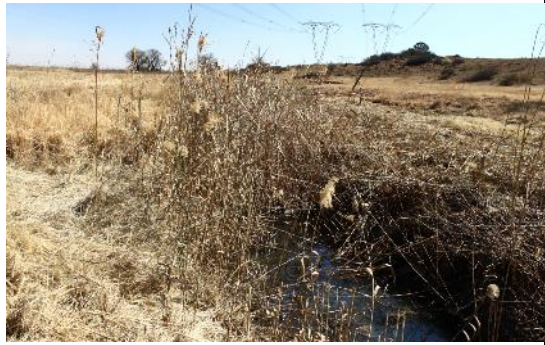
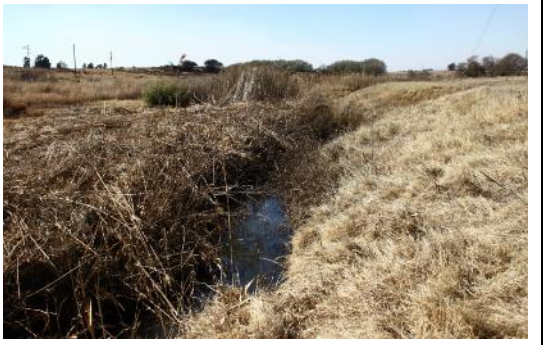
Vlak1	Downstream (Low flow)	Upstream (Low flow)

GPS coordinates	26° 4'31.04"S 28°54'18.44"E	
Site description	Site Vlak1 is situated on the Leeufontein River, a tributary of the Wilge River. Vlak1 is situated upstream of the mining operation. The site is characterized by deep slow moving waters over muddy substrate with marginal vegetation. Surrounded by agricultural land.	
Vlak2	Upstream (High flow)	Upstream (Low flow)

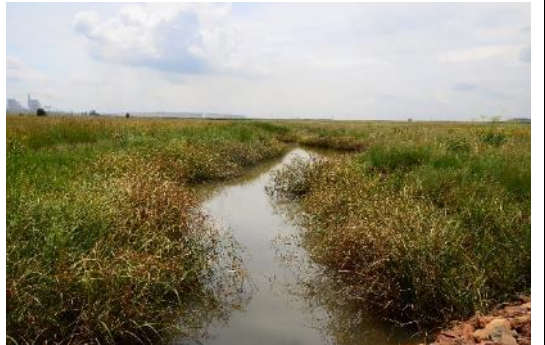
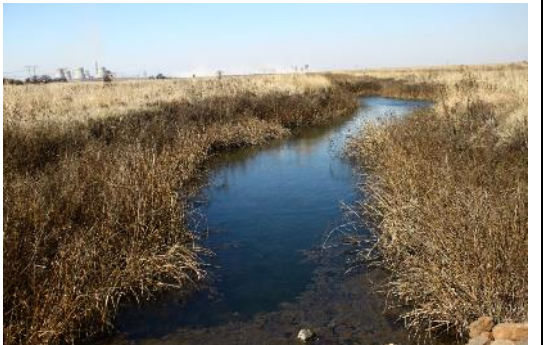
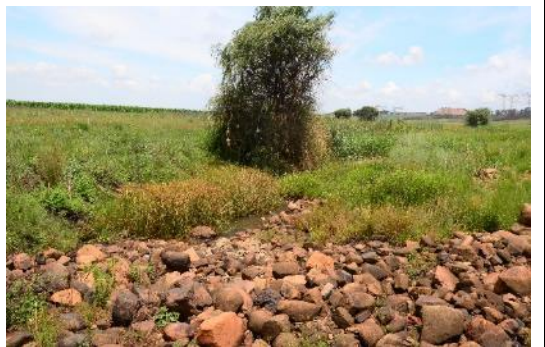
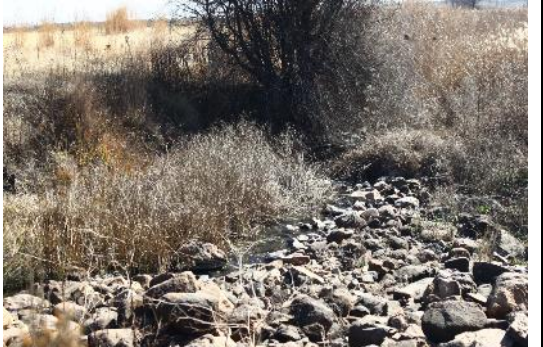
Site description	Site Vlak2 is situated on the Leeufontein River, a tributary of the Wilge River. Vlak2 is situated adjacent to Vlakvarkfontein Colliery. Vlak2 was characterised by slow moving waters over rocky and sandy substrate. A large pool is present upstream of the level crossing. Surrounded by agricultural land. Coal dust was noted in the sediment.	
Vlak3	Upstream (High flow)	Upstream (Low flow)

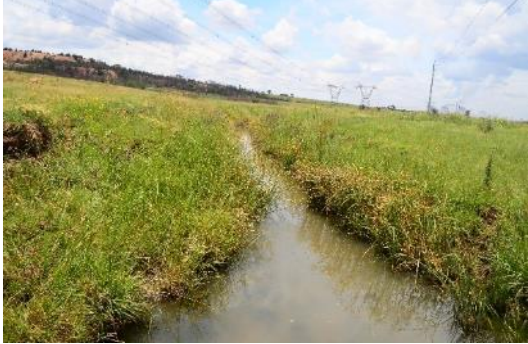
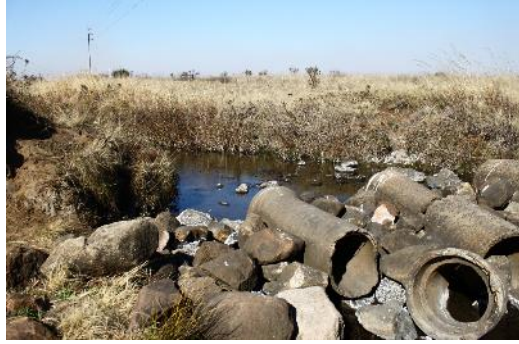
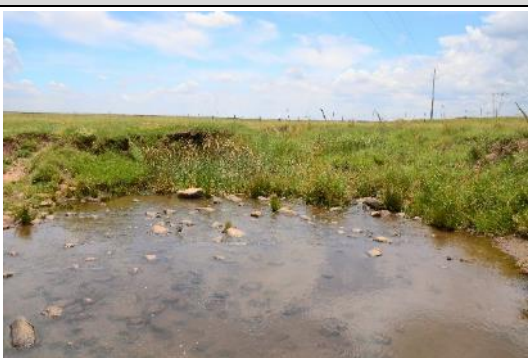
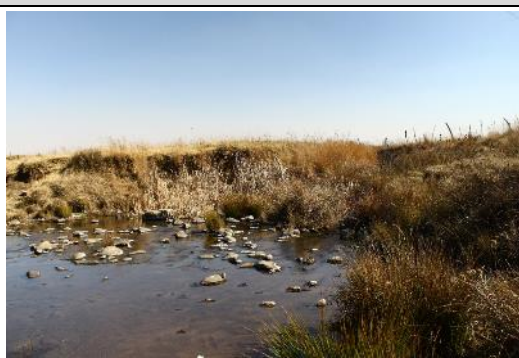
GPS coordinates	26° 4'9.55"S 28°53'10.39"E	
Site description	Site Vlak3 is situated on the Leeufontein River, a tributary of the Wilge River. Vlak3 is situated downstream of Vlakvarkfontein Colliery. This site was predominantly slow moving waters over scattered stones with sandy and muddy substrate. A small amount of algae was present during the high flow survey. White precipitate noted on the rocks.

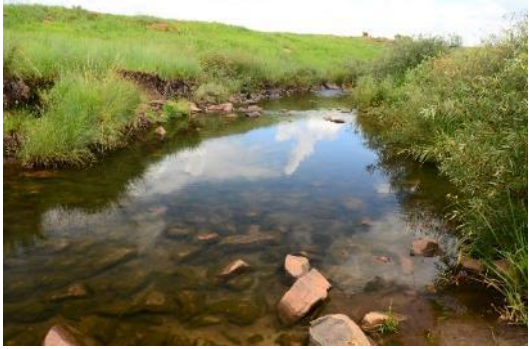
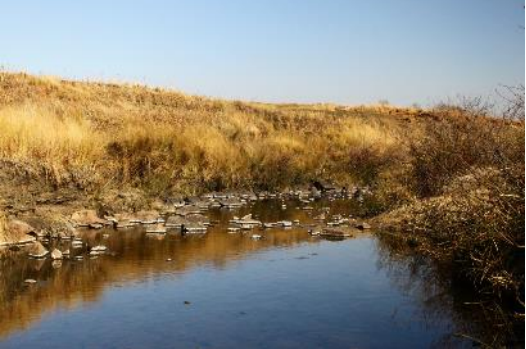
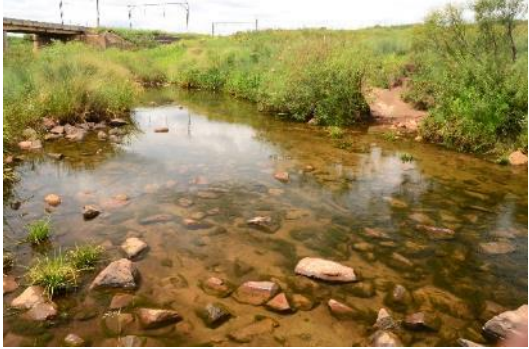
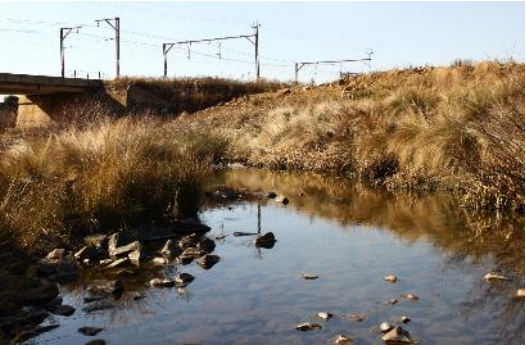
Vlak4	Upstream (High flow)	Upstream (Low flow)

GPS coordinates	26° 2'46.16"S 28°52'3.63"E	
Site description	Site Vlak4 is situated on the Wilge River, downstream of Leeufontein River confluence. Site Vlak4 had slow moving waters over sandy and rocky substrate. A large amount of algae and aquatic vegetation was observed during the high flow period. Some bank undercutting and sedimentation was present during the high flow. White precipitate noted on the rocks.

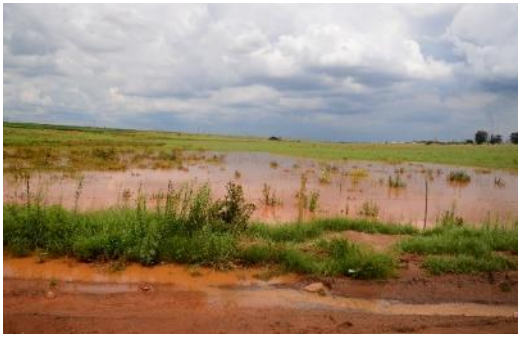
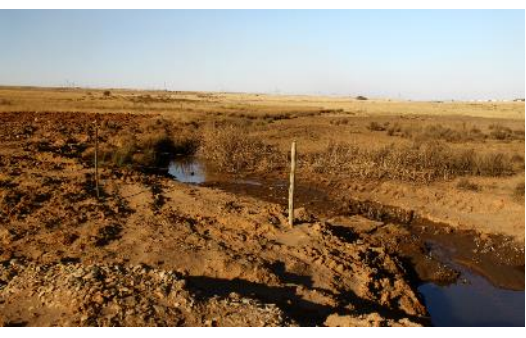
Vlak5	Upstream (High flow)	Upstream (Low flow)

<p>GPS coordinates</p>	<p>26° 2'6.04"S 28°53'1.28"E</p>	
<p>Site description</p>	<p>Site Vlak5 is situated on the Blesbok River, a tributary of the Wilge River. Vlak5 is situated downstream of Vlakvarkfontein Colliery. During the high flow, heavy sedimentation from the poorly maintained dirt road inundated the channel, suffocating much of the habitat. The recent low flow showed reconstruction of the channel. ONLY <i>in situ</i> water quality is carried out at this site.</p>

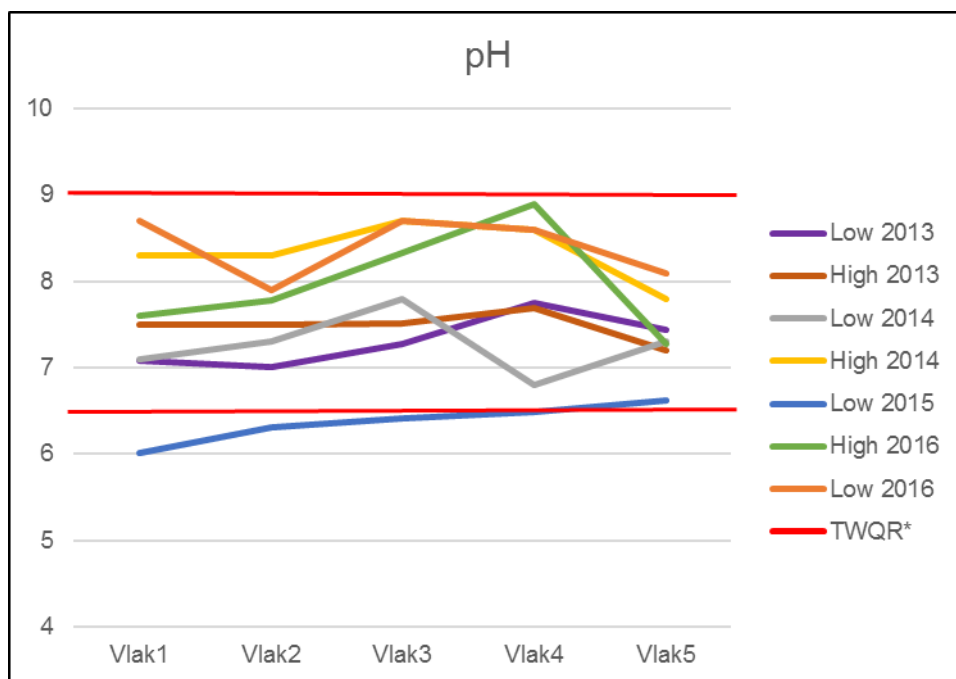
Figure 4: pH temporal trends for Vlakvarkfontein Colliery (2013-2016)

The pH remained relatively stable overtime only falling below the TWQR during the low flow 2015 survey. Site Vlak4 showed the most variation overtime but remained within guideline values. pH showed an increase downstream of the Vlakvarkfontein mining operation at sites Vlak3, Vlak4 and Vlak5. pH should be continued to be monitored.

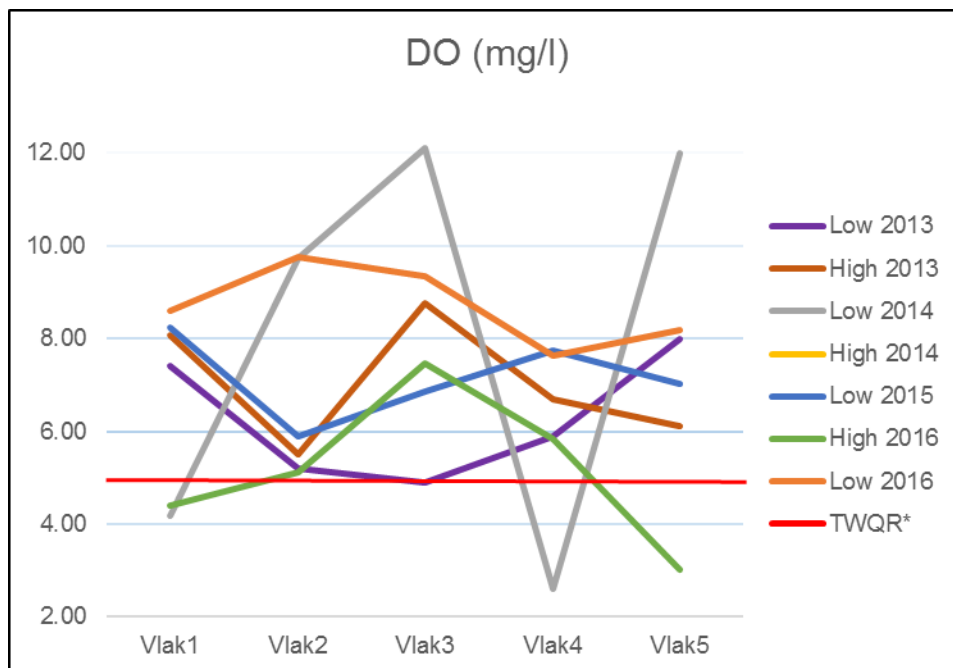
Figure 6: Dissolved Oxygen temporal trends for Vlakvarkfontein Colliery (2013-2016)

The DO concentration levels, although all over the place, showed a decrease at site Vlak2 and increased further downstream from sites Vlak3 to Vlak5 with some fluctuation. Generally, the DO concentration for the project area was adequate for aquatic biota with the exceptions of sites Vlak1 in 2014 low flow and 2016 high flow, Vlak4 during 2014 low flow and Vlak5 during the 2016 high flow. During these times the DO was below the TWQR with limiting effects on aquatic biota. Site Vlak2 showed the lowest levels of the three sites located on the Leeufontein River (Vlak1 to Vlak3) which may be due to the site located adjacent to the mining operation. DO concentration levels remained adequate in the Wilge River at site Vlak4 and Blesbok River at site Vlak5, both located downstream of Vlakvarkfontein mine.

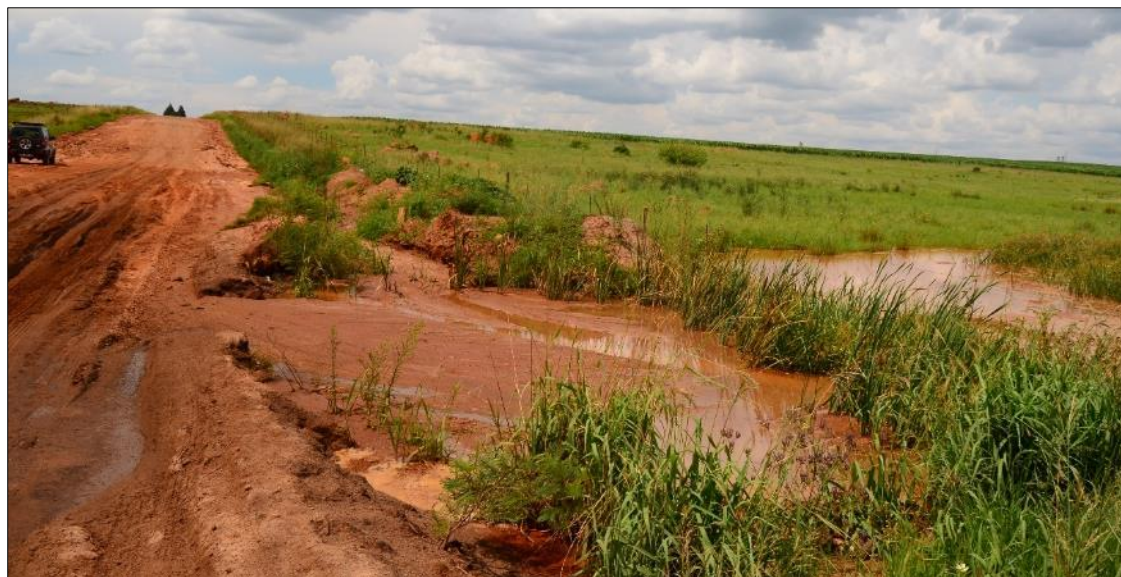
Habitat at sites from poor at Vlak1 on the Leeufontein River, to Good at Vlak4 on the Wilge. Low IHAS scores were attributed to low water levels, sedimentation, and inundation of available habitat due to algae. Some suitable rocky substrate was present at site Vlak2, Vlak3 and Vlak4 which benefits aquatic biota. Although no IHAS or macroinvertebrate sampling was carried out at site Vlak5, it should be stressed that the poorly maintained dirt road crossing the site had serious damage after recent heavy rains. This resulted in the soil berms that keep the soils from flowing from the road collapsing, allowing heavy sedimentation and smothering of the instream channel (Figure 8).

Figure 8: Heavy sedimentation and smothering of instream channel from poorly maintained dirt road

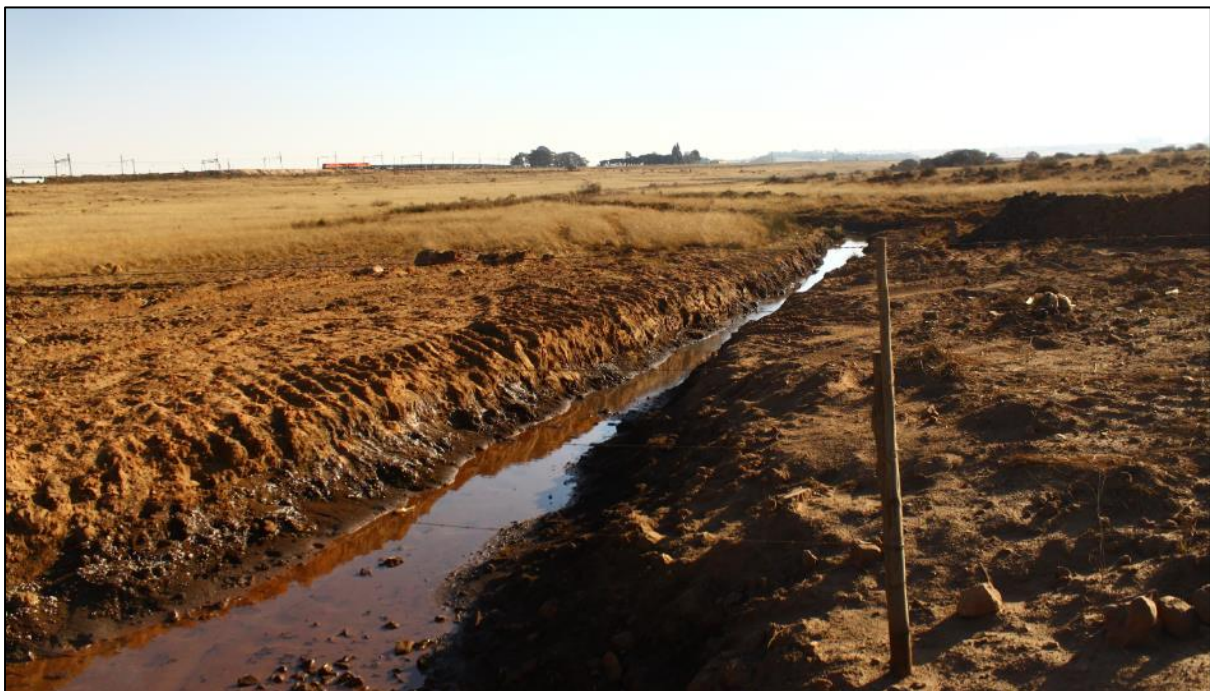
The main channel of the Blesbok River at Vlak5 has been reworked to cater for natural flow through the digging of the channel, removal of sediment build-up (noted in the 2016 high flow report) and installation of culverts under the road crossing (Figure 9). Additionally, side channels catering for stormwater from surface runoff from the road were created diagonal to the main channel (Figure 10). These activities will go a long way to re-establishing the biotic integrity of the Blesbok River. It is recommended that the side channels banks be reworked to create a gentle gradient. The steeper the bank, the more susceptible the embankments are to erosion. It is further recommended to plant vigorous growing indigenous grasses in these side channels to protect the soils (limiting erosion) while slowing the water and allowing infiltration of stormwater. Steep banks do not revegetate easily if at all, remaining exposed to erosion. Aggregate clumps can be placed across the stormwater channels (both the newly dug channels and the road side drainage leading into these channels) at regular intervals to attenuate flows and trap sediment. An example of a typical stormwater channel can be seen in Figure 11. The concreting of these channels will increase surface run-off velocity of the water entering the Blesbok River resulting in scouring and erosion of the Blesbok River at their confluence. Concreting of the side channel should be avoided.

Figure 9: Blesbok River at Vlak5 cleared of sediment build-up with recreation of channel

The recent biomonitoring run results have not deviated from trends noted in previous biomonitoring results with the aquatic systems remaining in an impacted condition. Some recent reshaping of the Blesbok River channel was seen during the July 2016 low flow survey. This reshaping will result in the improvement of the biotic integrity in the long run. Some recommendations have been put forth regarding these reshaping activities and stormwater channels according best practice methodologies.

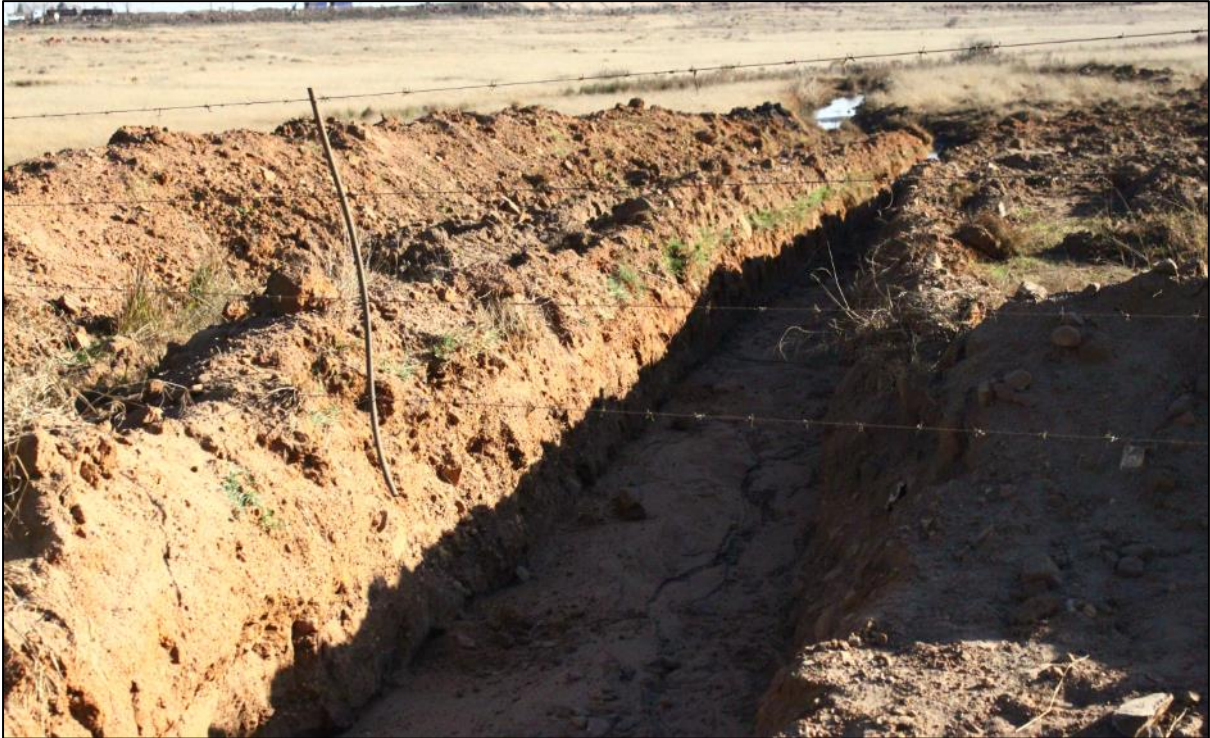
Figure 10: Side channel with steep banks catering for stormwater runoff at Vlak5

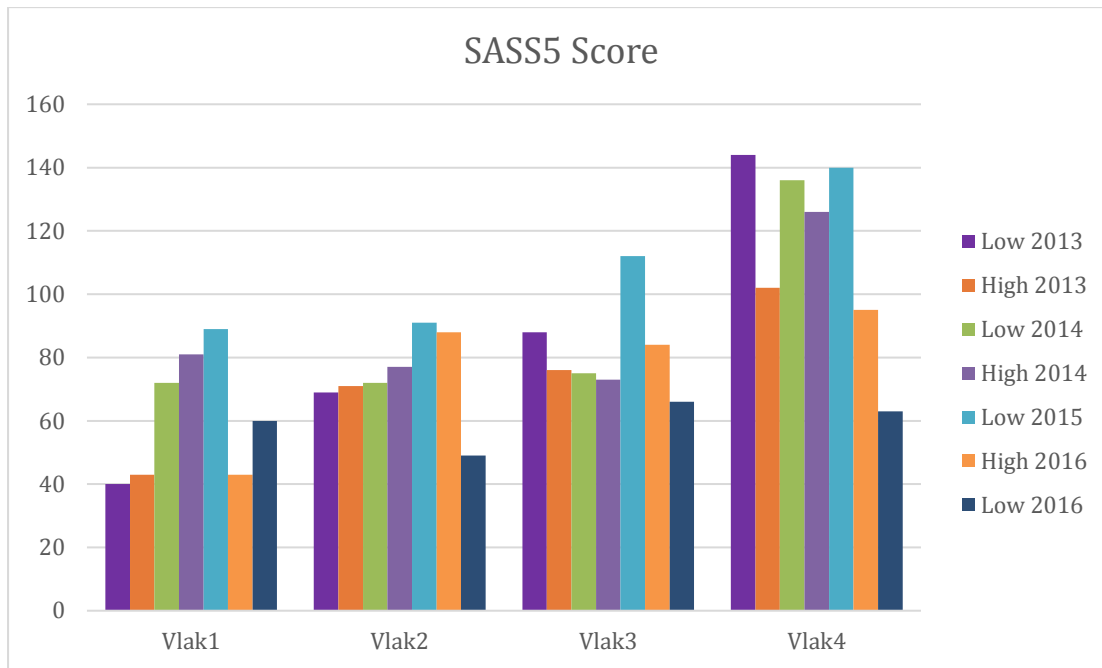
Figure 12: SASS5 scores for Vlakovarkfontein Colliery (2013-2016)

SASS scores recorded ranged from 49 to 66 at sites Vlak2 and Vlak3 respectively during the 2016 low flow survey. ASPT ranged between 3.8 and 4.6 at sites Vlak2 and Vlak1 respectively. The 2016 low flow survey showed much lower values compared to the previous low flow survey.

From Figure 12 and Figure 13 it can be seen that the 2015 low flow SASS5 scores and number of taxa is higher than previous surveys at all sites. The difference in SASS5 scores and number of taxa has changed the overall category of the site Vlak4 from a Class E/F to a Class D, with the other three sites changes not great enough to change the overall category. Since the 2015 low flow survey, Vlak4 has decreased back to Class E/F. The water quality and invertebrate trends indicate conditions over the period of 3 years in the Leeufontein River have improved slightly, whilst the Wilge River (Vlak4) has shown no particular trend.
