March 2010

Aquatic Specialist Study for the Proposed Kuka Ropeway

Report Number: 11490

KUKA ROPEWAY AQUATIC ASSESSMENT

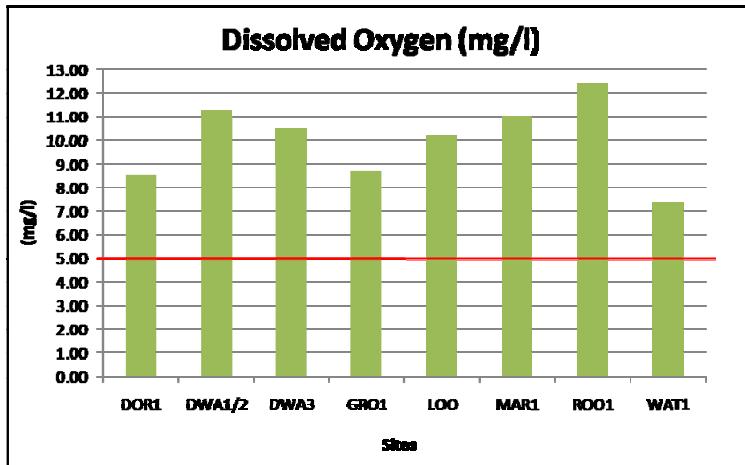
During the November 2009 survey DO levels were considered adequate with all sites being recorded to be above 5 mg/l. From these results, DO is not considered to have a limiting effect on aquatic biota (Figure 4).

Figure 4: DO concentrations recorded during the November 2009 survey (red line indicates guideline value)
