**COMPREHENSIVE RESERVE DETERMINATION STUDY
FOR SELECTED WATER RESOURCES (RIVERS,
GROUNDWATER AND WETLANDS) IN THE INKOMATI
WATER MANAGEMENT AREA, MPUMALANGA**

**SABIE-SAND AND CROCODILE SYSTEMS:
ECOCLASSIFICATION REPORT – VOLUME 2**

DECEMBER 2009

DWA Project No: WP 9133
Report No: 26/8/3/10/12/009

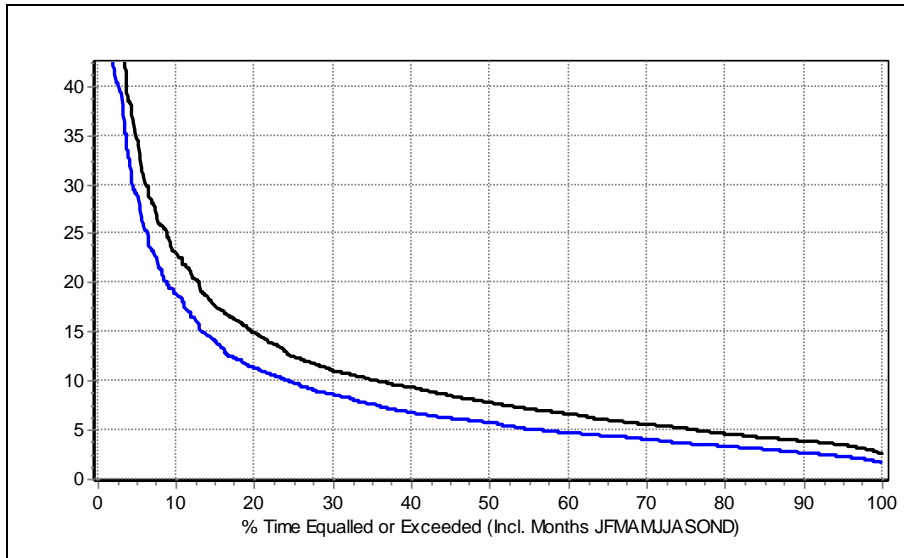
Figure A16 Annual monthly flow duration curves (data 1920 to 2004) for site SB1 (Black = Natural, Blue = Present Day)

HYDROLOGY METRICS	RATING	CONFIDENCE
LOW FLOWS	3.0	3.00
ZERO FLOW DURATION	0.0	4.00
SEASONALITY	0.0	5.00
MODERATE EVENTS	2.0	3.00
EVENT HYDROLOGY(HIGH FLOWS-FLOODS)	2.0	3.00

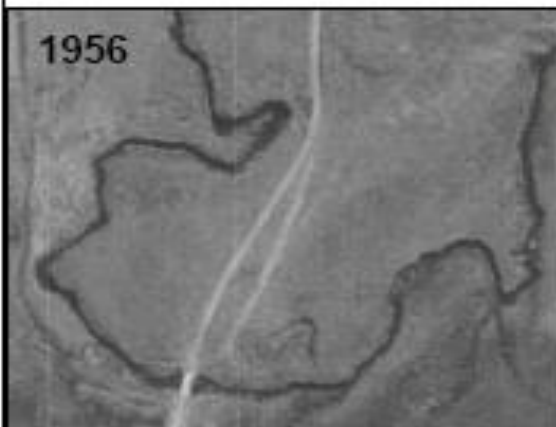
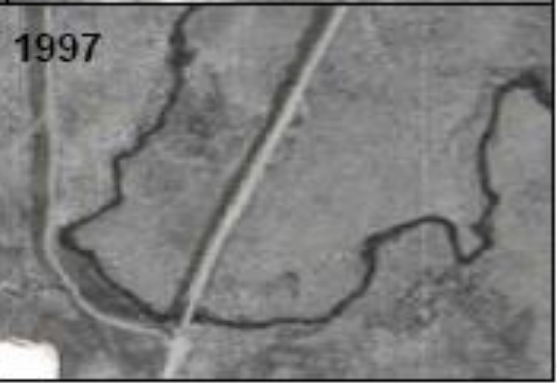
<p>1997</p> </div> </div> <p>Croc EWR Site 1: No directional changes for EWR Site 1 could be observed from the aerial photographs due to the large scale of the photographs and the narrow channel. The channel appears to have been straightened upstream (on the left) of the site between 1956 and 1964 upstream of the site; probably associated with the agricultural activities which are evident at this time.</p>	3
<p>The site has typical meandering floodplain with ox-bow features on the floodplain. The floodplain consists of cut banks, advancing point bars and cut-off meanders. This site is classified as an alluvial meandering channel type and is representative of the macro-reach; being typical of eastern-draining rivers above the escarpment. Small wetlands are present on the floodplain.</p>

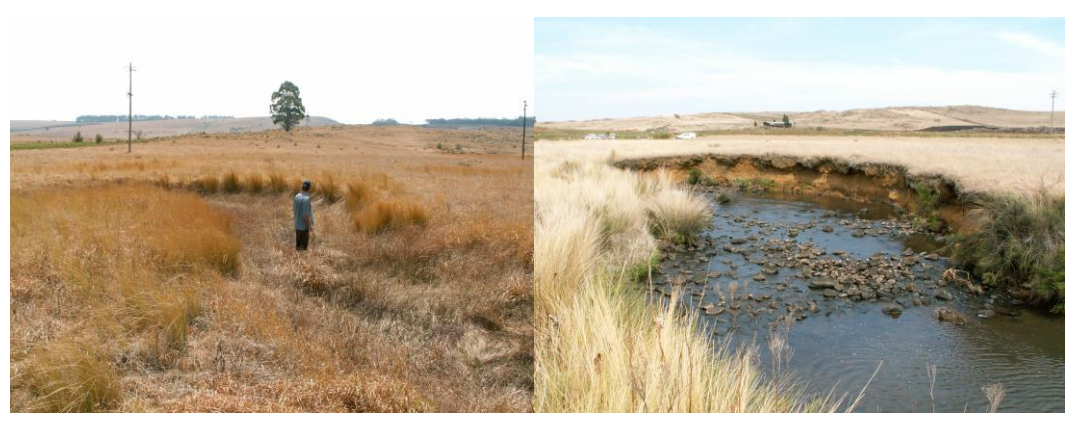
Morphology of the site	<p>No good quality Google Earth imagery was available. The site is a typical meandering floodplain with ox-bow features on the floodplain. The floodplain consists of cut banks, advancing point bars and cut-off meanders. An oxbow lake is evident on the eastern flank of the floodplain. Aerial photograph analysis indicates that this predates 1956. No directional changes could be observed from the aerial photographs due to the large scale of the photographs and the narrow channel. The channel appears to have been straightened upstream of the site between 1956 and 1964. These changes are associated with agricultural activities which are evident at this time. Other localised impacts have arisen from the roads.</p>		
PES	B (85.3%)	Confidence	3

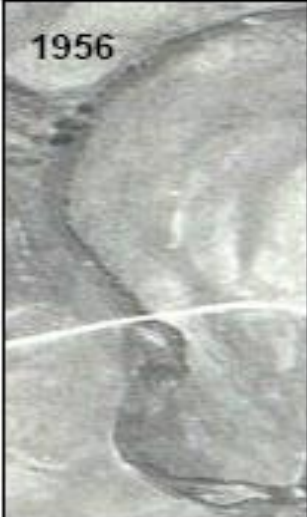
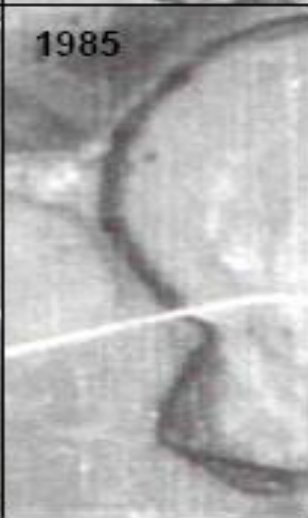
<p>1985</p> </div> </div> <p data-bbox="236 1720 1278 1821"> Croc EWR Site 2: Few directional channel changes at EWR Site 2 could be observed due to the large scale of the photographs and the small channel. However the active channel appears to have narrowed in places and there has also been an increase in woody riparian species on the riverbanks occurred for the period 1956 to 1975. </p>	2.5
<p>The reference state is similar to the current condition, although the river may have been slightly wider and perhaps less deeply incised.</p>

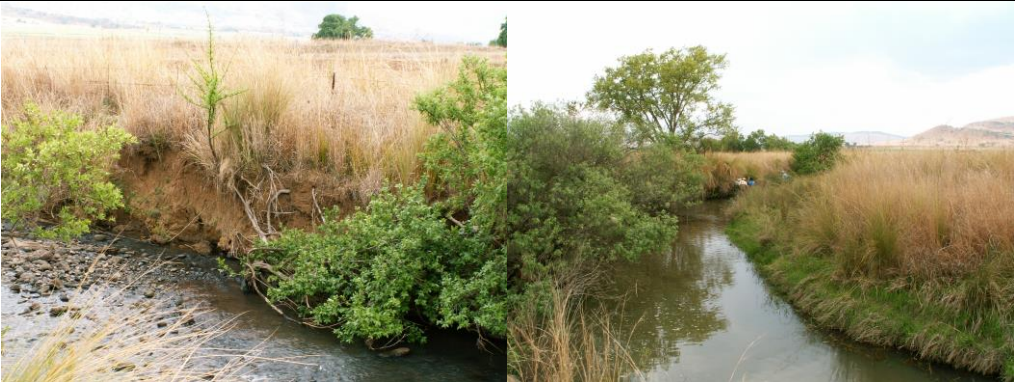
Morphology of the site	Alluvial river incised into the floodplain. Banks are well vegetated.		
	The EWR site is within a meandering alluvial river section. Within the channel there are small riffles and long runs/pools. There is erosion on both banks (i.e. both banks are cut) suggesting a possible incision problem, but this is likely to be a localised impact associated with flow confinements under the bridge crossing. Riparian vegetation plays an important role in stabilizing the banks.		
PES	B (85.1%)	Confidence	2.5

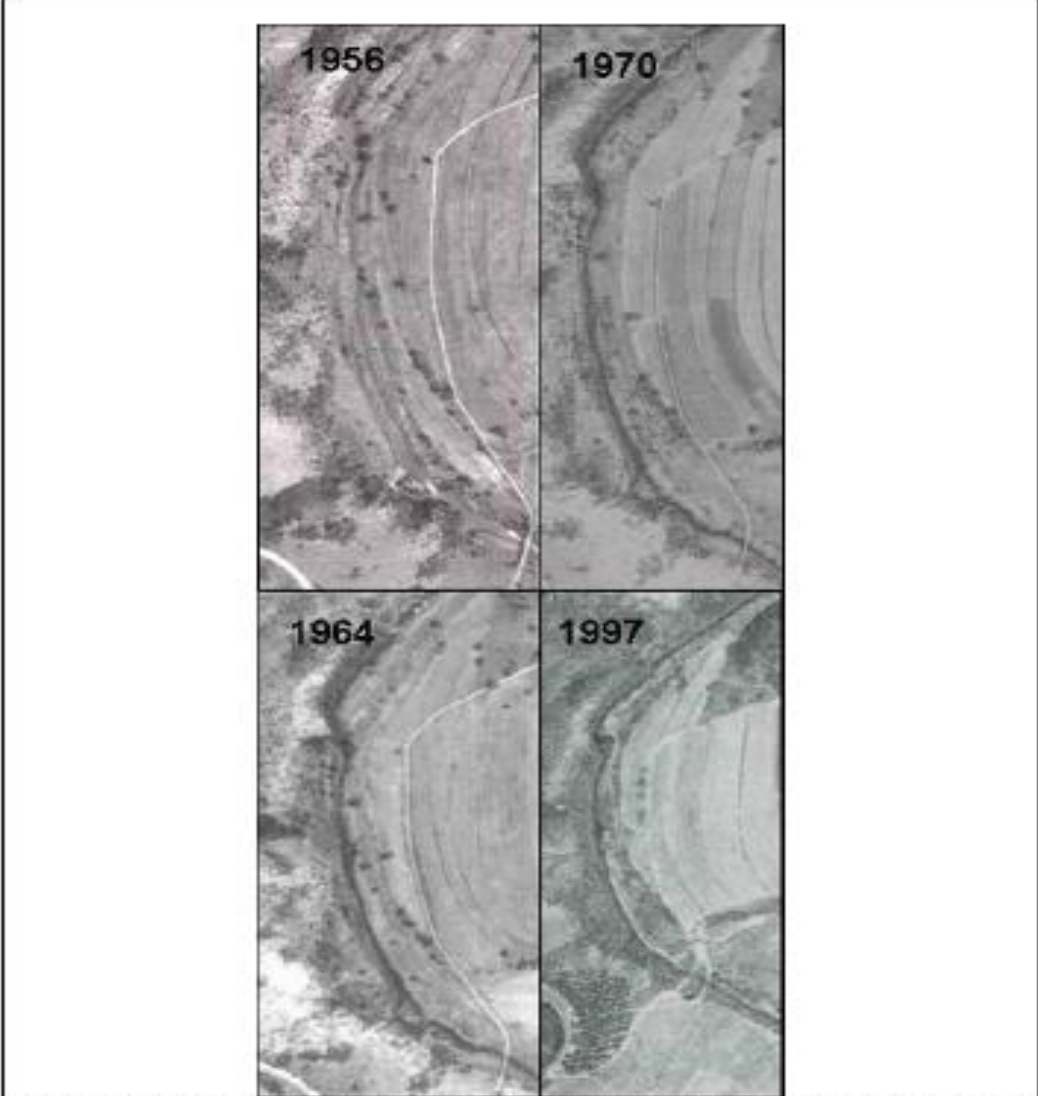
</div> <p data-bbox="231 1758 1273 1814">Croc EWR Site 3: EWR Site 3 shows progressive channel narrowing since 1956 with an increase in woody riparian vegetation. Site 3 is below the large Kwena Dam.</p>	3.5
<p>The reference state would have been a pool-riffle channel types with (relative to current conditions) a wider channel experiencing more frequent floods; finer bed and gentler sloping banks with well-vegetated marginal zones. This would have been a lower energy channel with more fines and gravels. Possibly a bit of a sinuous channel; with some in-channel vegetated bars and more marginal vegetation.</p>

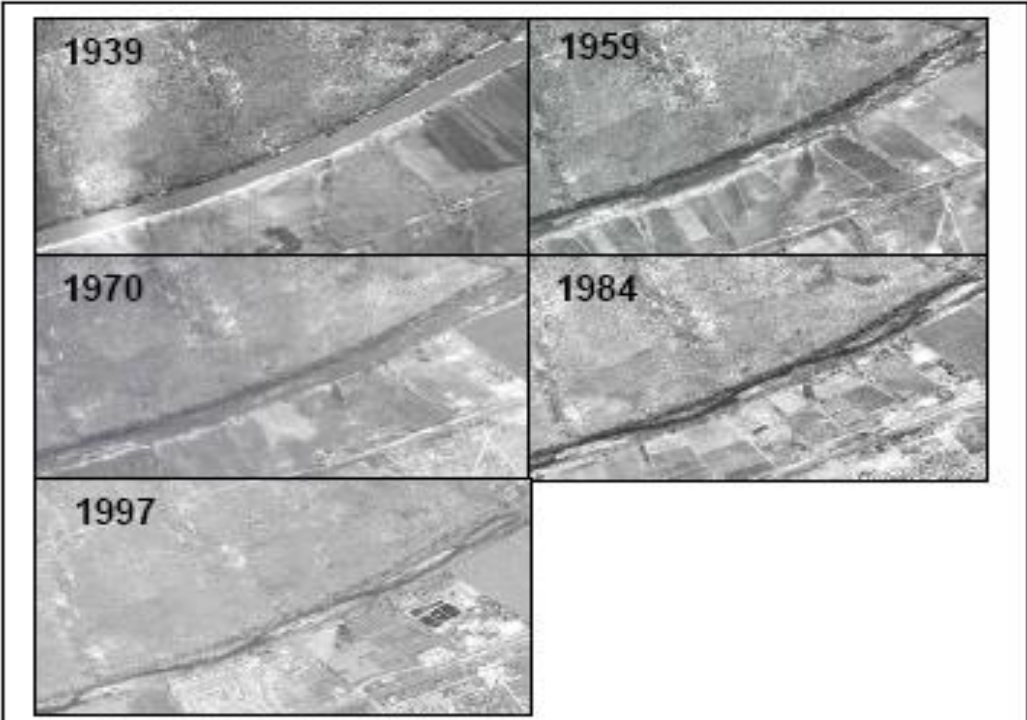
3
<p>Croc EWR Site 5 EWR Site 5 shows progressive channel narrowing since 1939, and a general increase in depositional features is evident. Aerial photographs indicate an increase in mid-channel bars and lateral bars, coincidental with colonisation by vegetation. This would suggest a directional change towards more stable, vegetated morphological features and subsequent reduced floodplain conveyance.</p>	
<p>A very wide, sandy bed river system. Vegetation was restricted to the macro-channel banks (and encroachment prevented by bank to bank seasonal flows and large flood flows which scoured sediment from the channel). This combination of factors maintained a mobile sand bed which further inhibited vegetation establishment and stabilisation of sediment.</p>

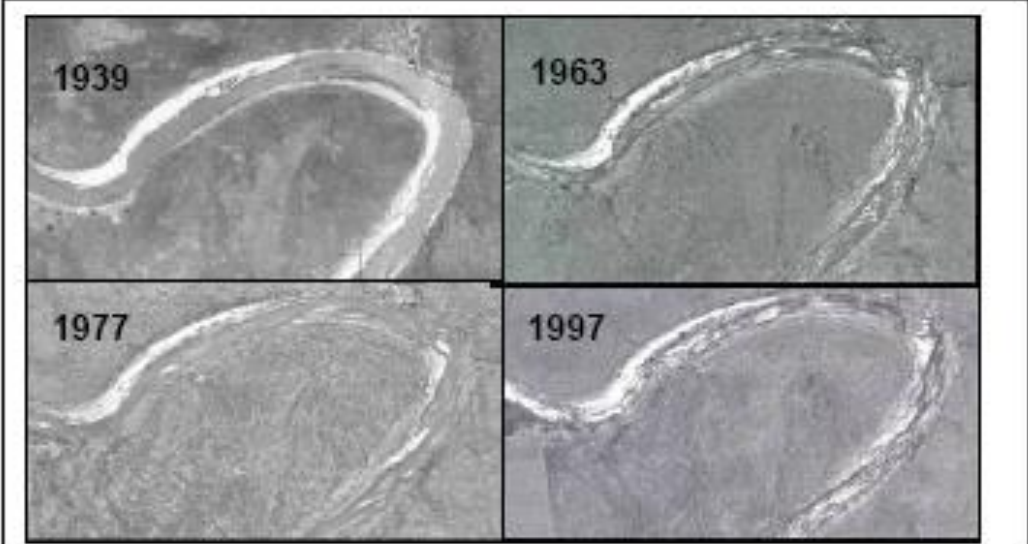
<p>Croc EWR Site 6 As with EWR Sites 4 and 5, aerial photographs indicate an increase in mid-channel bars and lateral bars, coincidental with colonisation by vegetation, suggesting a directional change towards more stable, vegetated morphological features. This is probably due to reduced floods.</p> <p>The reference state is a more open wider active channel, larger (wider) rapids and smaller bar areas.</p>	3

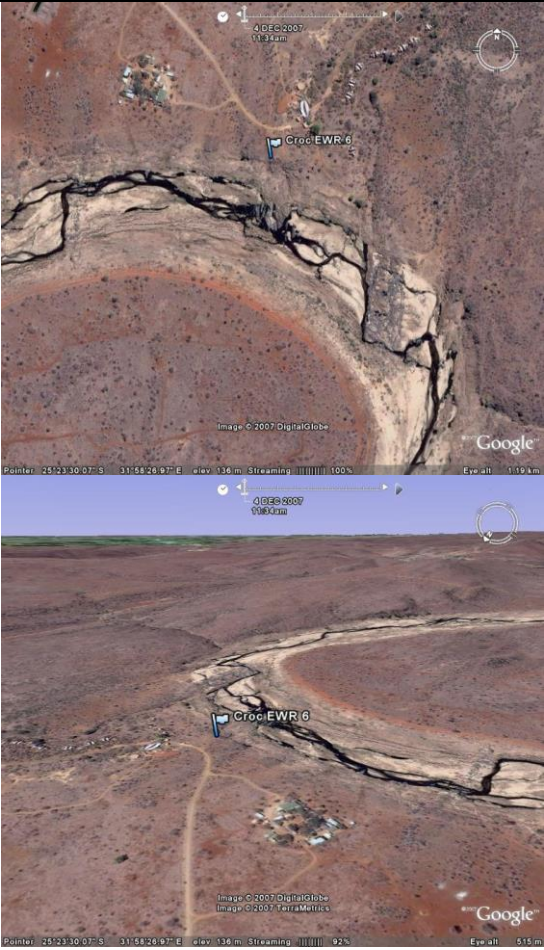
<p>Morphology of the site</p>	<p>EWR 6 is a mixed anastomosing channel type and is representative of the macro-reach. The site runs across a bedrock rapid area. Downstream there is a deep pool. The channel consists of a number of active channels inset into a wider macro-channel. There is strong bedrock influence. A relatively thin, mostly sandy veneer of alluvium overlies the dominant bedrock. The bed is mobile, even under the lowest flow conditions. The aerial photographic record demonstrates a strong directional change from a wide channel to a few much smaller, narrower active channel, probably due to reduced floods and flows generally. The bars and banks have become more vegetated and stabilised.</p>		
<p>PES</p>	<p>C (66.6%)</p>	<p>Confidence</p>	<p>3</p>

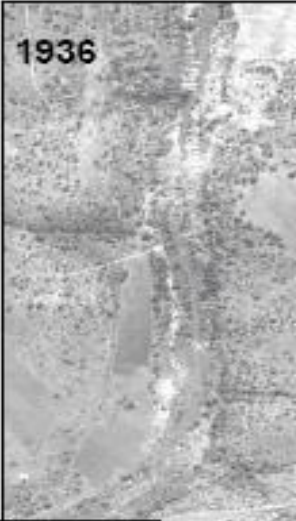
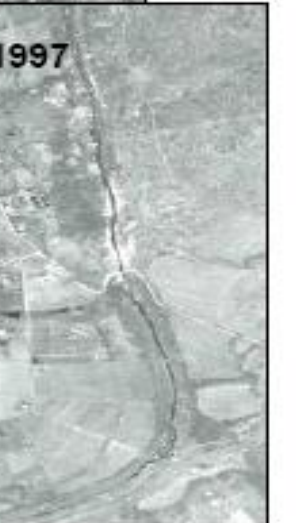
<p>1997</p> </div> </div> <p data-bbox="277 1749 1225 1821" style="font-size: small; margin-top: 10px;"> Croc EWR Site 7: EWR Site 7 is bedrock gorge channel type with strong bedrock influence. Upstream of the bridge there has been an increase in bars followed by vegetation colonisation and stabilisation, leading to a reduction in active channel width. </p>	2.5
<p>The current state is close to the reference condition.</p>

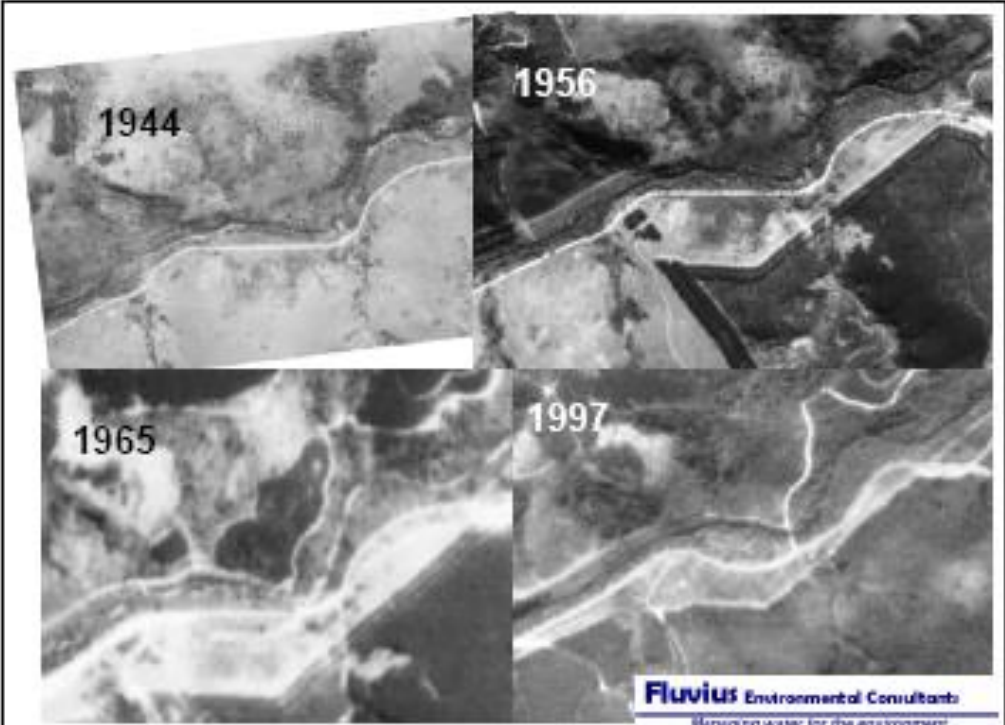
<p data-bbox="245 1377 1254 1467"> Sabie EWR Site 1: An increase in woody vegetation is evident from the aerial photographs. The small size of the channel and poor quality of the aerial photography preclude any detailed analysis of inchannel features. </p>	3
<p>The reference condition is a pool-riffle system, with a boulder/cobble bed with gravels. The valley is confined, and thus whilst there is a large flood terrace on one bank, the opposite bank is a steep cut bank. Woody cover under natural condition probably less than present.</p>

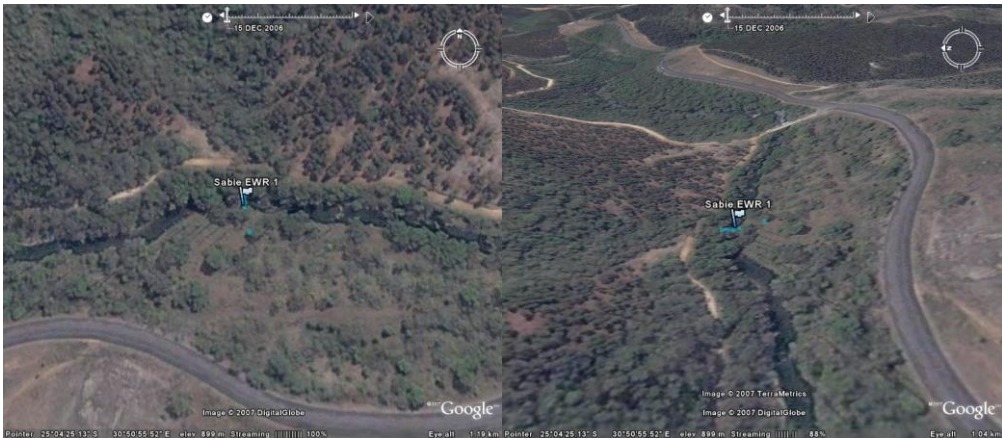
<p>Upstream impacts upon the site include: Forestry; A few, small weirs and illegal abstraction, and Return sewage flows from Sabie town. Virgin MAR: 152 MCM; Present MAR: 115 MCM</p>			
Morphology of the site	<p>The site is a pool-riffle system with a boulder/cobble bed and gravel and large sand component. It is possible that the sand component has increased due to upstream forestry activities and has led to a reduction in channel size. Aerial photos indicate an increase in woody vegetation cover. The riparian zone is heavily infested with exotic vegetation and has recently burnt prior to the site visit. The flood terraces are composed of fine sands and not paired, as one bank is a steep cut bank.</p>			
PES	B (83.3%)	Confidence		3.5

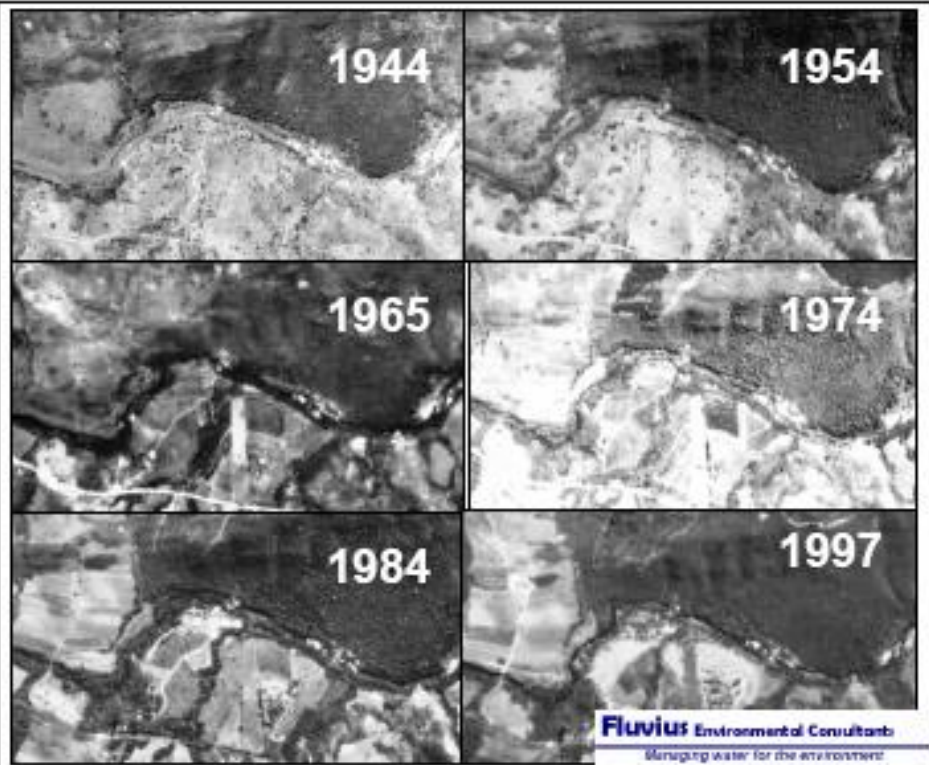
<p>Sabie EWR Site 2: An increase in woody vegetation is evident from the aerial photographs. The small size of the channel and poor quality of the aerial photography preclude any detailed analysis of inchannel features. The small bedrock anastomosing section is stable.</p> </div> <p>The 1940's condition of the river (prior to any intensive catchment development) is assumed to represent a component of the natural (reference state) dynamics of the site. At this site, the reference condition would thus range from the current well-wooded banks and bars with associated narrow channel across a range of morphologies which would also include a slightly wider active channel and more open (i.e. less well wooded) channel banks and bars. The larger bedrock exposures downstream would not be covered with sediment. Thus the current condition of the river currently is close to natural. The only anticipated changes from reference state are probably a higher component of fines in the bed material and slightly infilled pools (both due to higher sediment loads from forestry and other disturbed areas in the catchment).</p>	3

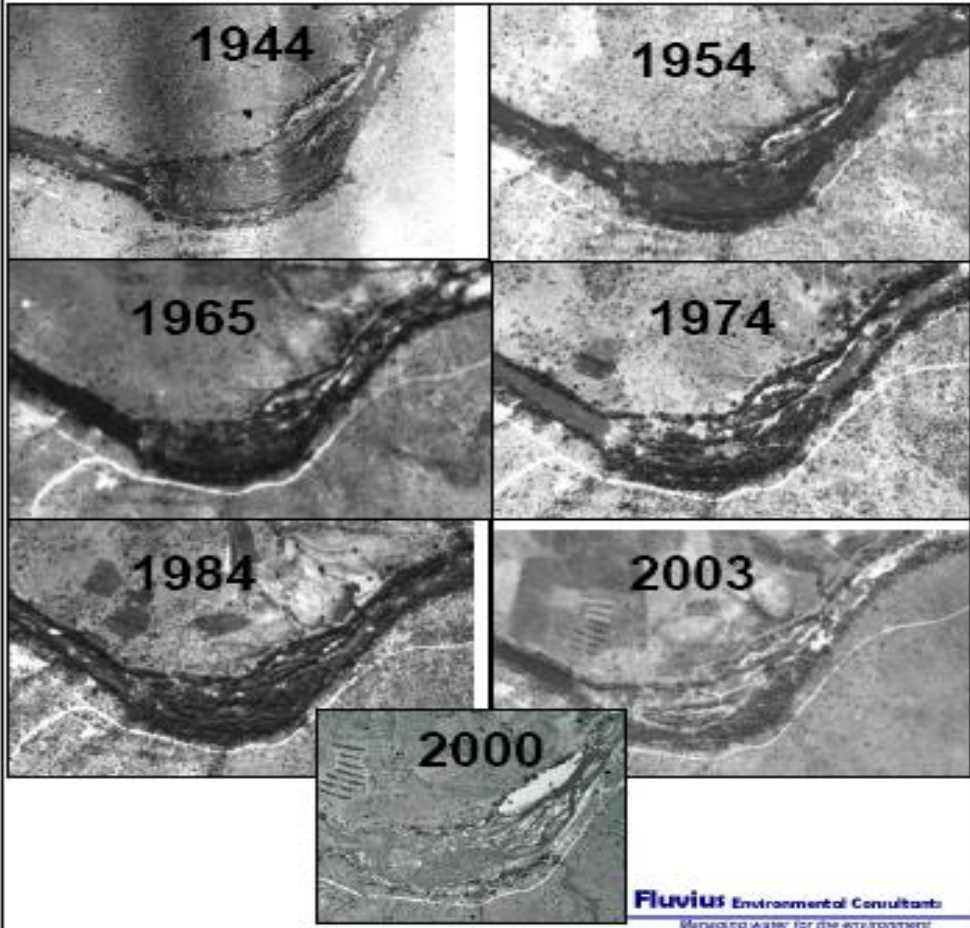
</div> <p data-bbox="256 1601 1230 1675">Sabie EWR Site 3: This site displays the typical cyclical patterns of sediment deposition and vegetation establishment (1944-1984) interrupted by large infrequent floods which scour the system (as in 1921 and 2000). Over the long term, the site is stable.</p> <p data-bbox="164 1684 1345 1926">This is a very well-studied site within the Kruger National Park. The site has representative sections of the bedrock anastomosing channel type. Although from 1944 until 1984, there was a very strong trend of increasing extent of woody vegetation, this trend was reversed following an extreme flood in February 2000. Thus the post – 2000 imagery appears very similar to the earliest 1944 imagery – the system has been “reset” by the 2000 flood, as has the 1944 image following the similarly large 1921 flood. The degrees of changes recorded by this sequence of aerial photography record a commonly identified pattern of sediment storage within Southern African eastern seaboard river (Rountree <i>et al.</i>, 2000; Rountree <i>et al.</i>, 2001; Rountree and Rogers, 2004). Sediment (and vegetation) accumulates in river systems over a period of decades and then this is removed when large infrequent flood events occur.</p>	4

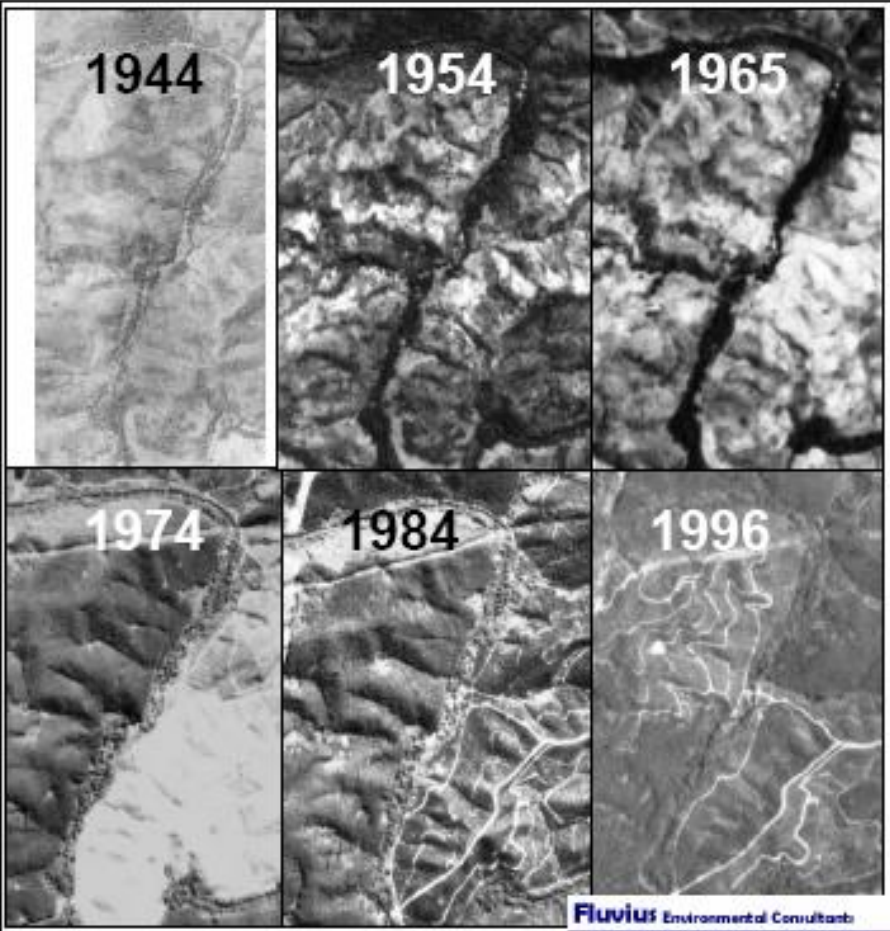
<p style="font-size: small; margin-top: 5px;"> Sable EWR Site 4: There seems to be an increase in woody vegetation. The small size of the channel and poor quality of the aerial photography preclude any detailed analysis of inchannel features. </p> </div> <p>From the aerial photographs, there appears to have been an increase in woody vegetation. The channel and areas of exposed bedrock which were evident in 1944 are again evident in the 2006/7 Google Earth imagery (which represents the site post the large floods in 2000). Overall, however, the site is very close to the natural condition.</p>	3.5

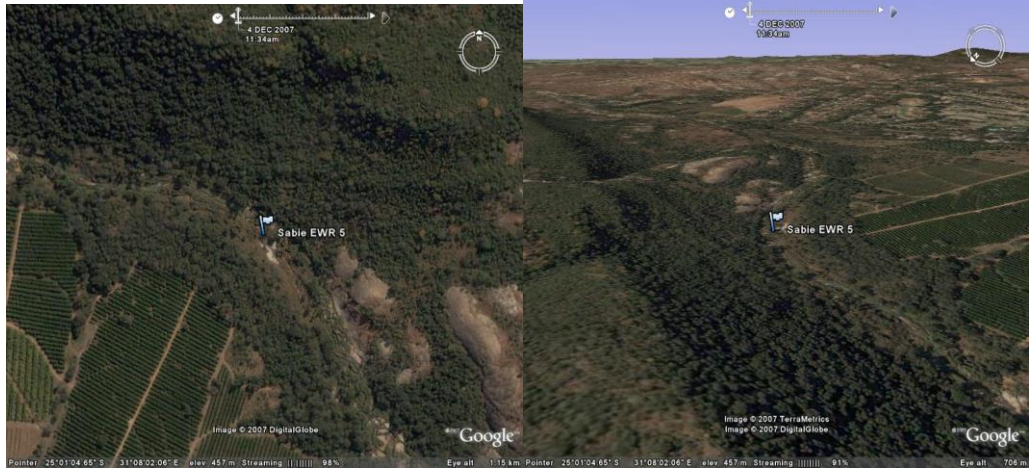
<p>Morphology of the site</p>	<p>The river is sandy and boulder dominated. Riffles and deep pools are present with sandy runs upstream. The site has shown progressively more stabilisation and vegetation encroachment of the bars since the 1980's, and there has been little removal of this vegetation from the extreme 2000 floods. The scale of photography and size of the channel makes it difficult to confidently assess the (likely) sedimentation issues at the site and hence ascribe the "natural" flux of the system to determine PES with high accuracy.</p>		
<p>PES</p>	<p>C (65.23%)</p>	<p>Confidence</p>	<p>2.5</p>

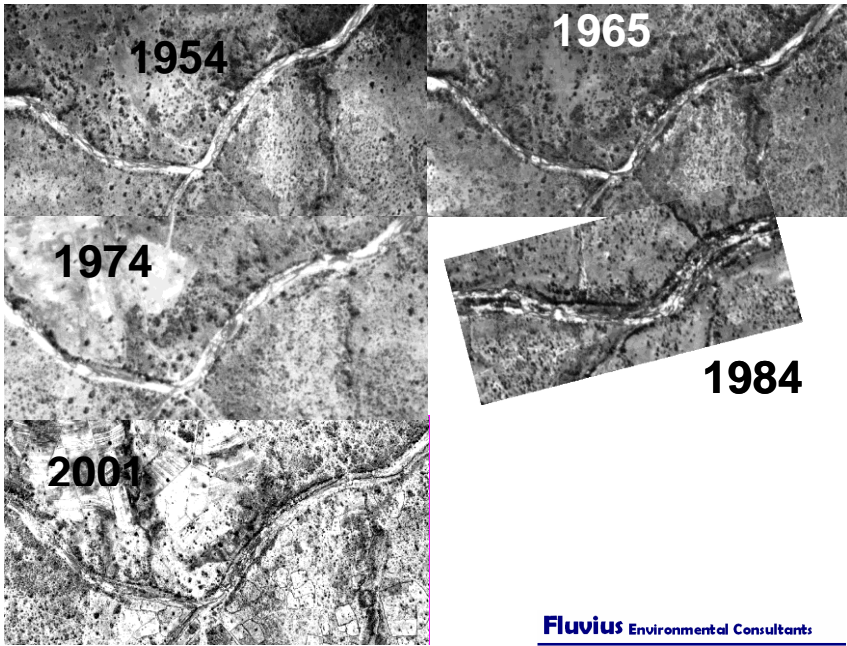
<p style="text-align: right; margin-right: 50px;">Fluvius Environmental Consultants <i>Managing water for the environment</i></p> <p>Sabie EWR Site 6: There has been a net increase in vegetation on the macro-channel floor, suggesting increased stabilisation of the sediment.</p> </div> <p>Reference state is a sandy, wide channel with bedrock outcrops and large boulders in the channel. The macro-channel floor is moderately vegetated.</p>	3

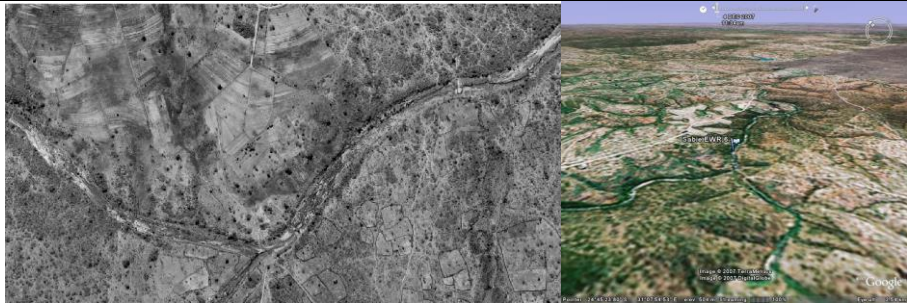
Morphology of the site	<p>The site is a multi-channel, bedrock to mixed anastomosing channel type; strongly bedrock controlled. The macro-channel floor has become more stabilised through larger, increasingly vegetated bars and sediment loads from the upstream catchment areas have increased significantly due to poor land management. Some (small-scale) sand mining within the macro-channel is occurring along the reach (MRU). There are no morphological cues, so Potential Bed Material Transport (PBMT, or bedload sediment) modelling is essential at this site. Possibly a terrace occurs, but is not paired. The general absence of fine sediment in the channels indicates a typically high energy environment.</p>		
PES	C (71.0%)	Confidence	3

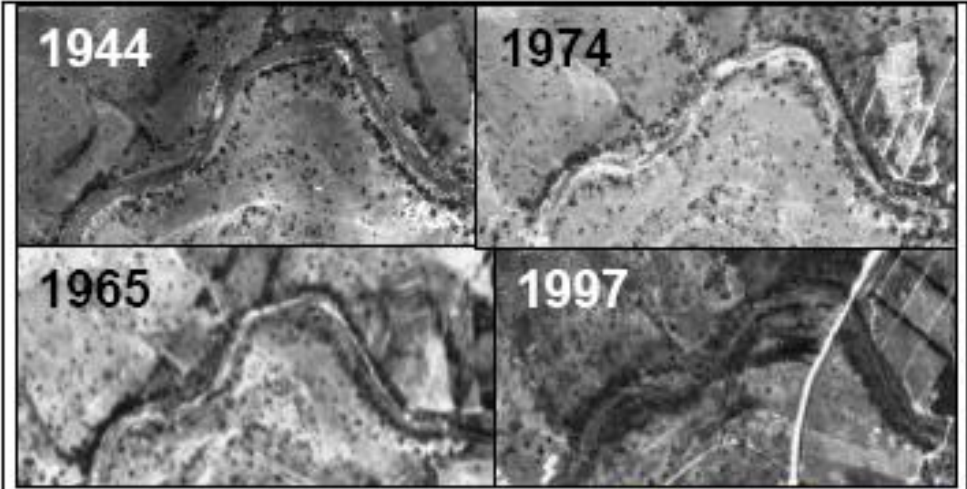
<p>Sable EWR Site 7: The active channel width has reduced significantly and there has been a net increase in vegetation on the macro-channel floor, suggesting a reduction in flood flows and a stabilisation of the sediment.</p>	3
Historically had a much wider active channel and more open macro-channel (i.e. less woody vegetation).

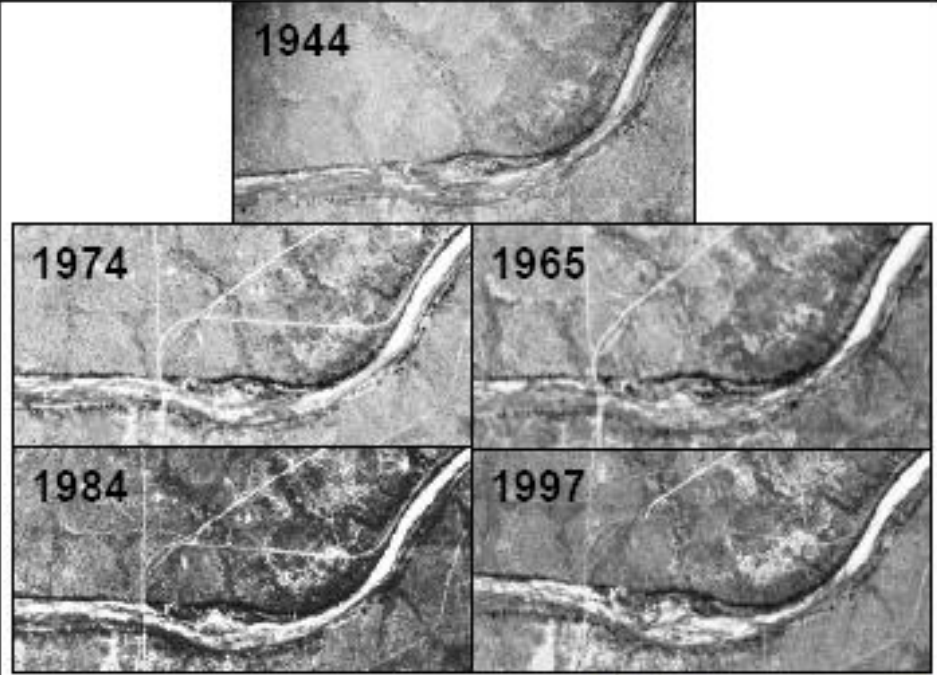
<p style="text-align: right; margin-right: 50px;">Fluvius Environmental Consultants <small>Managing water for the environment</small></p> <p>Sable EWR Site 8: There is little perceptible change, although the active channel width may have narrowed, and the macro-channel floor appears increasingly stabilised. This suggests a small reduction in flood flows and possible stabilisation of the sediment.</p> </div> <p>Reference condition includes a wide active channel with a less stable macro channel floor.</p>	3.5

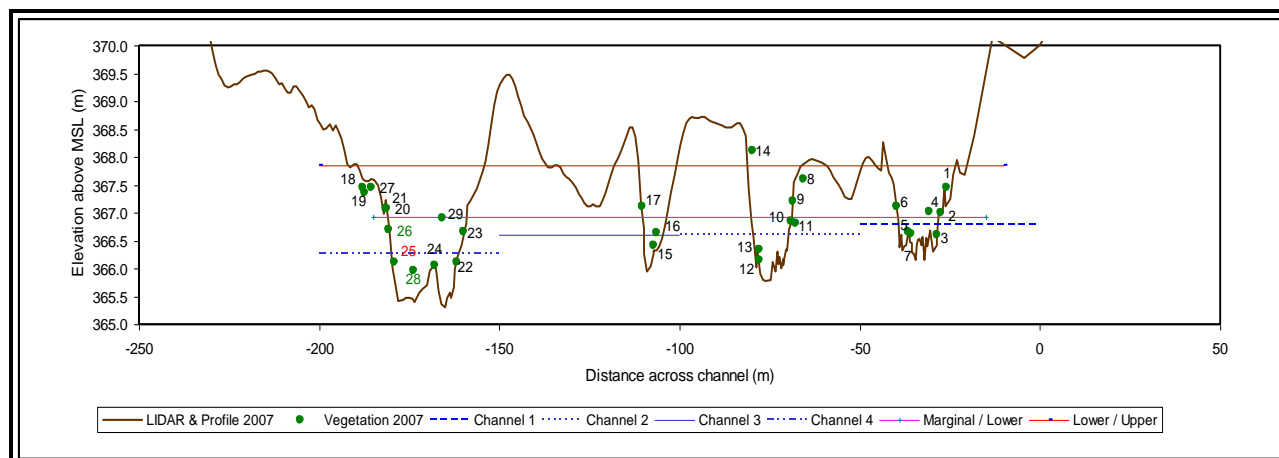
Figure H10 EWR 3: Riparian vegetation survey points used to assess flow requirements

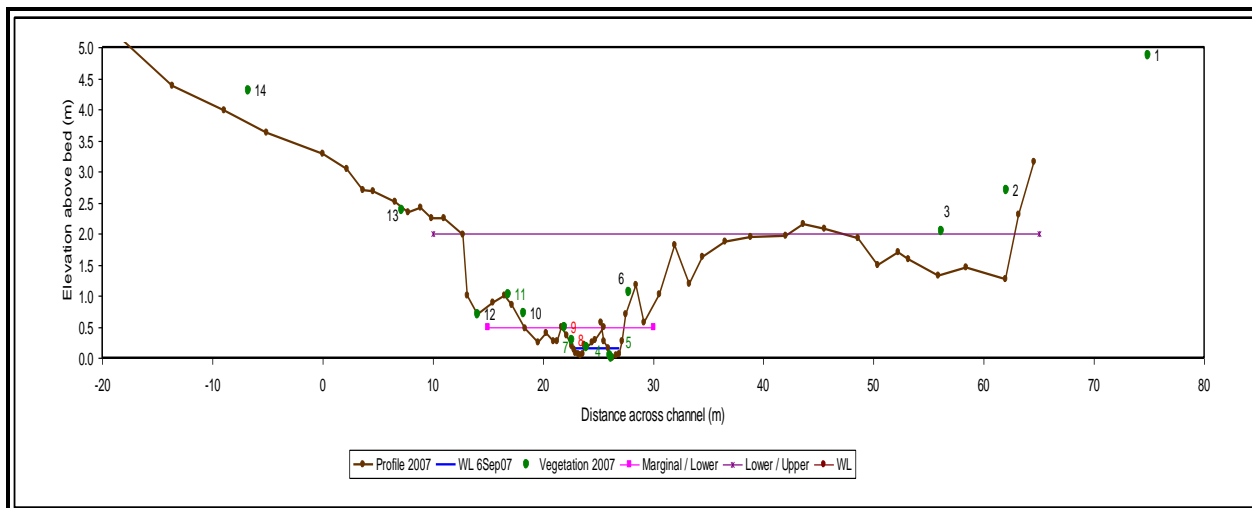
Figure H14 EWR 7: Riparian vegetation survey points used to assess flow requirements

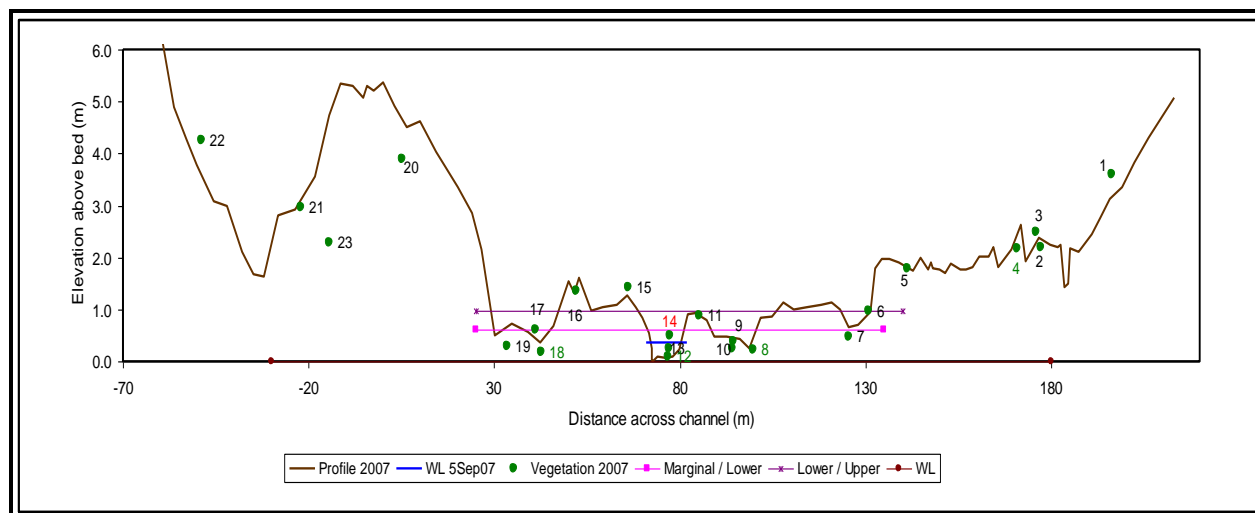
Figure H15 EWR 8: Riparian vegetation survey points used to assess flow requirements
