DETERMINATION, REVIEW AND IMPLEMENTATION OF THE RESERVE IN THE OLIFANTS/LETABA SYSTEM

Report Title: Eco-classification Report

ECO-CLASSIFICATION REPORT

Golder Associates Africa

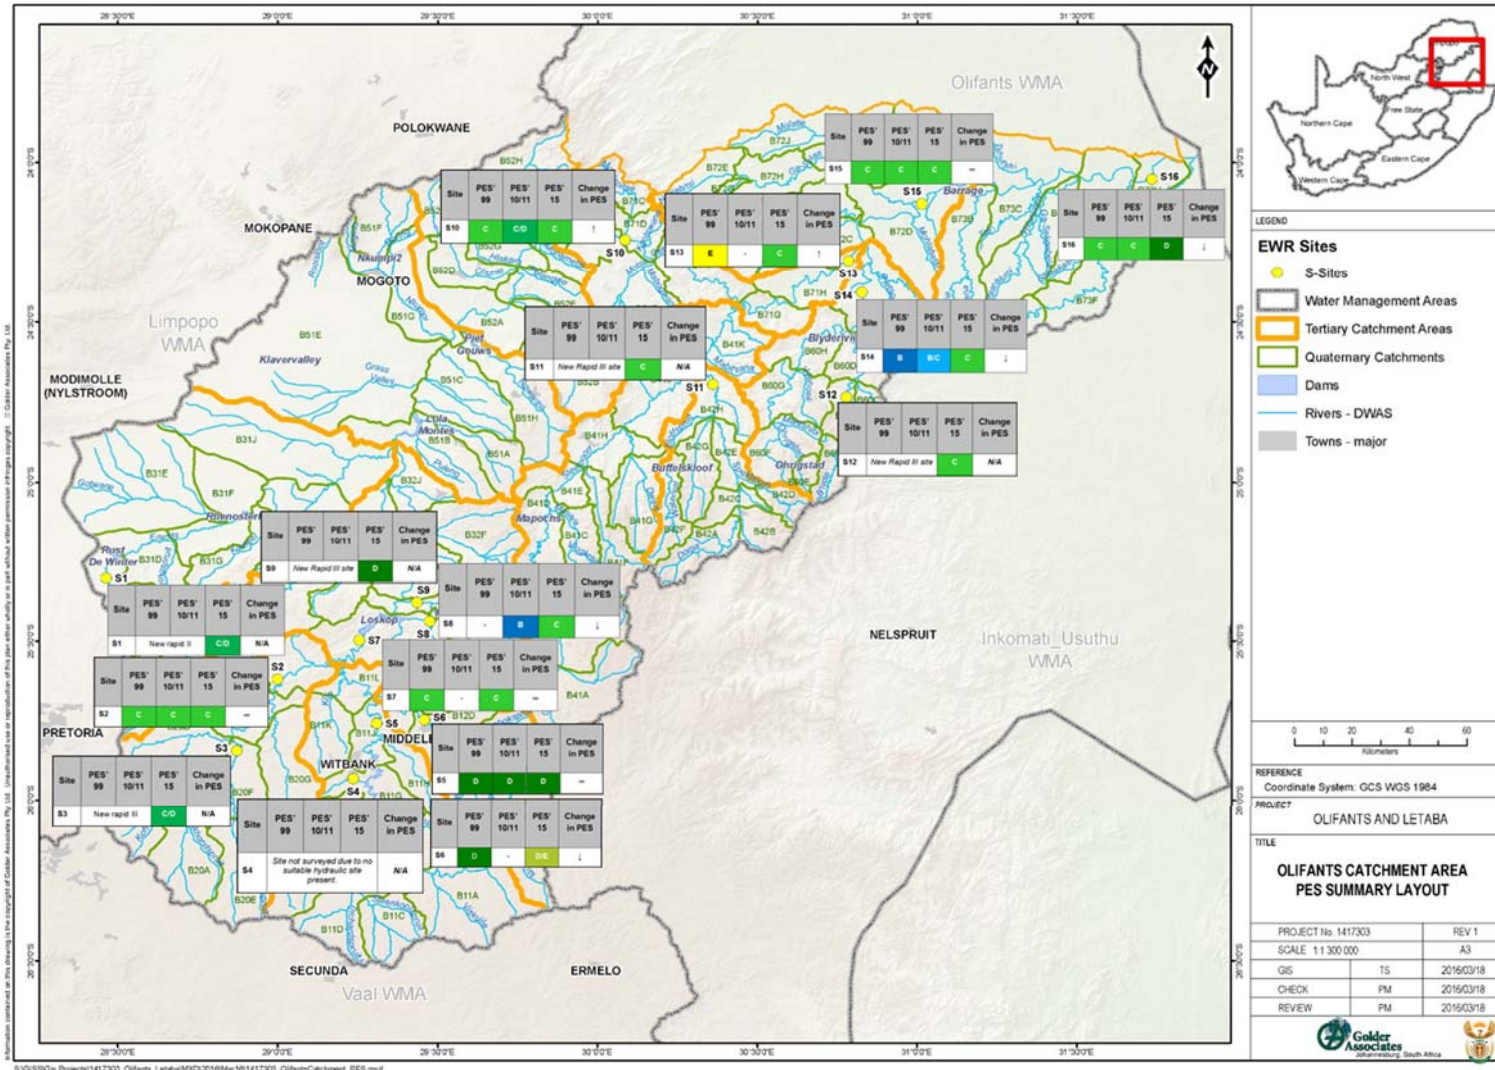
Figure A: Summary illustrating the overall change in the PES for each EWR site within the Olifants catchment (map created by Golder)

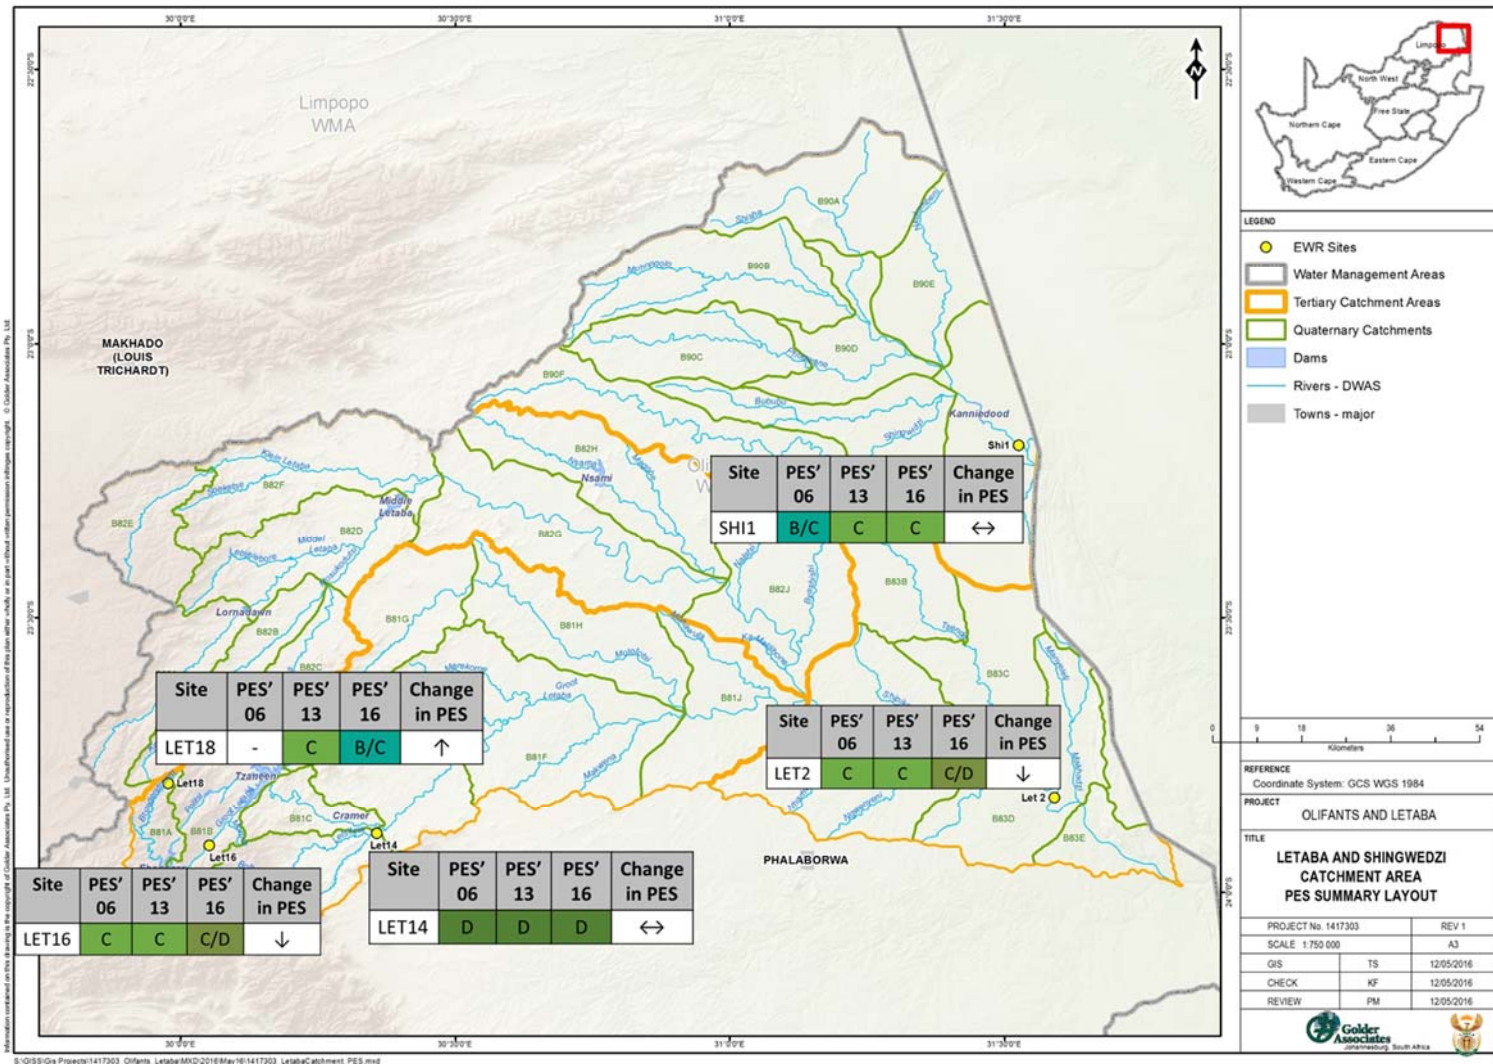
Figure B: Summary illustrating the overall change in the PES for each EWR site within the Letaba and Shingwedzi Catchments (map created by Golder)

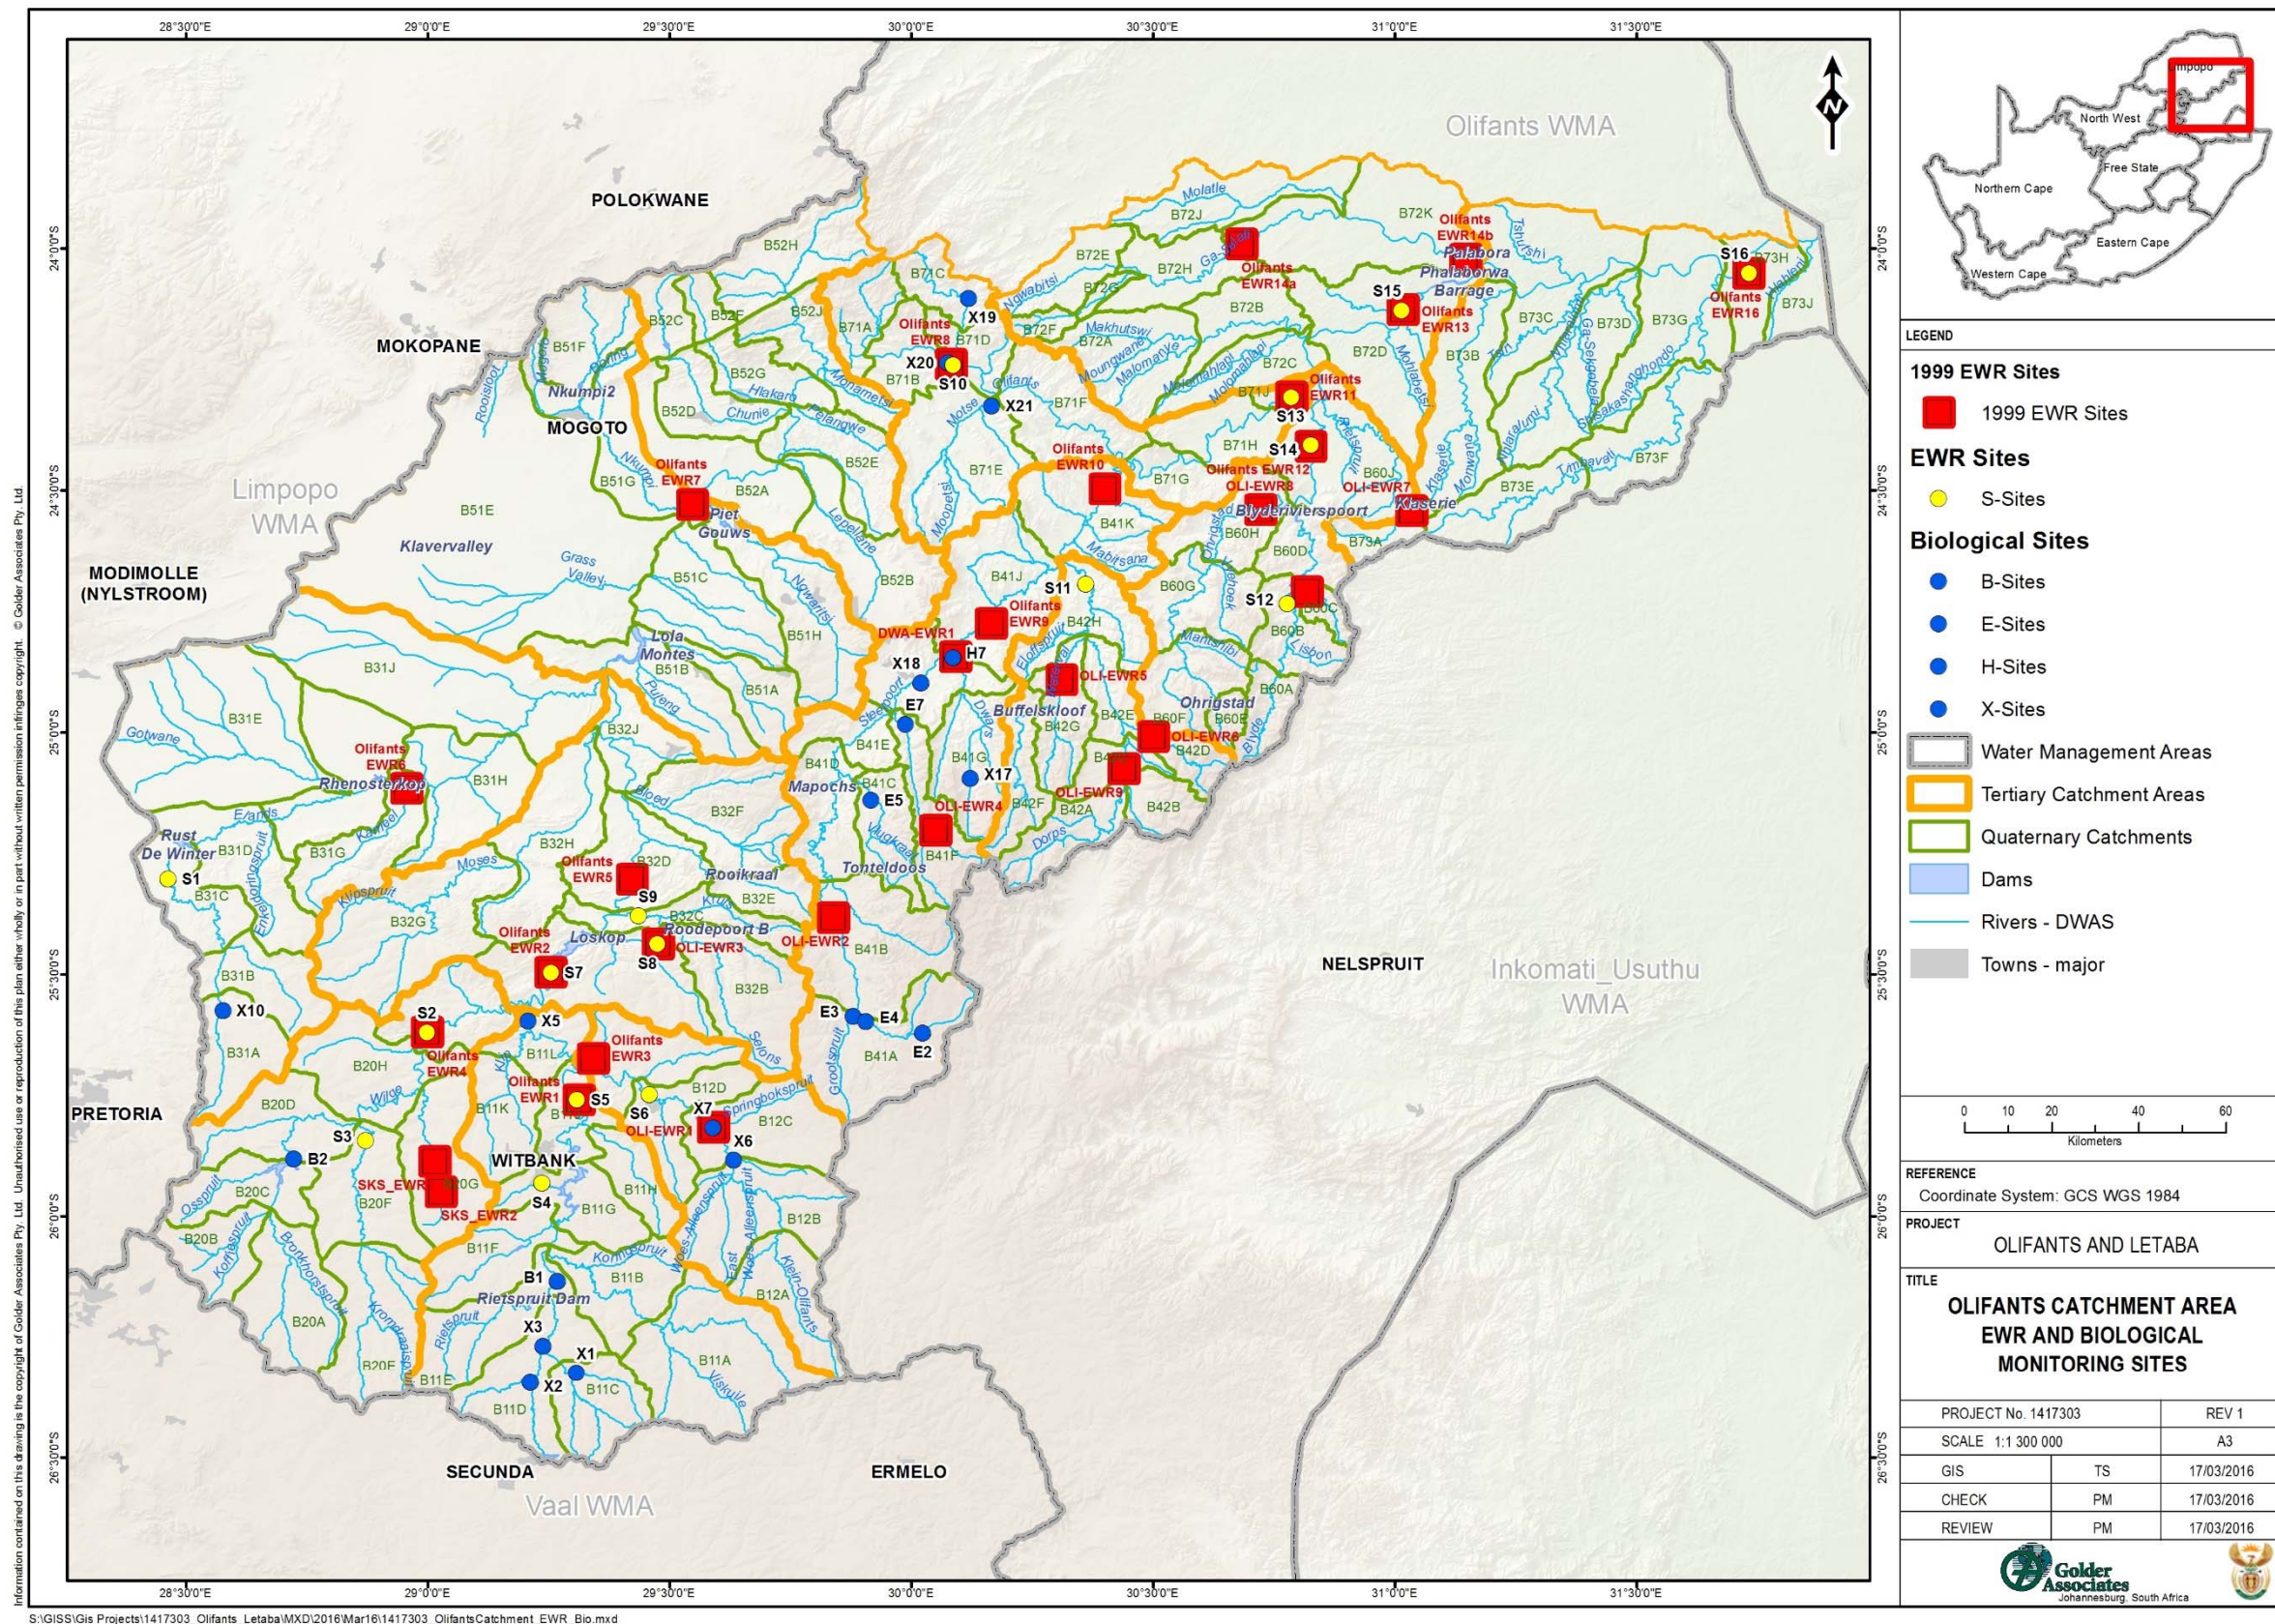
Figure 2: Priority sites identified indicating type of survey required in the Olifants Catchment (map created by Golder)

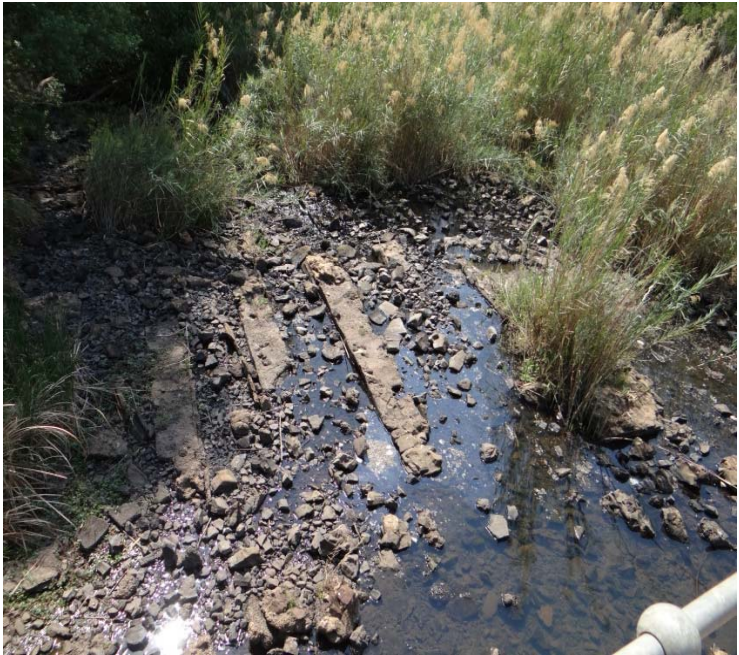
3.1.1 SITE S1: ELANDS RIVER

| SITE | DETAILS | VIEW |
|---|---|---|
| SITE AND UPSTREAM IMPACTS <ul style="list-style-type: none"> Very low flows Exposed soils (erosion) Agricultural activities Several small dams Artificial widening of river owing to a bridge High organic material content observed namely algae and silt. This can be attributed largely to leaves from canopy | | |

| S1: Site Evaluation | | | |
|---|---|---|--|
| Hydraulics | 1 | The site is easily accessible. | An upstream bridge (and remains of an old bridge) and downstream reed beds will influence the hydraulics under high flow conditions. The bridge pillars deflect flows towards the right hand bank. The wide site is not representative of the river. |

This is a new rapid 2 site following the gap analysis. Limited access to biotopes as a result of the low and reduced water levels observed at the time of the survey (October 2015), resulted in a reduced ecostatus.

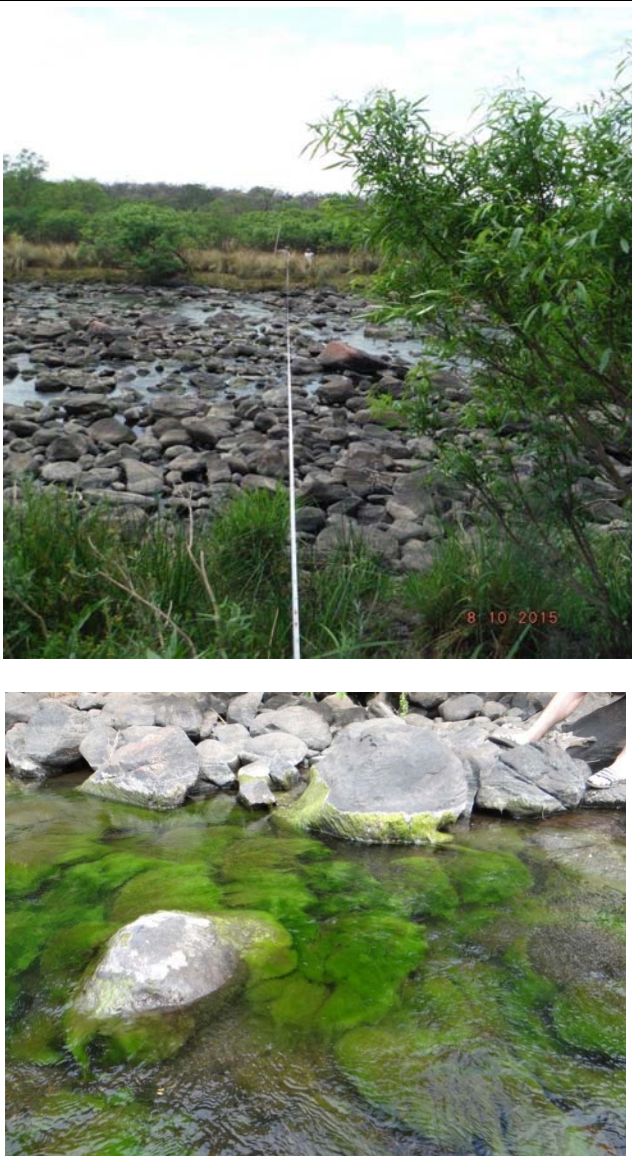
3.1.2 SITE S2: LOWER WILGE RIVER (old comprehensive Olifants-EWR4)

- Dense algae and fine sediments were observed
- Green algae dominate in fast flowing water
- Sediments noted out of channel and as a result less green algae
- Agricultural activities
- Upstream abstraction activities

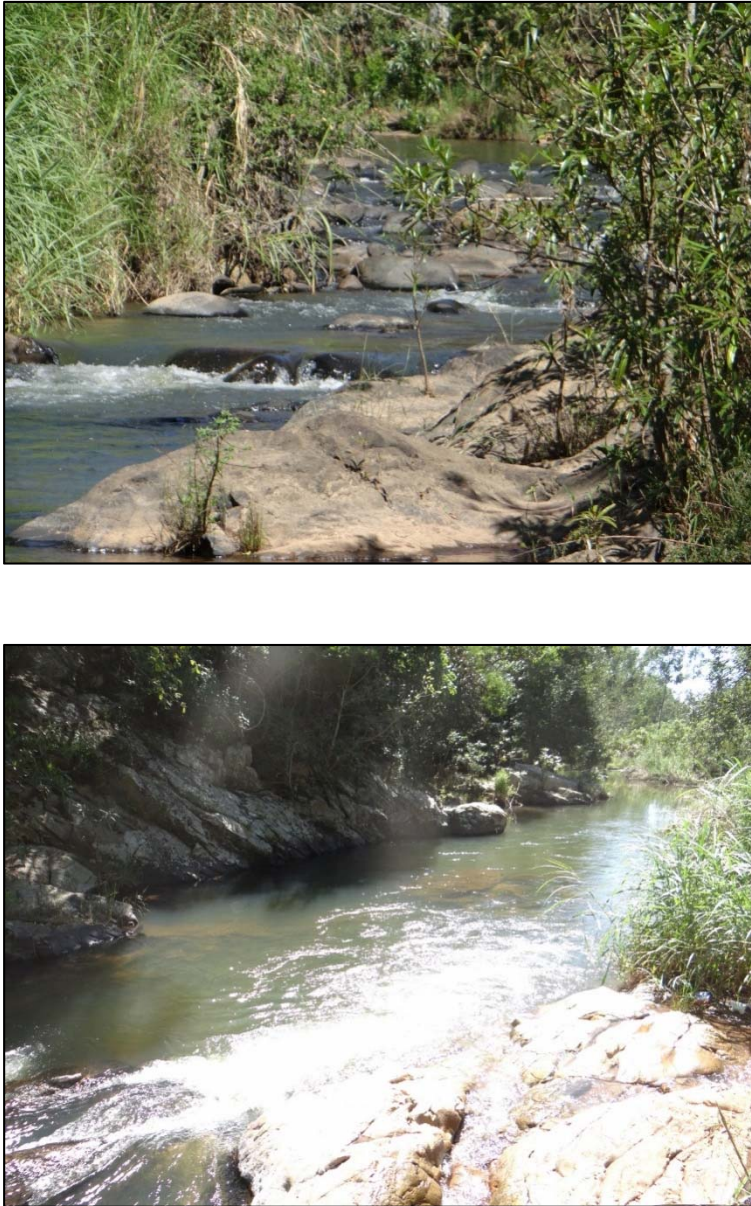
4.1.3 SITE LET16: LETABA RIVER (OLD LETABA EWR1 SITE)

| Let16: PES and causes | |
|---|--|
| Macroinvertebrates | The modified flow and dry conditions resulted in poor habitat availability and therefore a large number of families were absent. Of the 56 families associated with flow, only 12 were recorded, only 14 of the 56 associated with the biotope |

| | diversity and only 17 of the 72 associated with the water quality conditions. |

- Owing to the proximity of this site, full comprehensive surveys should be conducted annually
- Stringent management measures for this reach should be revised and updated within the existing catchment management plan
- Chemical and *in situ* water quality should be monitored bi-annually
- Diatom samples should be taken minimum annually
- Fish (FRAI) and macroinvertebrates (MIRAI) should be monitored annually during the low flow conditions
- Riparian VEGRAI should be conducted every 3 years
- The IHI should be conducted annually

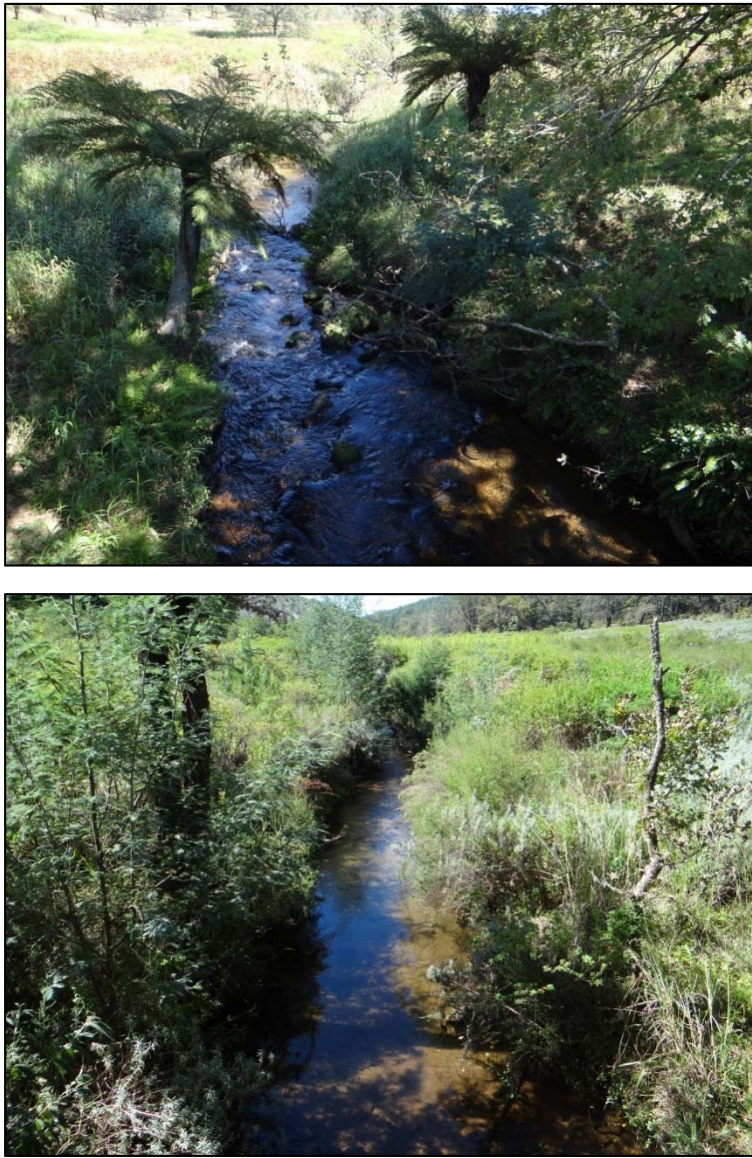
4.1.4 SITE LET18: BROEDERSTROOM

| Let18: PES per component for EWR site and Ecstatus | | | |
|--|---|---|---|
| Fish | D (48.2) | F & NF | <p>Low diversity of fish expected, due to location in the upper catchment.</p> <p>Long history of <i>Oncorhynchus mykiss</i> (OMYK) has resulted in the predation of indigenous species.</p> <p>As the FRAI model is based on a deviation of fish species expected to occur, to those observed, no result could be obtained due to no indigenous fish being present.</p> <p>The instream and riparian habitat proved to be sufficient for the expected <i>Enteromius (Barbus) Neefi</i> and <i>Linmaculatus</i> and <i>Amphilius uranoscopus</i> species.</p> <p>The FRAI model has been adjusted to take into account the habitat which is present for the fish species despite the site only consisting of alien fish species. The class D is owing to the highly modified view that the alien fish species have reduced the indigenous fish species.</p> |

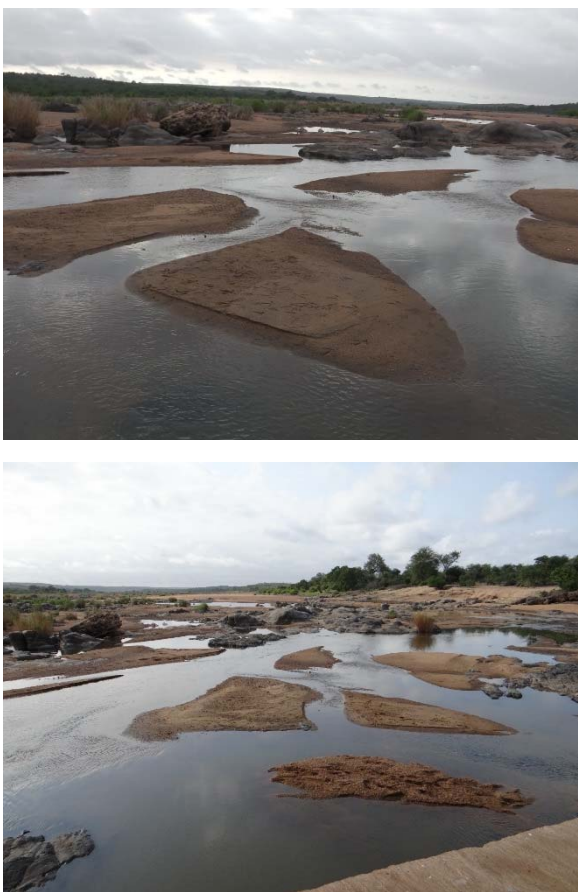
4.2.1 SITELET1: LETABA RIVER

| SITElet: 1 | DETAILS | VIEW |
|--|---|---|
| <p>HABITAT AND BIOTA</p> <ul style="list-style-type: none"> • Bedrock and sand dominated, some boulders with limited cobbles (mostly bedrock) – no root wads or marginal vegetation. • Aquatic macroinvertebrates: ASPT: 6.0 (moderately tolerant taxa) • Fish Habitat: Moderate (Lacking diversity under current flow conditions) | | |

| LET 1: Site evaluation | | | |
|---|---|--|---|
| Fish | 4 | Bedrock in this section of river provides good habitat and refugia for fish, as well as the physical structures for a variety of velocity-depth classes. | Low flow conditions. No marginal or instream vegetation |

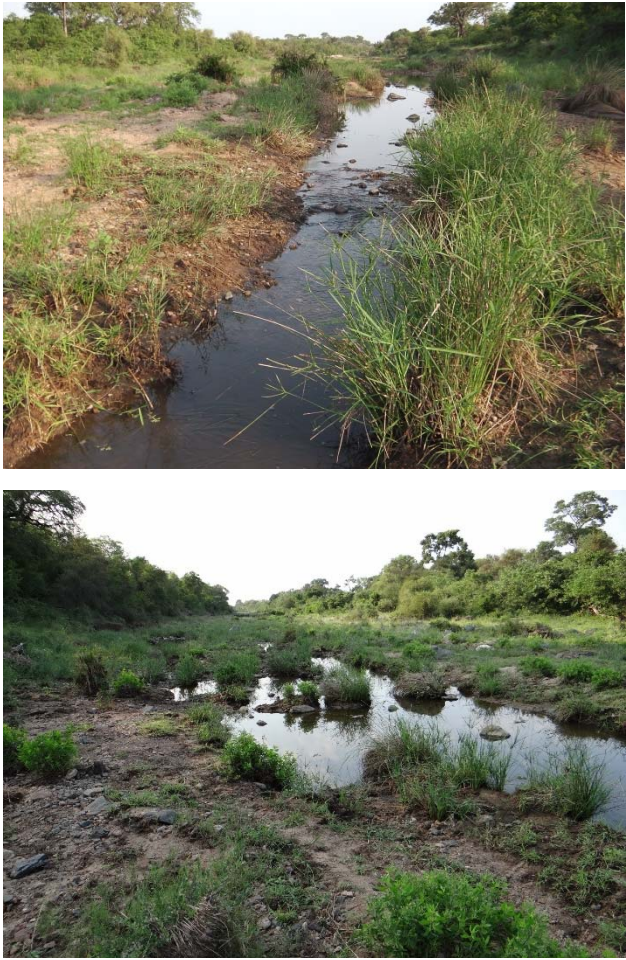
4.2.2 SITELET 3: TSENDE RIVER

| SITE | DETAILS | VIEW |
|---|---|---|
| <p>HABITAT AND BIOTA</p> <ul style="list-style-type: none"> • Most biotopes present, but under current flow conditions, most exposed. • Trampling of riparian and marginal vegetation (wildlife). • Aquatic macroinvertebrates: ASPT: 5.2 (moderately to highly tolerant taxa) • Fish Habitat: Moderate - Good | | |

| LET 3: Site evaluation | | | |
|---|---|--|--|
| Fish | 3 | SD and SS habitats available. Undercut banks and substrate heterogeneity. Some overhanging vegetation. | Low flow conditions have limited the extent of sampling in side channels and marginal vegetation. |
| Riparian vegetation / Habitat Integrity | 4 | Represent the river reach Vegetation in a good condition | Low flows exposed good SIC/SOC during current survey Limited impacts from mega herbivores related to drought conditions |

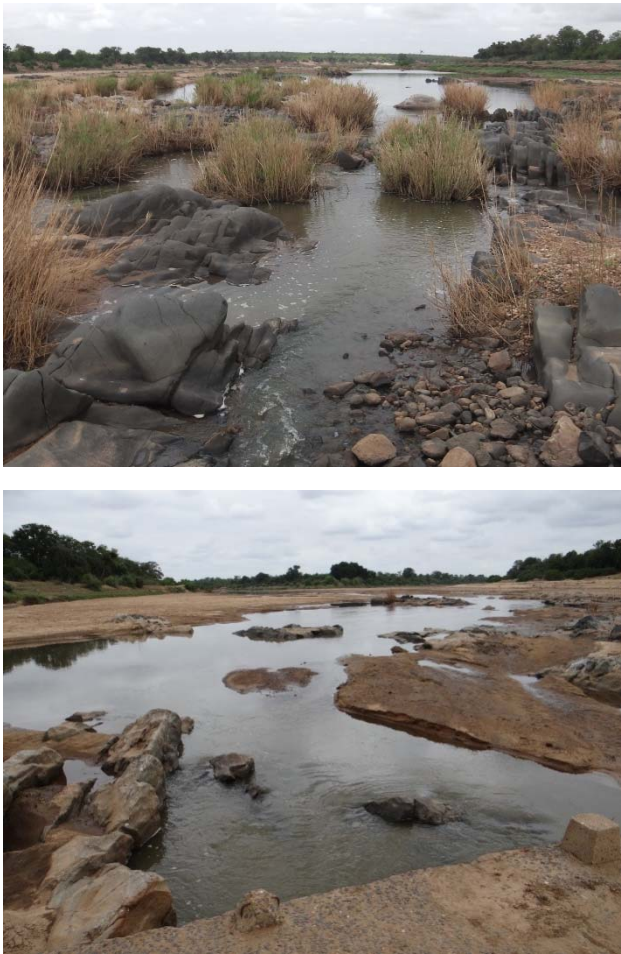
4.2.3 SITELET 4: LETABA RIVER

| LET 4: Site evaluation | | | |
|---|---|--|---|
| Fish | 4 | Good diversity of velocity-depth classes even under current flow conditions. Substrate heterogeneity (sand, cobbles, boulders and mud). | Low flow conditions meant banks and side channels were not activated. |

The site is located in the Letaba River, just below the confluence of the Groot and Klein Letaba tributaries. Upstream impacts from the catchment include agricultural activities, informal settlements and land degradation, all which are contributing to the degraded status of the water quality. It is important that this site is continually monitored as it is a benchmark for the rivers state as it enters the Kruger National Park.

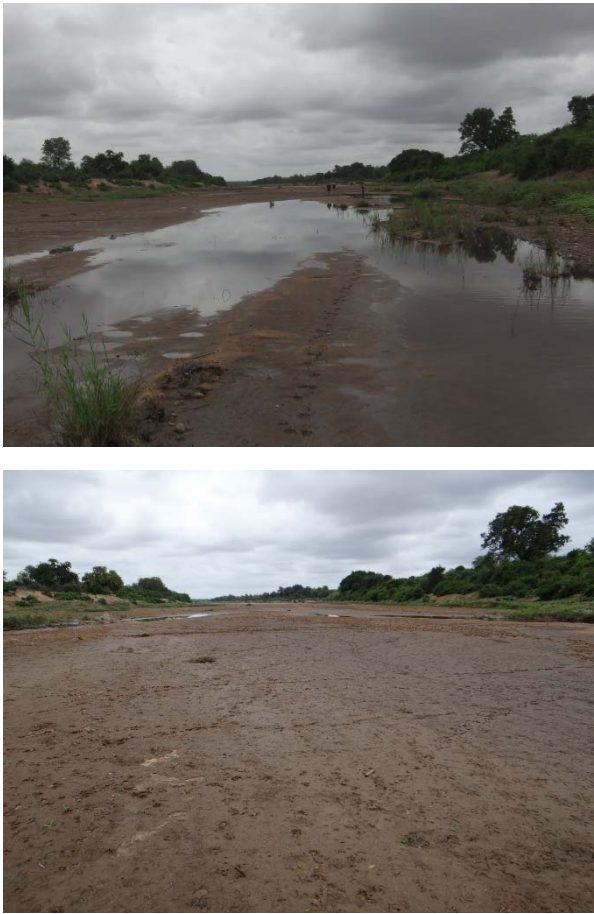
4.2.4 SITELET 5: KLEIN LETABA RIVER

| SITE | DETAILS | VIEW |
|---|---|---|
| <p>HABITAT AND BIOTA</p> <ul style="list-style-type: none"> Limited habitat diversity – dominated by GSM – some marginal vegetation available under normal flow conditions. Aquatic macroinvertebrates: (no SASS5 conducted due to lack of habitat/flow, shallow puddles) Fish Habitat: Poor (fish not sampled) | | |

| LET 5: Site evaluation | | | |
|---|---|---|---|
| Riparian vegetation / Habitat Integrity | 4 | Intact in the park, habitat in good condition | Outside impacts having a negative impact on the habitat – low flows and siltation |

The site is located in the lower section of the Klein Letaba River before the confluence with the Groot Letaba (becoming Letaba River). Originating outside of the Park, the Klein Letaba flows through the Hlanganani and Giyani regions and as a result of land use practices and informal settlements, water quality is considered degraded with nutrients and high sediment loads present.

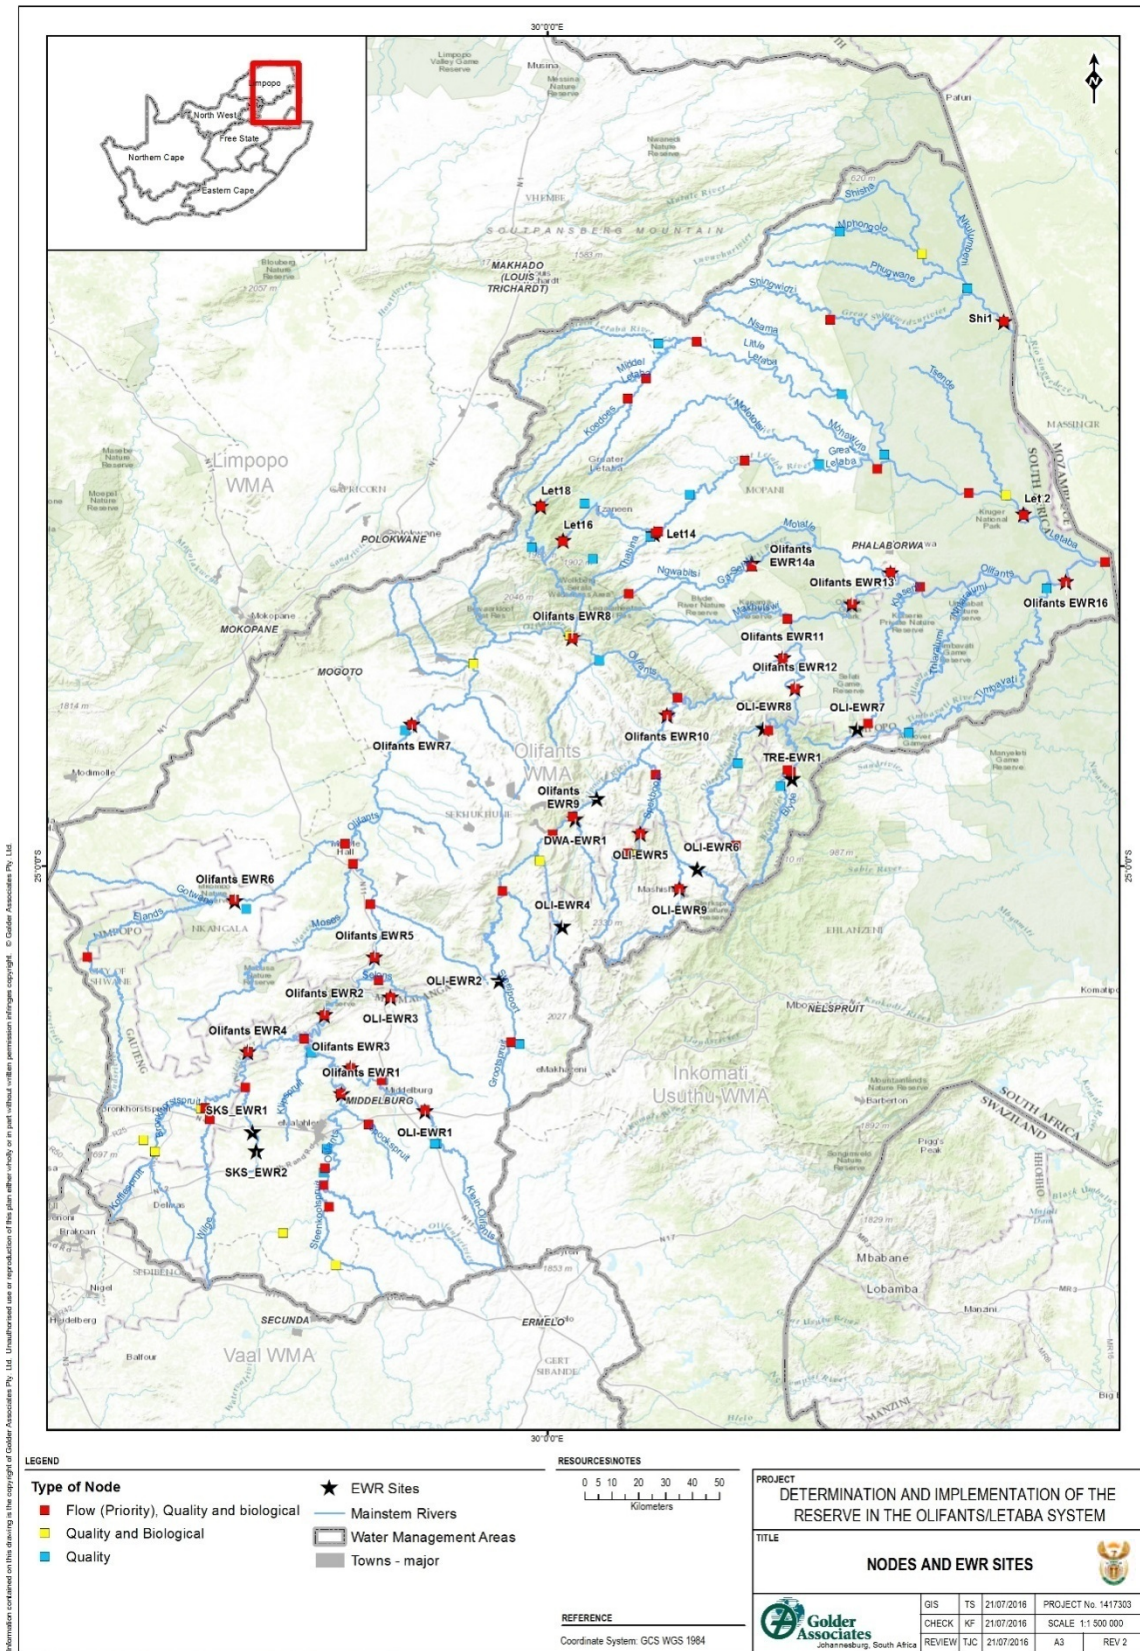
Figure 5: Indicating IUAs with location of initial selection of hydronodes and EWR sites. The black stars indicate the existing EWR sites. The red blocks show the priority sites where flow is a high priority, yellow blocks indicate a high priority for quality and biological and the blue blocks a high priority for water quality. (map created by Golder).

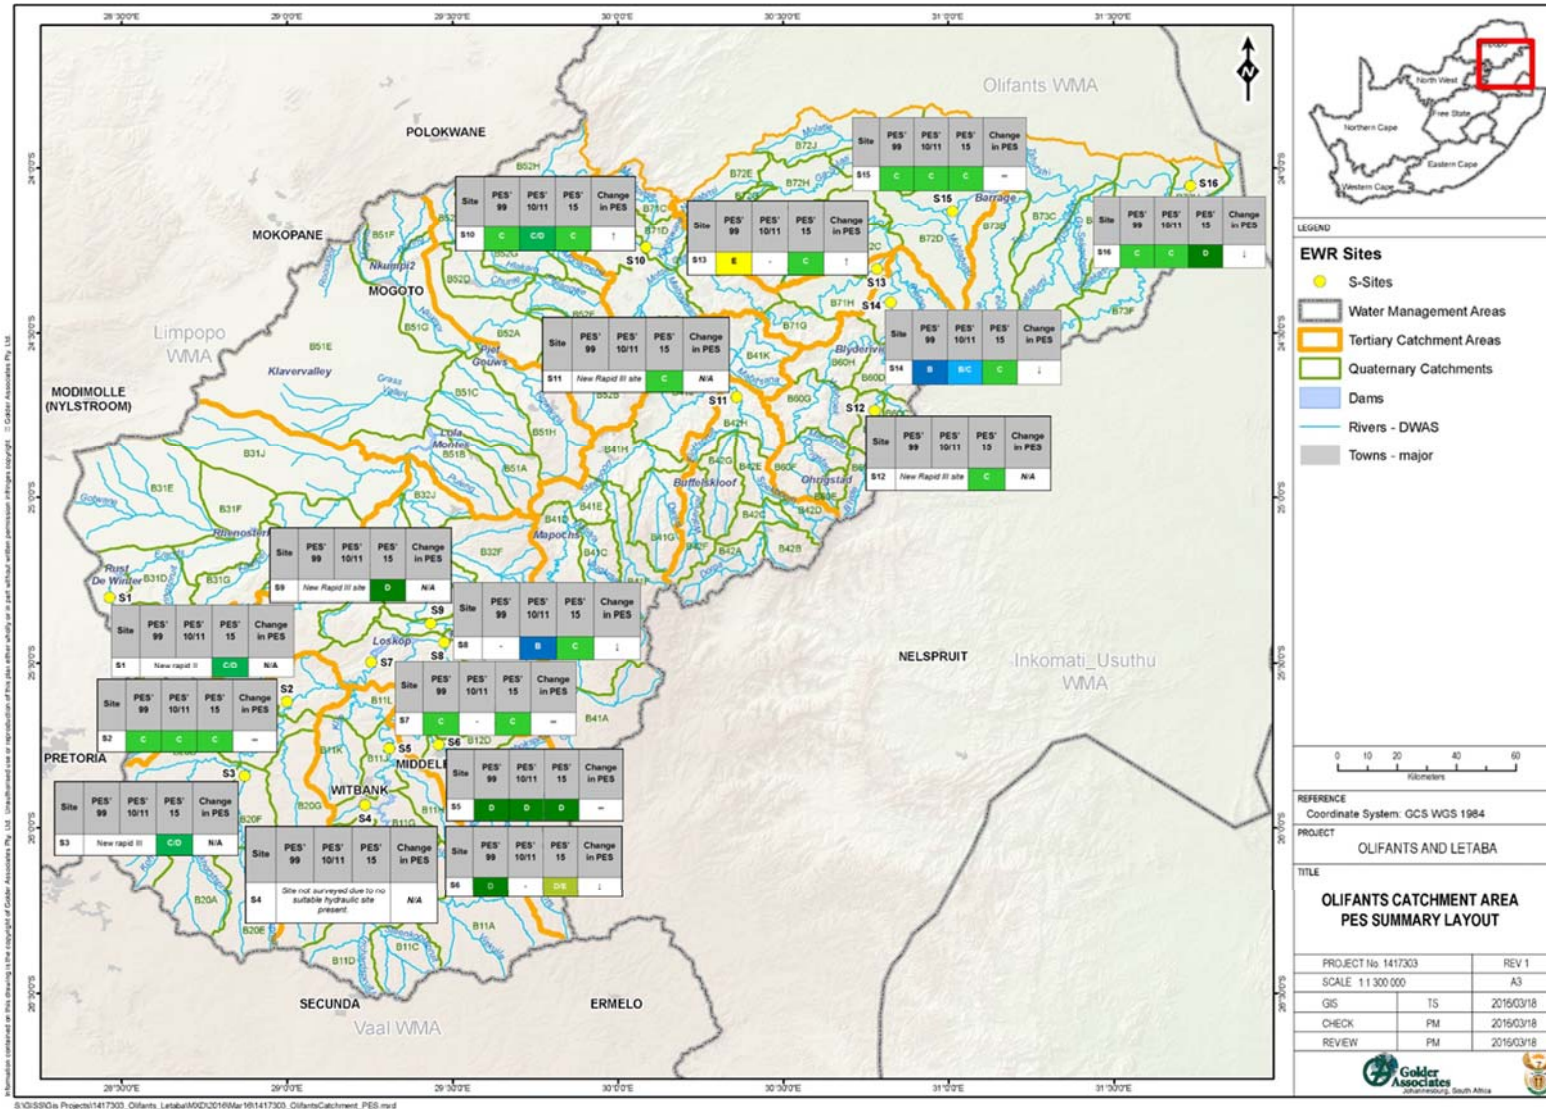
Figure 6: Summary illustrating the overall change in the PES for each EWR site within the Olifants catchment (map created by Golder)

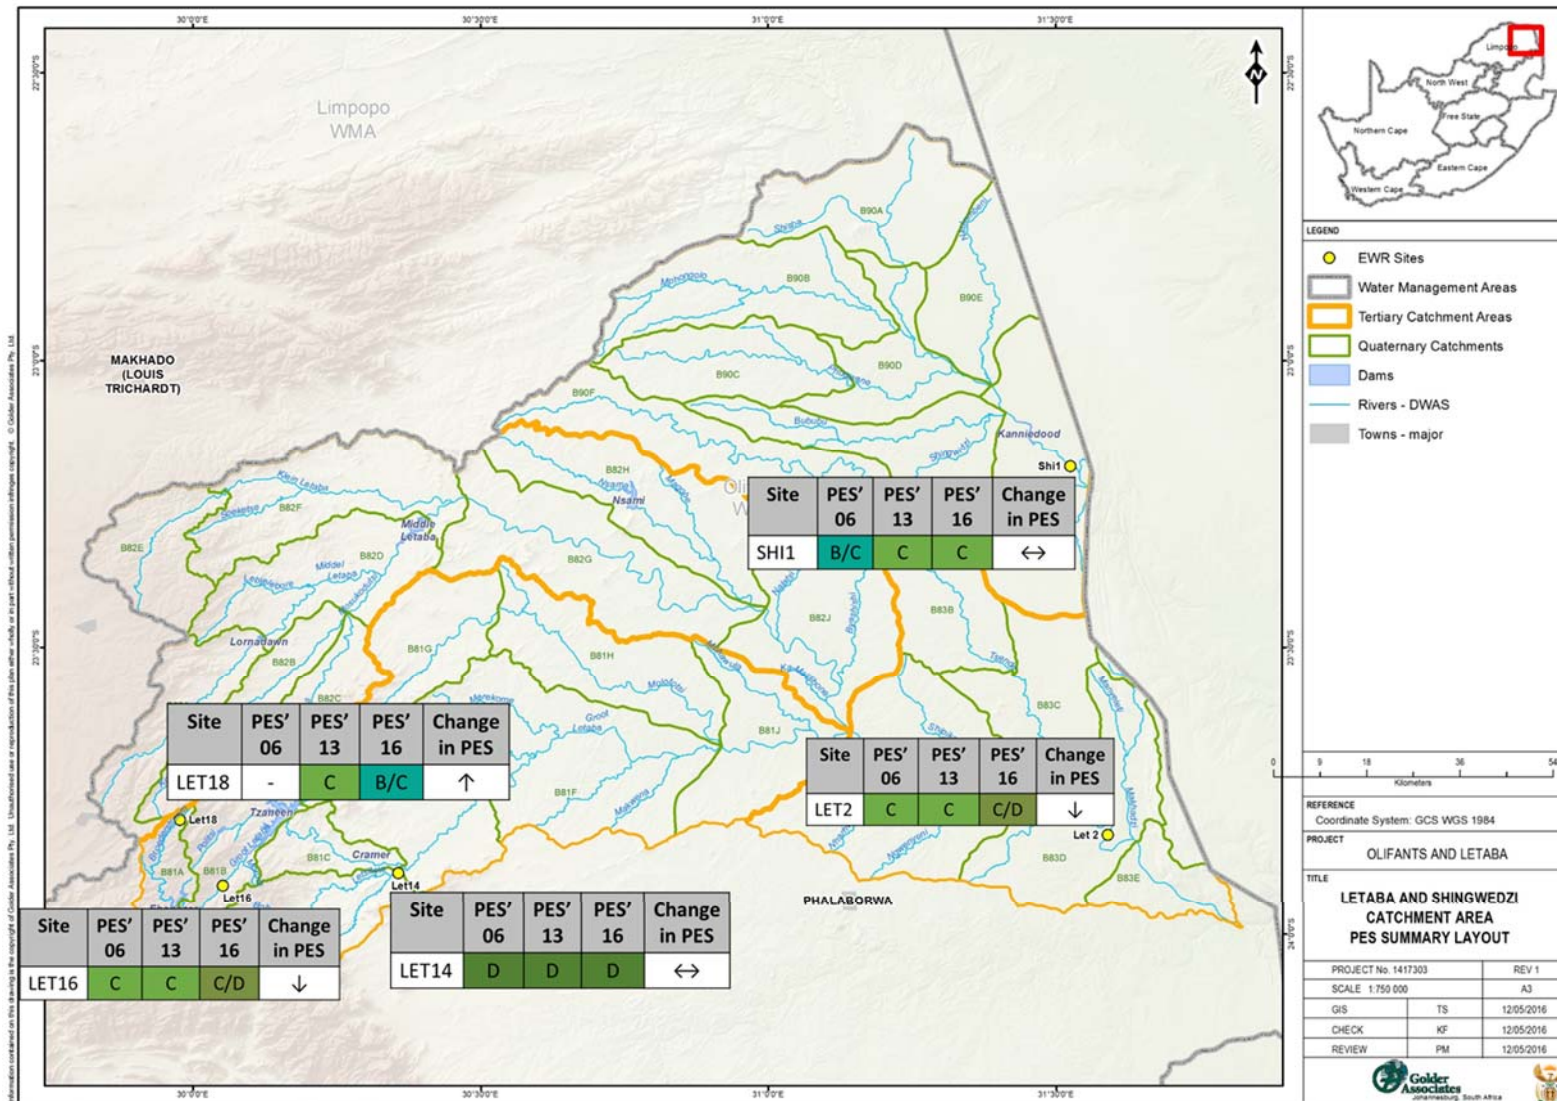
Figure 7: Summary illustrating the overall change in the PES for each EWR site within the Letaba and Shingwedzi catchments (map created by Golder)
